Watershed Emergency Response Team Evaluation

CZU LIGHTNING COMPLEX

CA-CZU-005205

October 1, 2020

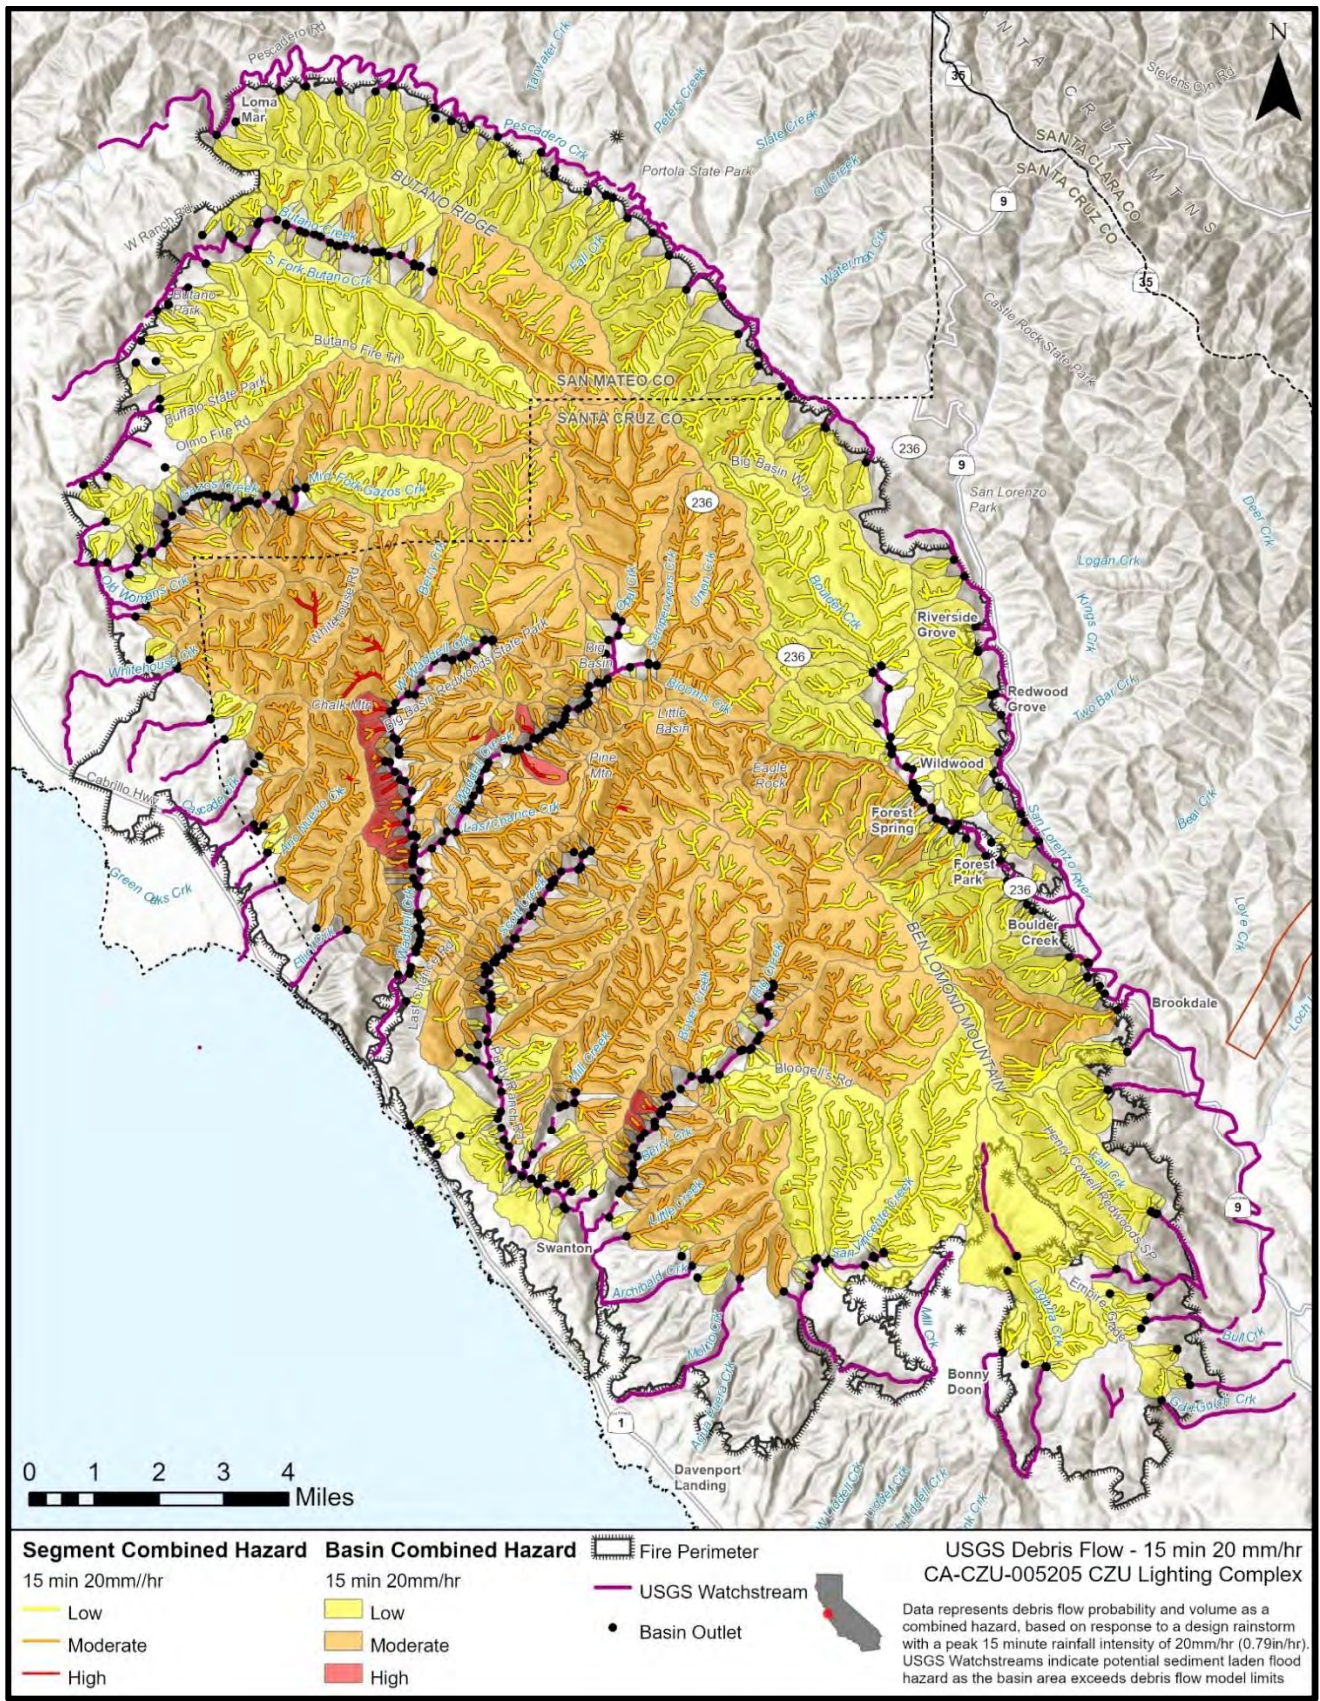
Figure 9. USGS debris flow model results for the 15-min 20 mm hr⁻¹, CZU Lightning Complex.

- A storm scenario of approximately 0.20 inches in 15-minutes (i.e., 0.79 in hr⁻¹ or 20 mm hr⁻¹ for the 15-minute duration) equates to a moderate combined hazard for the western and interior portions of the fire, and generally low combined hazard for the eastern portion of the fire (see Figure 9).

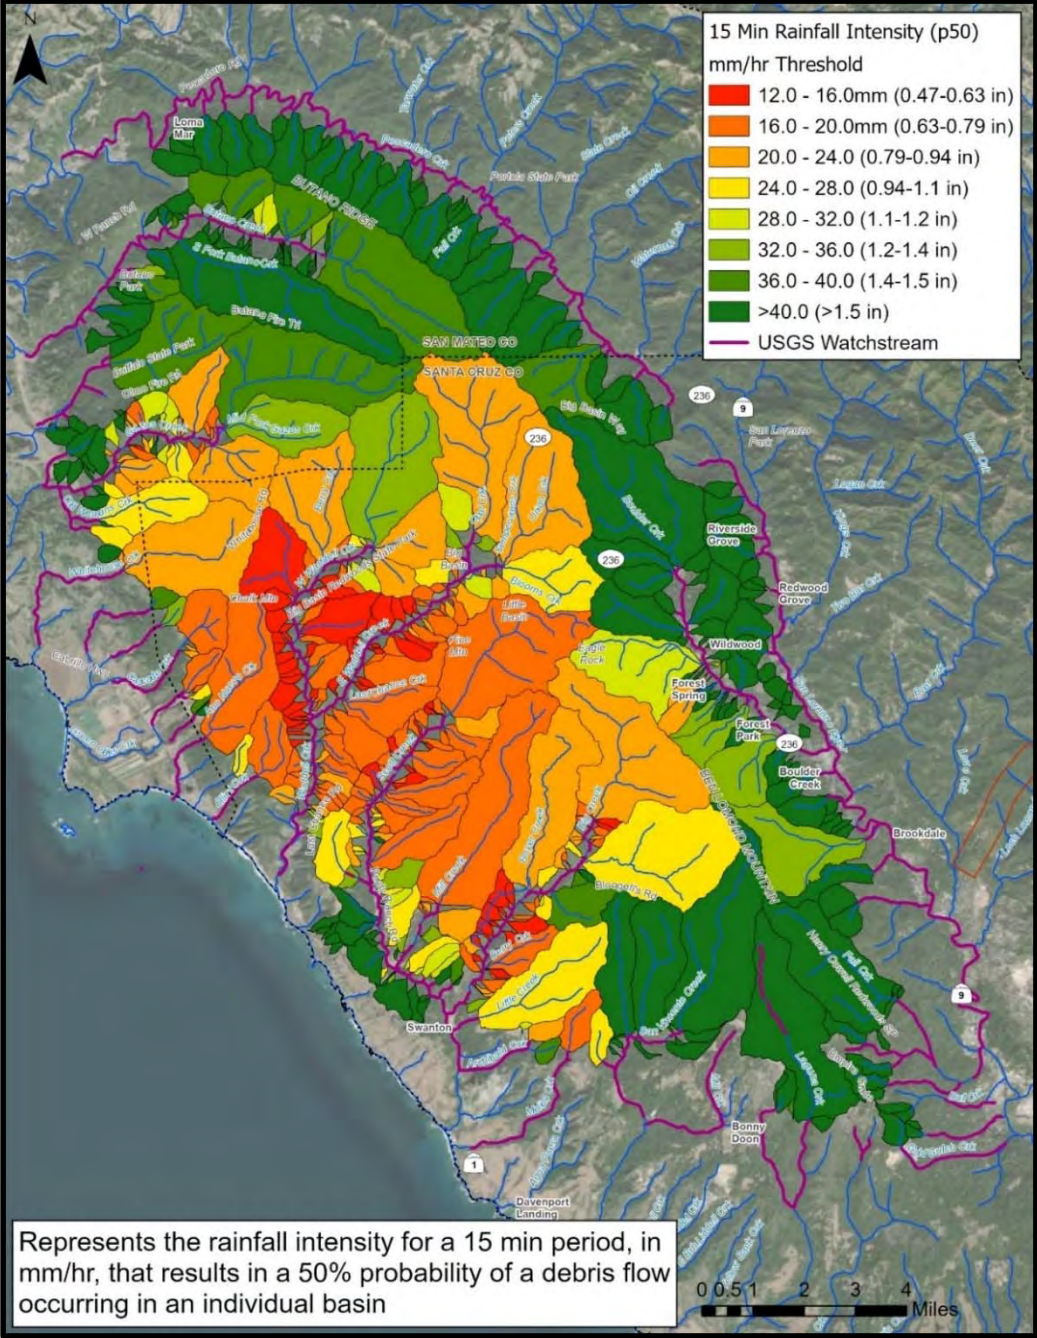
Figure 12. 15-minute rainfall intensity necessary to trigger a debris flow with a probability of 50 percent for the CZU Lightning Complex.

The USGS debris flow model can also calculate the 15-minute rainfall intensity necessary to trigger a debris flow with a probability of 50 percent. Figure 12 indicates that much of the western portion of the fire might see a triggering of debris flows when 15-minute intensities fall within the range of 12 to 24 mm hr⁻¹ (i.e., 0.47 to 0.94 in hr⁻¹). The eastern portion of the fire near the SR 9 and 236 corridors have basins with likely rainfall thresholds that range from 28 to 40 mm hr⁻¹ (1.1 to 1.5 in hr⁻¹). The spatially explicit calculation of basin specific rainfall thresholds can be a useful tool for revising rainfall thresholds if the initial Early Warning System threshold is deemed too conservative based on monitoring and observations.

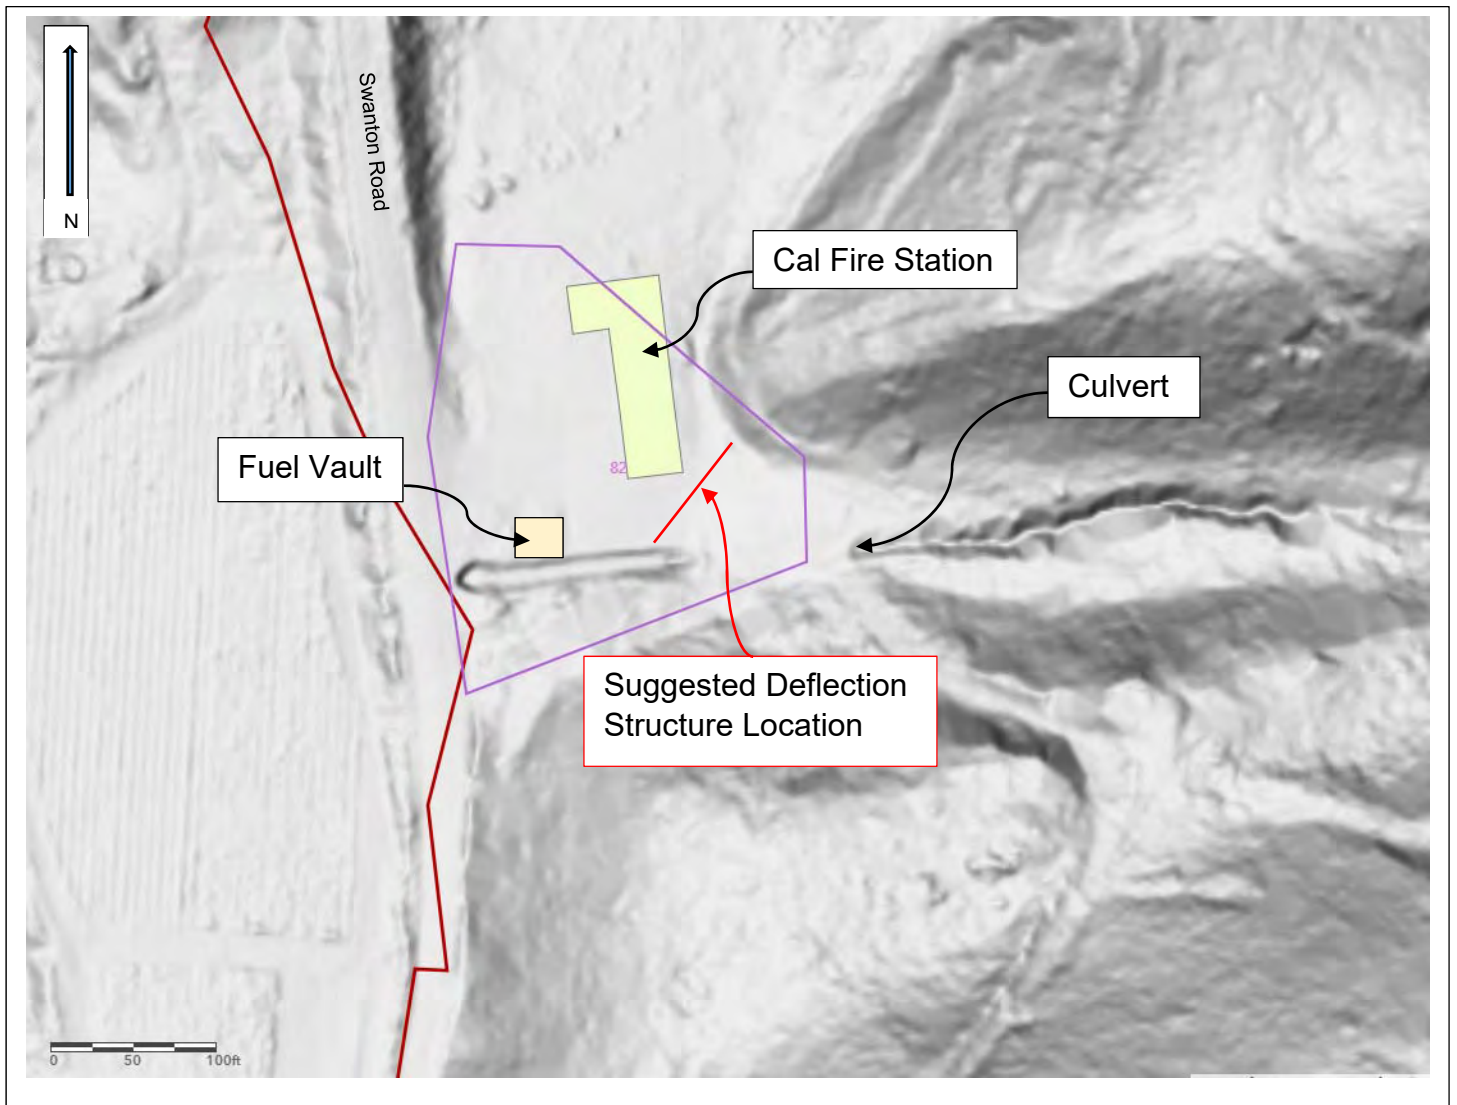
Infrastructure within the Swanton area (VARs 82 through 96) are located downslope of drainages with a moderate to high potential for debris flows and flooding. Bridges along Swanton Road could potentially plug and impact access to critical infrastructure. The CAL FIRE station (CZU Station #33 (Big Creek)) along Swanton Road (VAR 82) is located at the base of Winter Creek where it appears that if a culvert is plugged, flow would be directed towards the fire station and fuel vault (Figure 15).

Figure 15. Site map of CAL FIRE station (VAR 82) showing the potential location of a properly designed deflection structure. The culvert denotes the location where debris could plug the structure and flow towards the station and fuel vault.

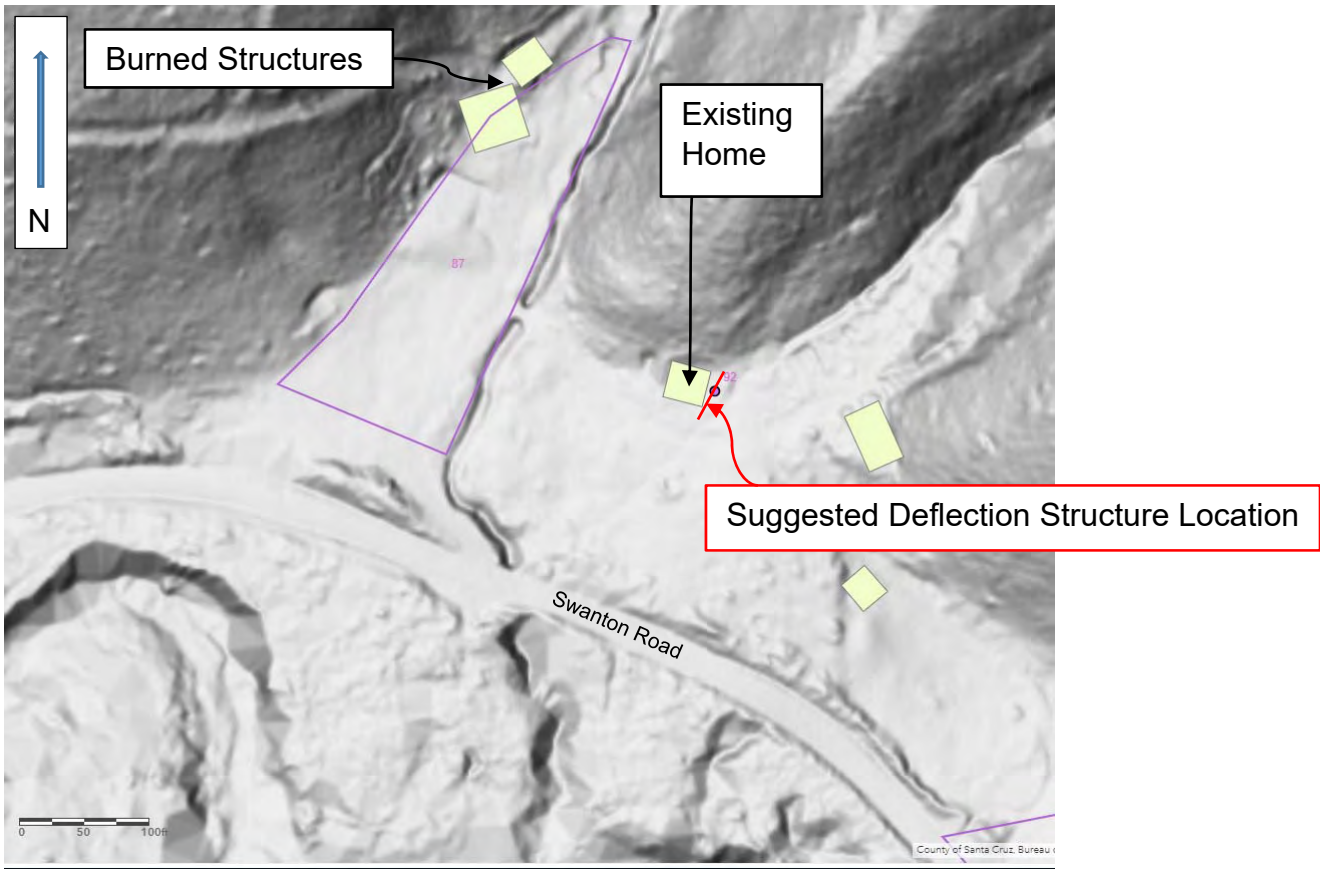
Several homes and a fish hatchery appear to be at risk from debris flows in the Big Creek watershed (VARs 84, 85, 89, and 90). VAR 92 consists of an existing unburned home located at the mouth of a drainage where it appears a deflection structure could help to limit the potential for flows impacting the home (Figure 16).

Figure 16. Site map of an existing home (VAR 92) showing the general location of a potential deflection structure. Any deflection structure would need to be properly designed for site conditions.

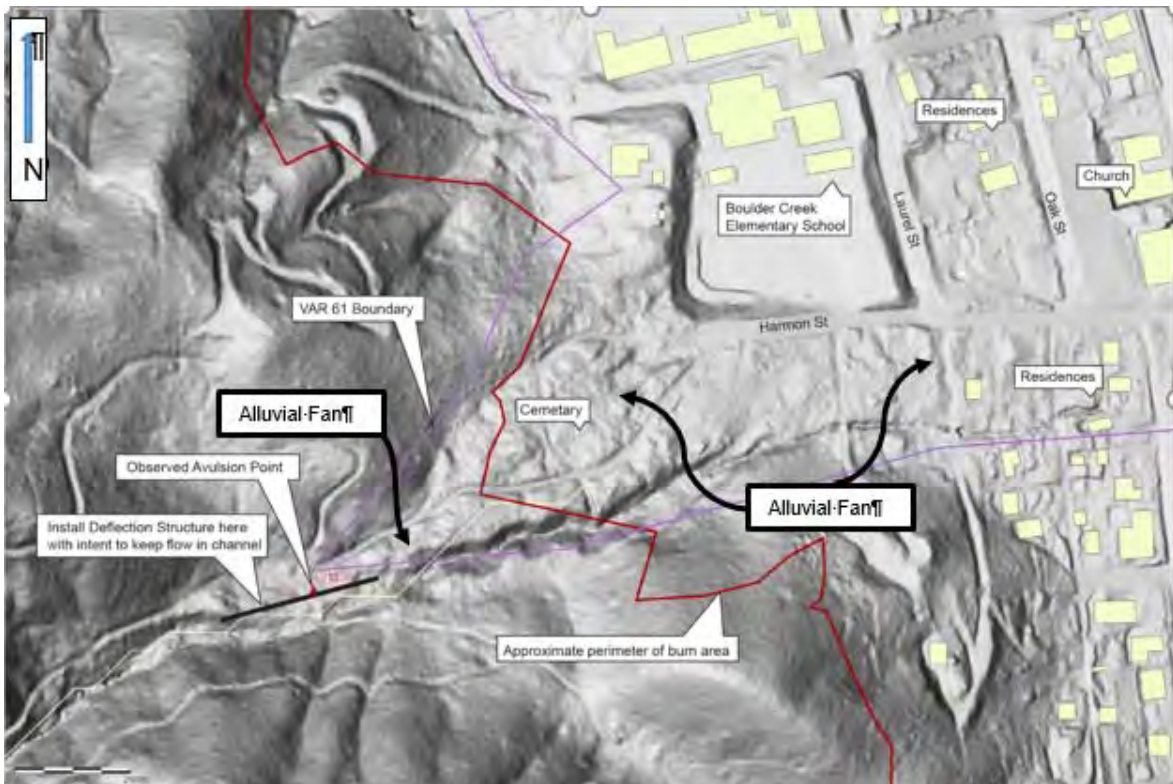
Based on our limited field reconnaissance a properly designed and located deflection structure may reduce the potential for avulsion from the current channel on an unnamed watercourse immediately upslope of Boulder Creek Elementary School and the adjoining residential neighborhood (VAR 61). A figure showing the location of the area is shown in Figure 17.

Figure 17. Site map of Boulder Creek (VAR 61) showing the potential location of a properly designed deflection structure to reduce the chance of avulsion from the current channel on an unnamed tributary southwest of the town. The red triangle denotes the location of the observed avulsion point.

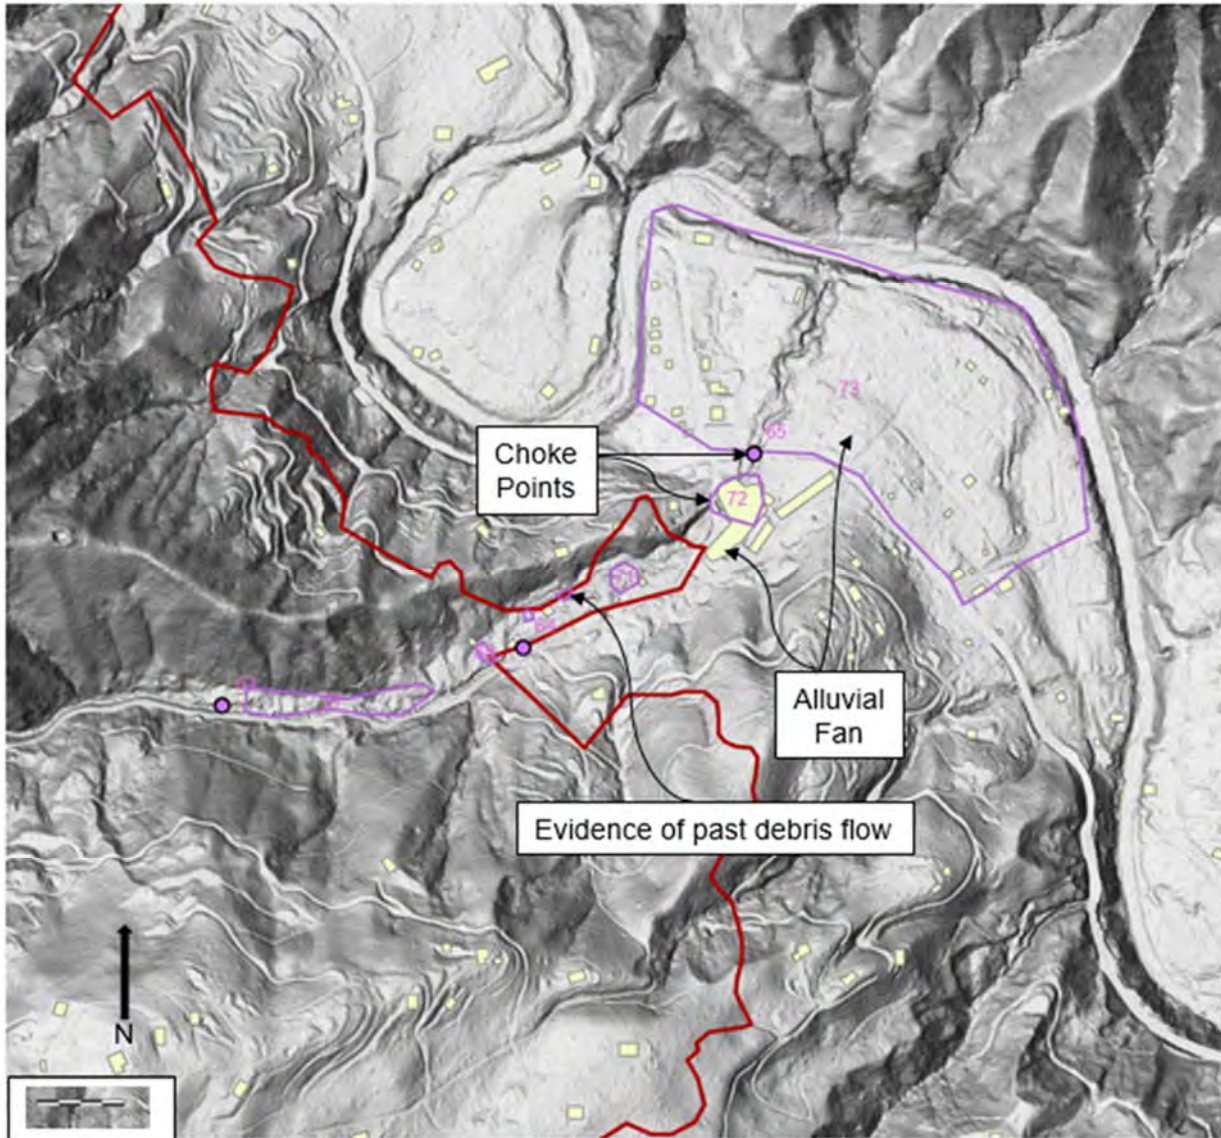
Flow paths on alluvial fan surfaces can be unpredictable and are influenced by roads, buildings, and other man-made infrastructure (Figure 18). The actual debris flow pathways are highly uncertain and were difficult to predict during this rapid evaluation. Deflection structures may prove effective in reducing the chance for avulsion in other areas where the potential for post-fire debris flow and flooding impacts were observed. For these reasons, we recommend further observations and determinations be made by a State-Certified Professional Geologist (PG) and Professional Engineer (PE).

Figure 18. Site map of Clear Creek and Brookdale (VARs 65 – 73) showing potential locations of choke points (potential avulsion points) and alluvial fans. Past debris flow deposits were observed in the channel.
