**Department of Public Works**  
**Crystal Springs County Sanitation District**

**Seneca Lane Mudslide Sewer  
Stabilization Project**

**November 14, 2017**

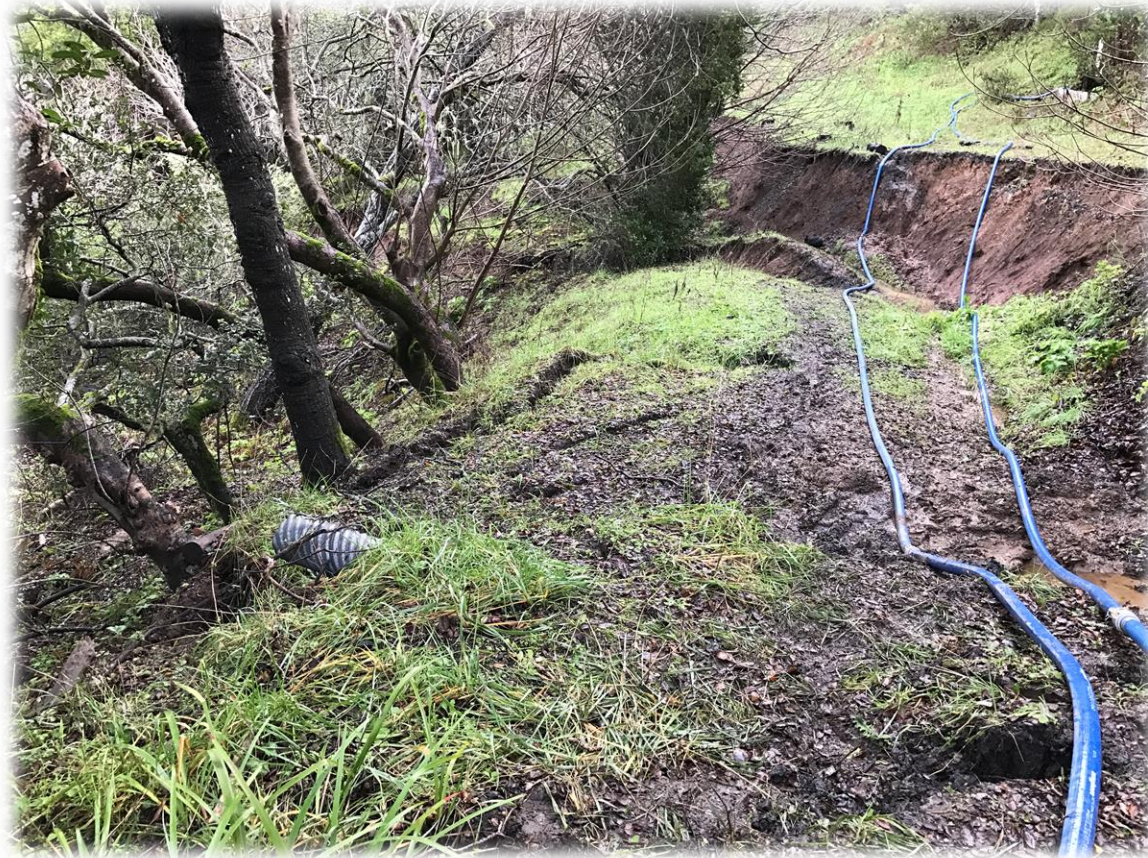
Mudslide Damaged Sanitary Sewer Line

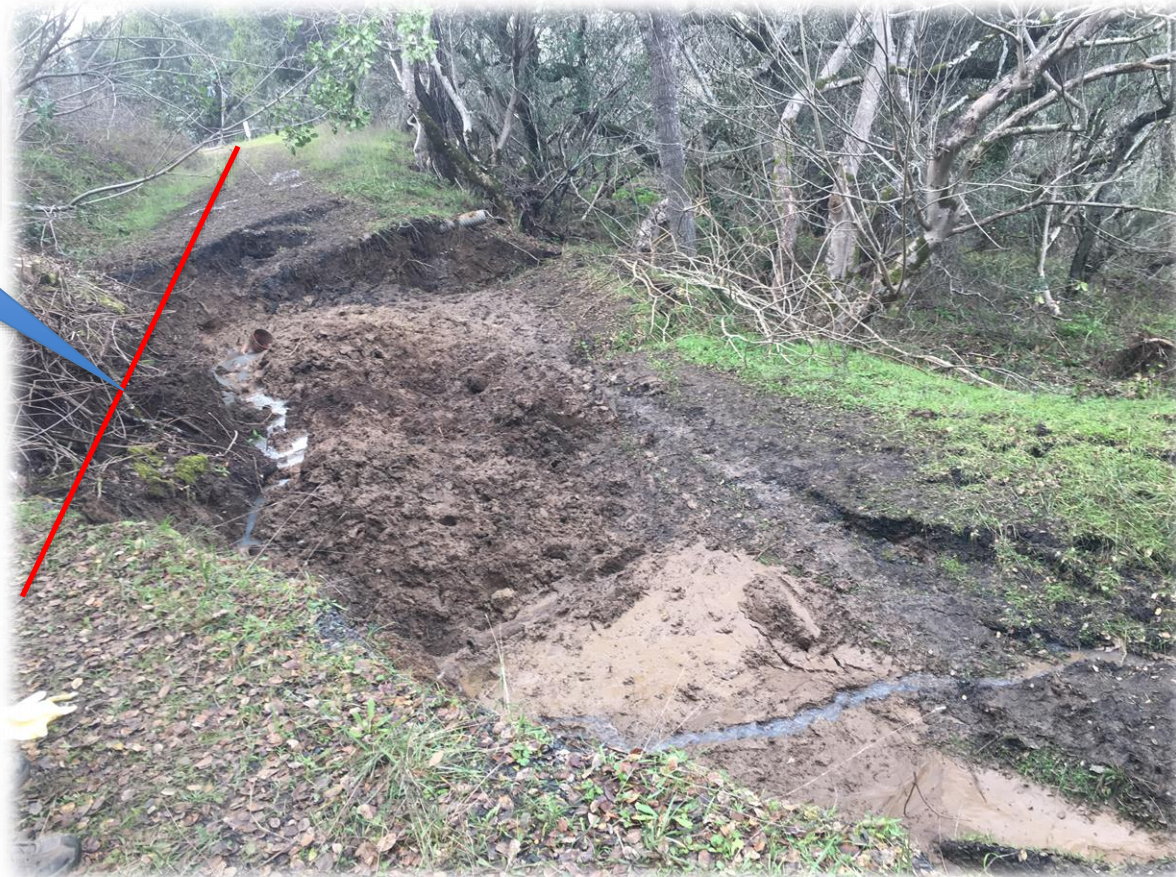
January 31, 2017

Alignment  
of original  
sewer line

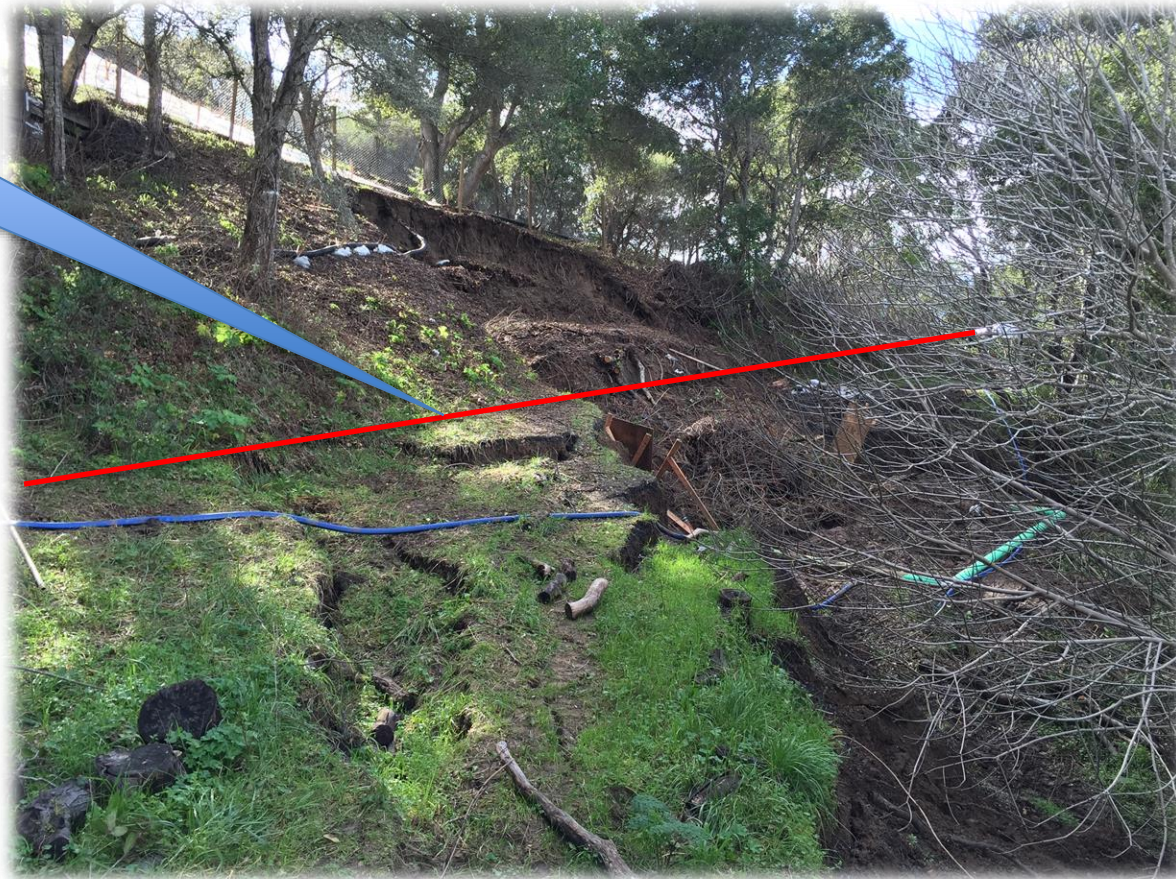
February 15, 2017

Alignment  
of original  
sewer line

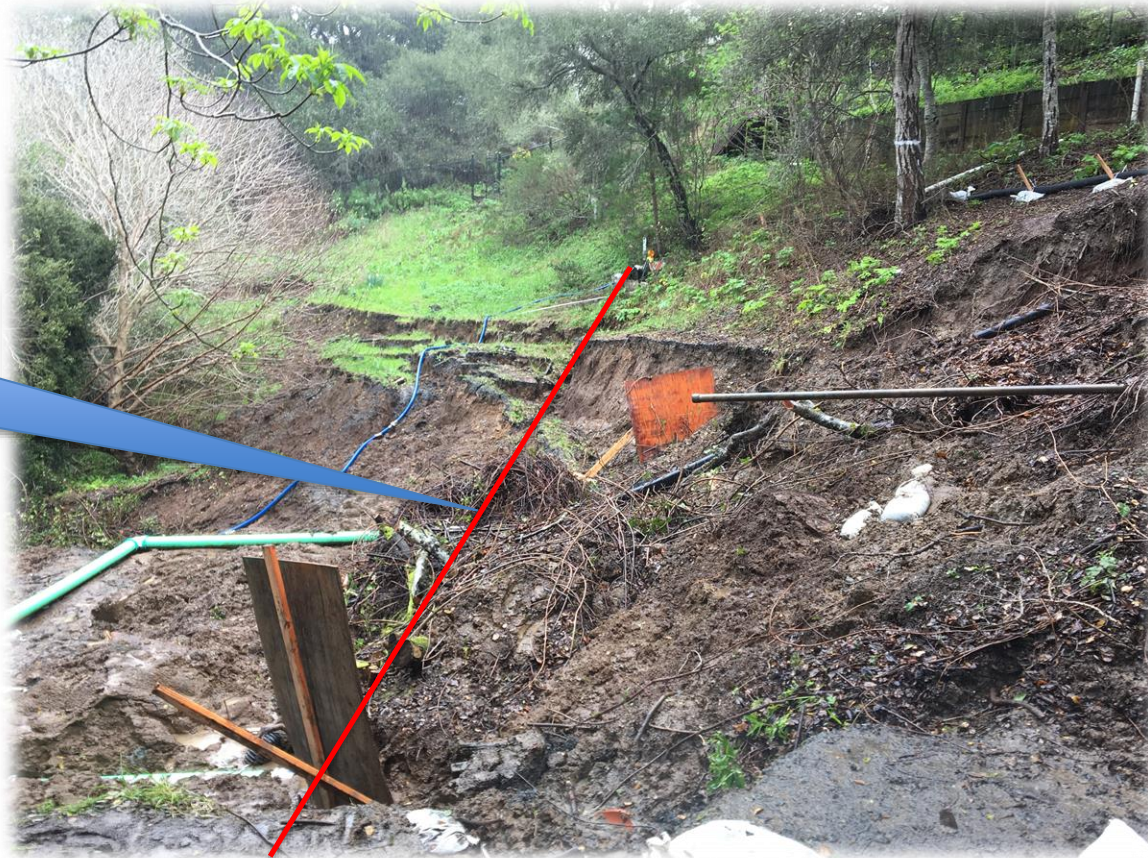
February 21, 2017

Alignment  
of original  
sewer line

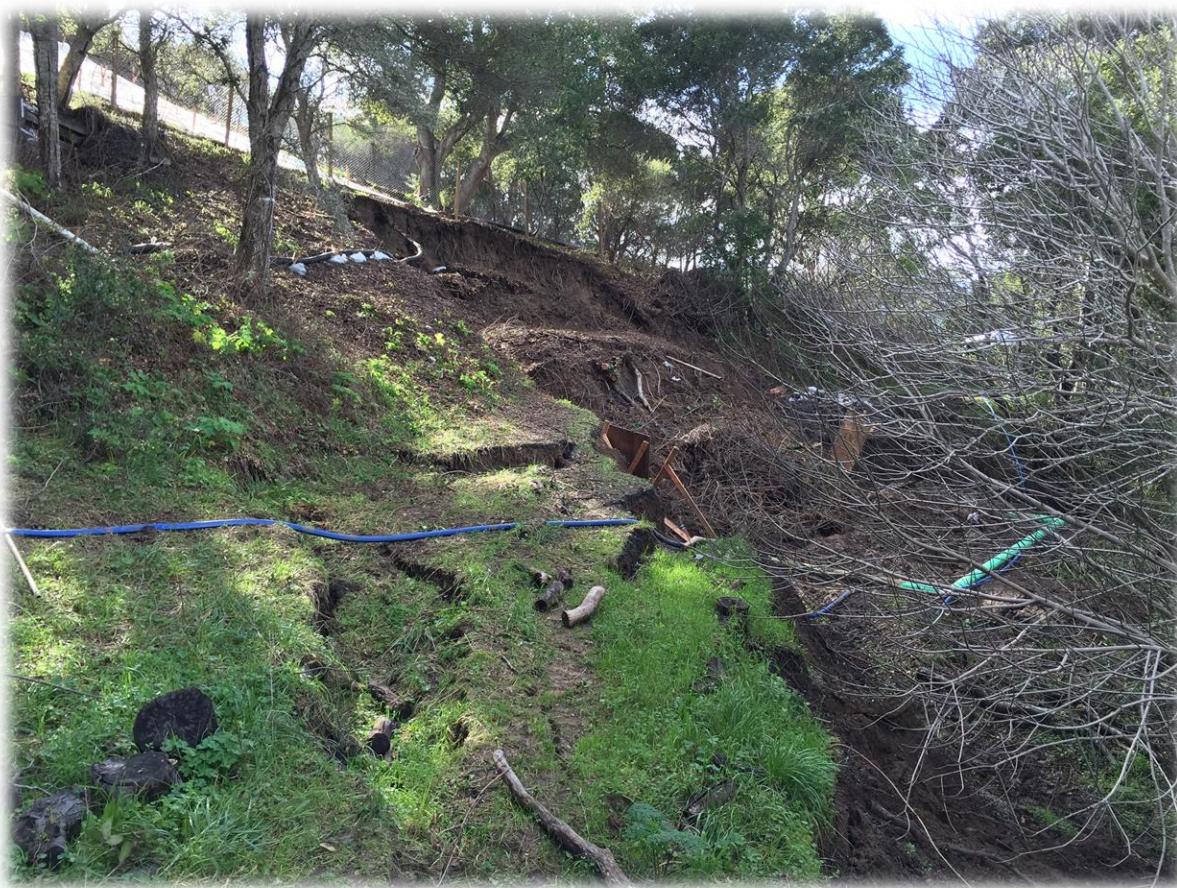
- Feb. 15, 2017 – Third temporary repair destroyed by expansion of mudslide. Photo shows non-functioning temporary sewer main (green) and pump bypass (blue) left in place.
- District Crew monitored bypass pump system 24 hours/day until PG&E approved power connection.

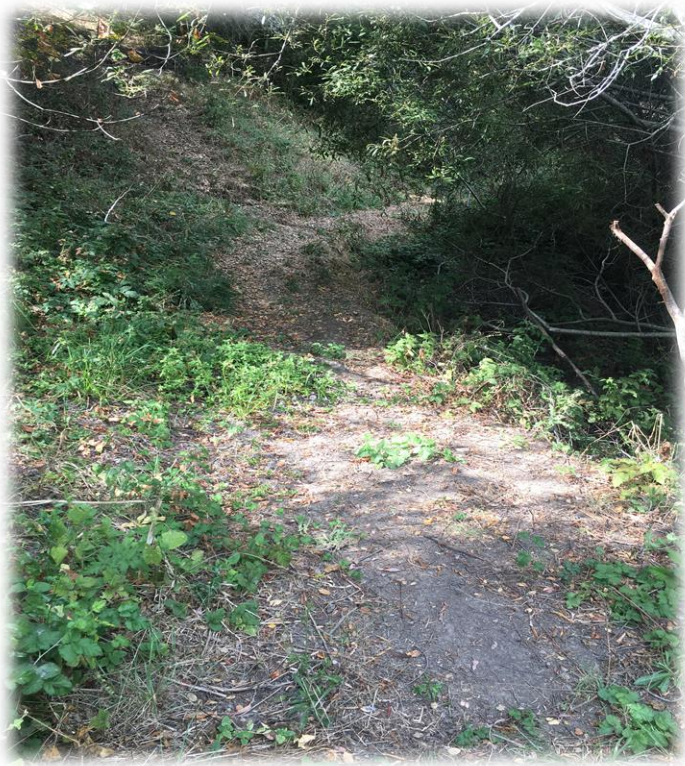
- Construction access to site from Seneca Lane is not feasible.
- Access route along Highlands Recreation District and private properties will need to be modified as necessary for equipment & materials for sewer stabilization project.

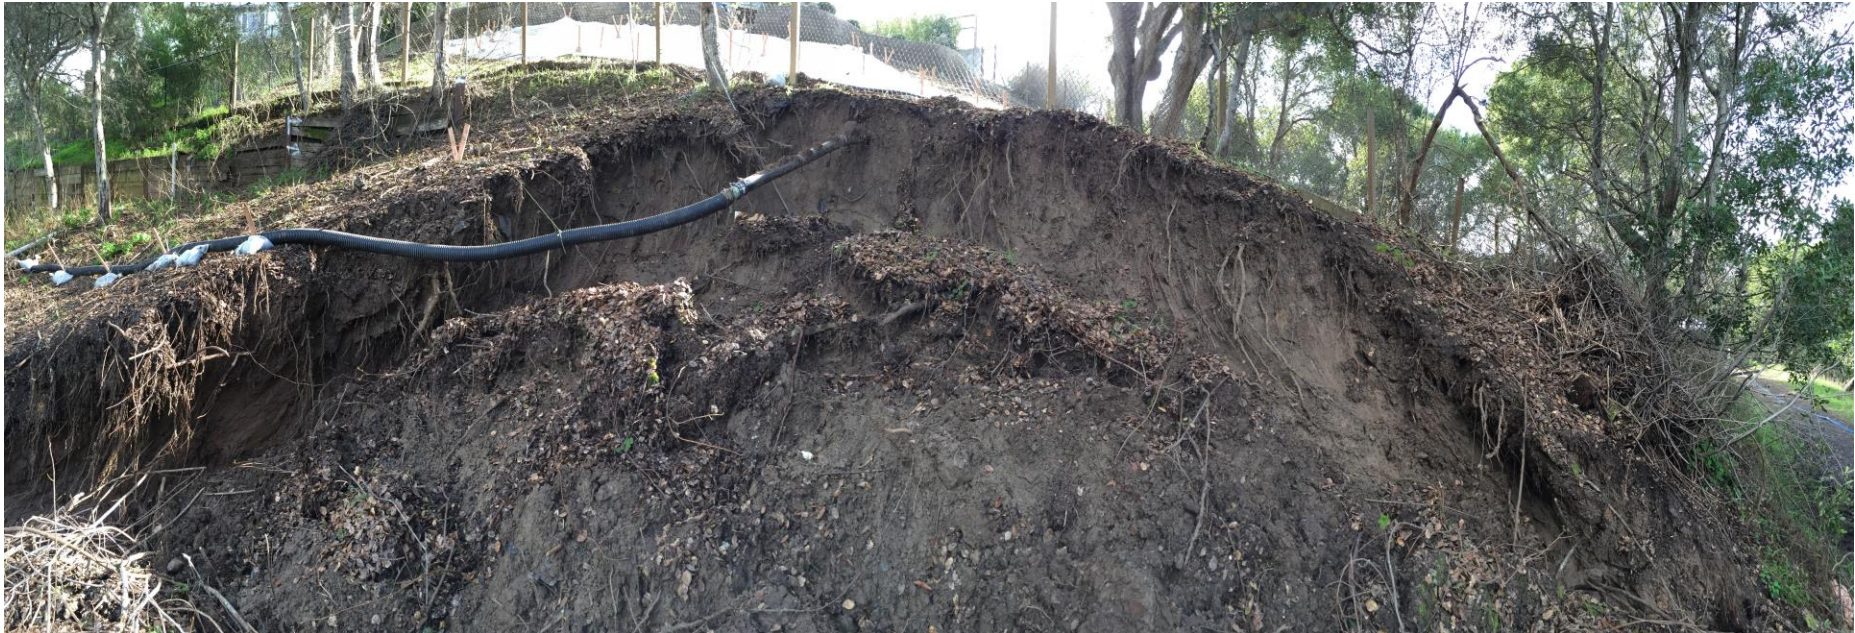
### Option 1. Line Reconstruction with No Mudslide Repair

- Ruled out as it would serve as temporary solution, due to potential of future slope failures.

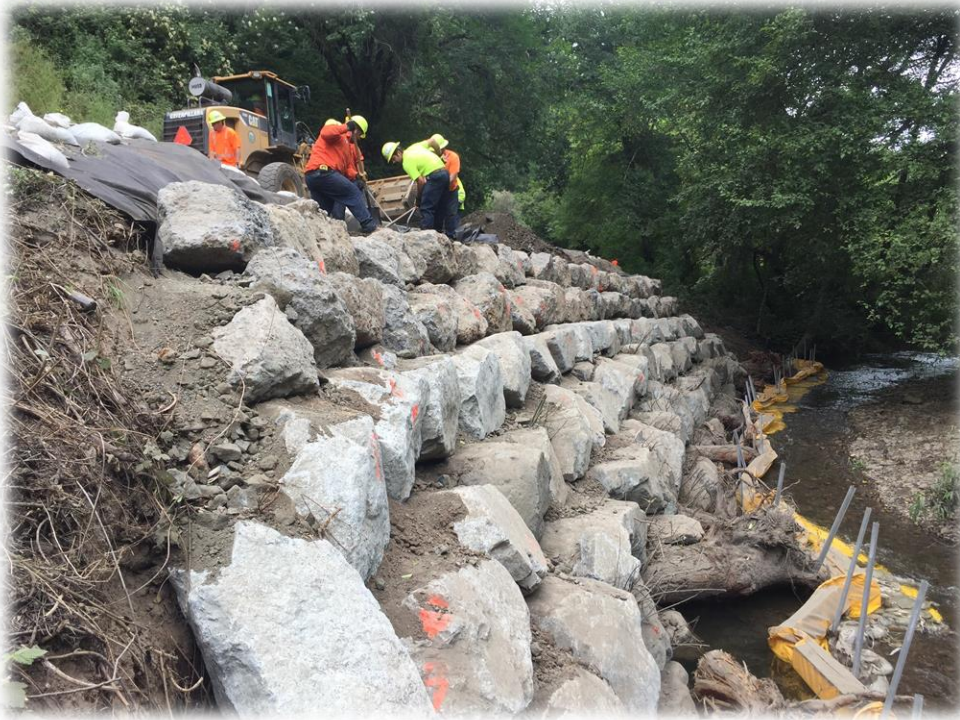
### Option 2. Reconstruct Slope Stability of Hillside

- Remove the loose mudslide material from scarp area down to the competent material and place rip rap lined with fiber fabric, keyed into the excavation area. (Example of Rock Rip Rap Construction on left)
- **Ruled out for the following reasons:**
  1. Extremely large volume of earthwork
  2. Access route issues
  3. Clearing the loose mudslide materials by steep cuts likely to result in temporary slope instability

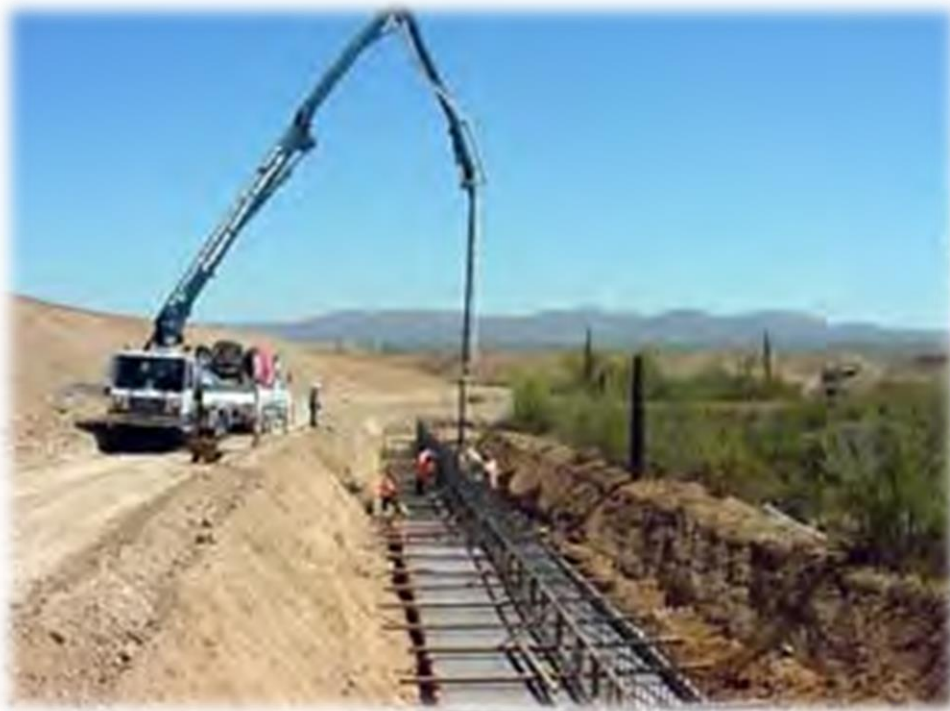
### Option 4. Cantilevered Retaining Wall

- Can be supported on both shallow and deep foundations, soil conditions require spread footing
- **Ruled out for the following reasons:**
  1. 14 foot wide footing required would cause easement issues
  2. Temporary shoring cannot be installed due to soil conditions
  3. Cost associated with excavation and shoring would be high.

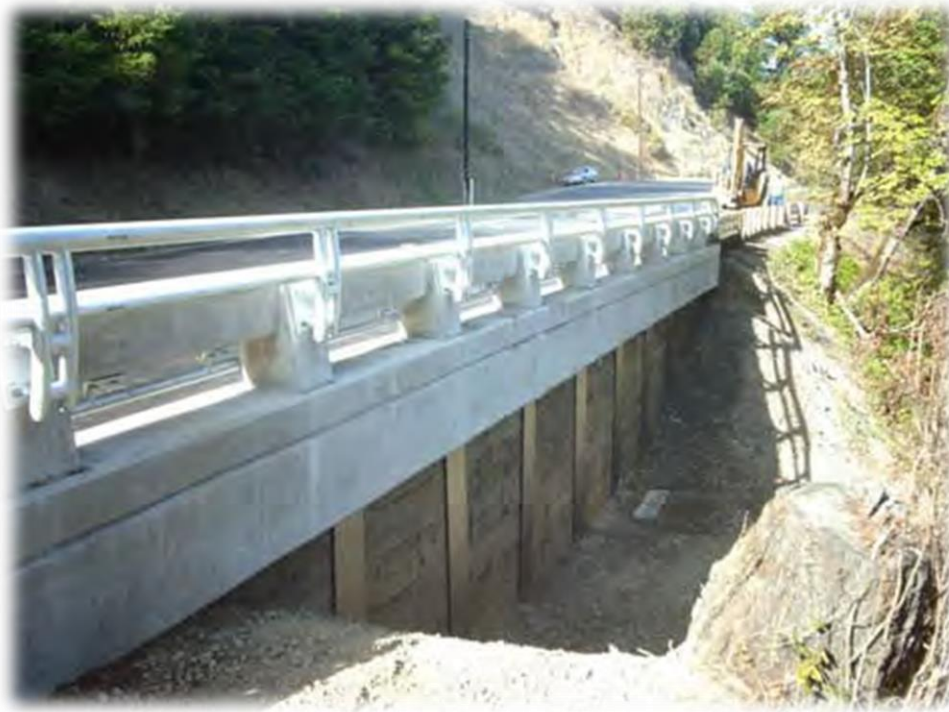
### Option 5. Soldier Pile Wall

- Steel piles placed in drilled holes backfilled with cast-in-place concrete and faced with timber lagging.
- **Ruled out for the following reason:**
  1. Maximum height of this type of wall is typically limited to 12-14 feet, our project requires a taller wall.

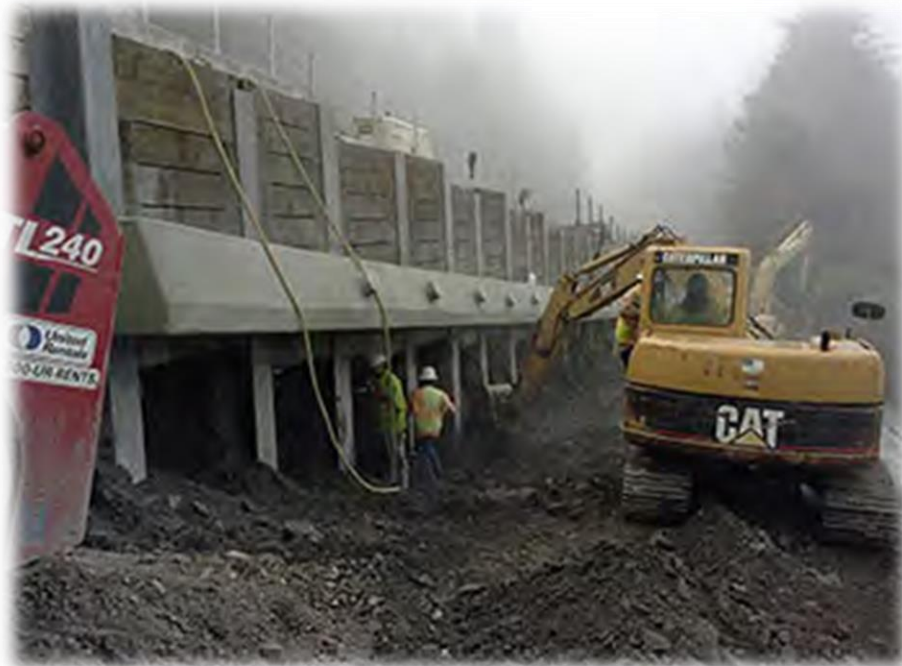
### Option 6. Soldier Pile Retaining Wall with Tie-Backs (Recommended)

- Consists of a soldier pile wall with horizontal walers of either structural steel or reinforced concrete beams spanning between piles.
- Walers support high strength steel ground anchors (tie-backs) consisting of drilled holes with grouted in prestressing steel tendons or bars extending from the wall face to an anchor zone located behind potential failure planes associated with the retained soil or rock mass.
- Tie-back walls are typically used to stabilize unstable sites and are readily used for heights up to 80 feet.

Considering the pros and cons of each of the non-structural and structural options, the selected option for this project is the construction of a soldier pile retaining wall with tie-backs.
