Watershed Emergency Response Team Evaluation

CZU LIGHTNING COMPLEX

CA-CZU-005205

October 1, 2020

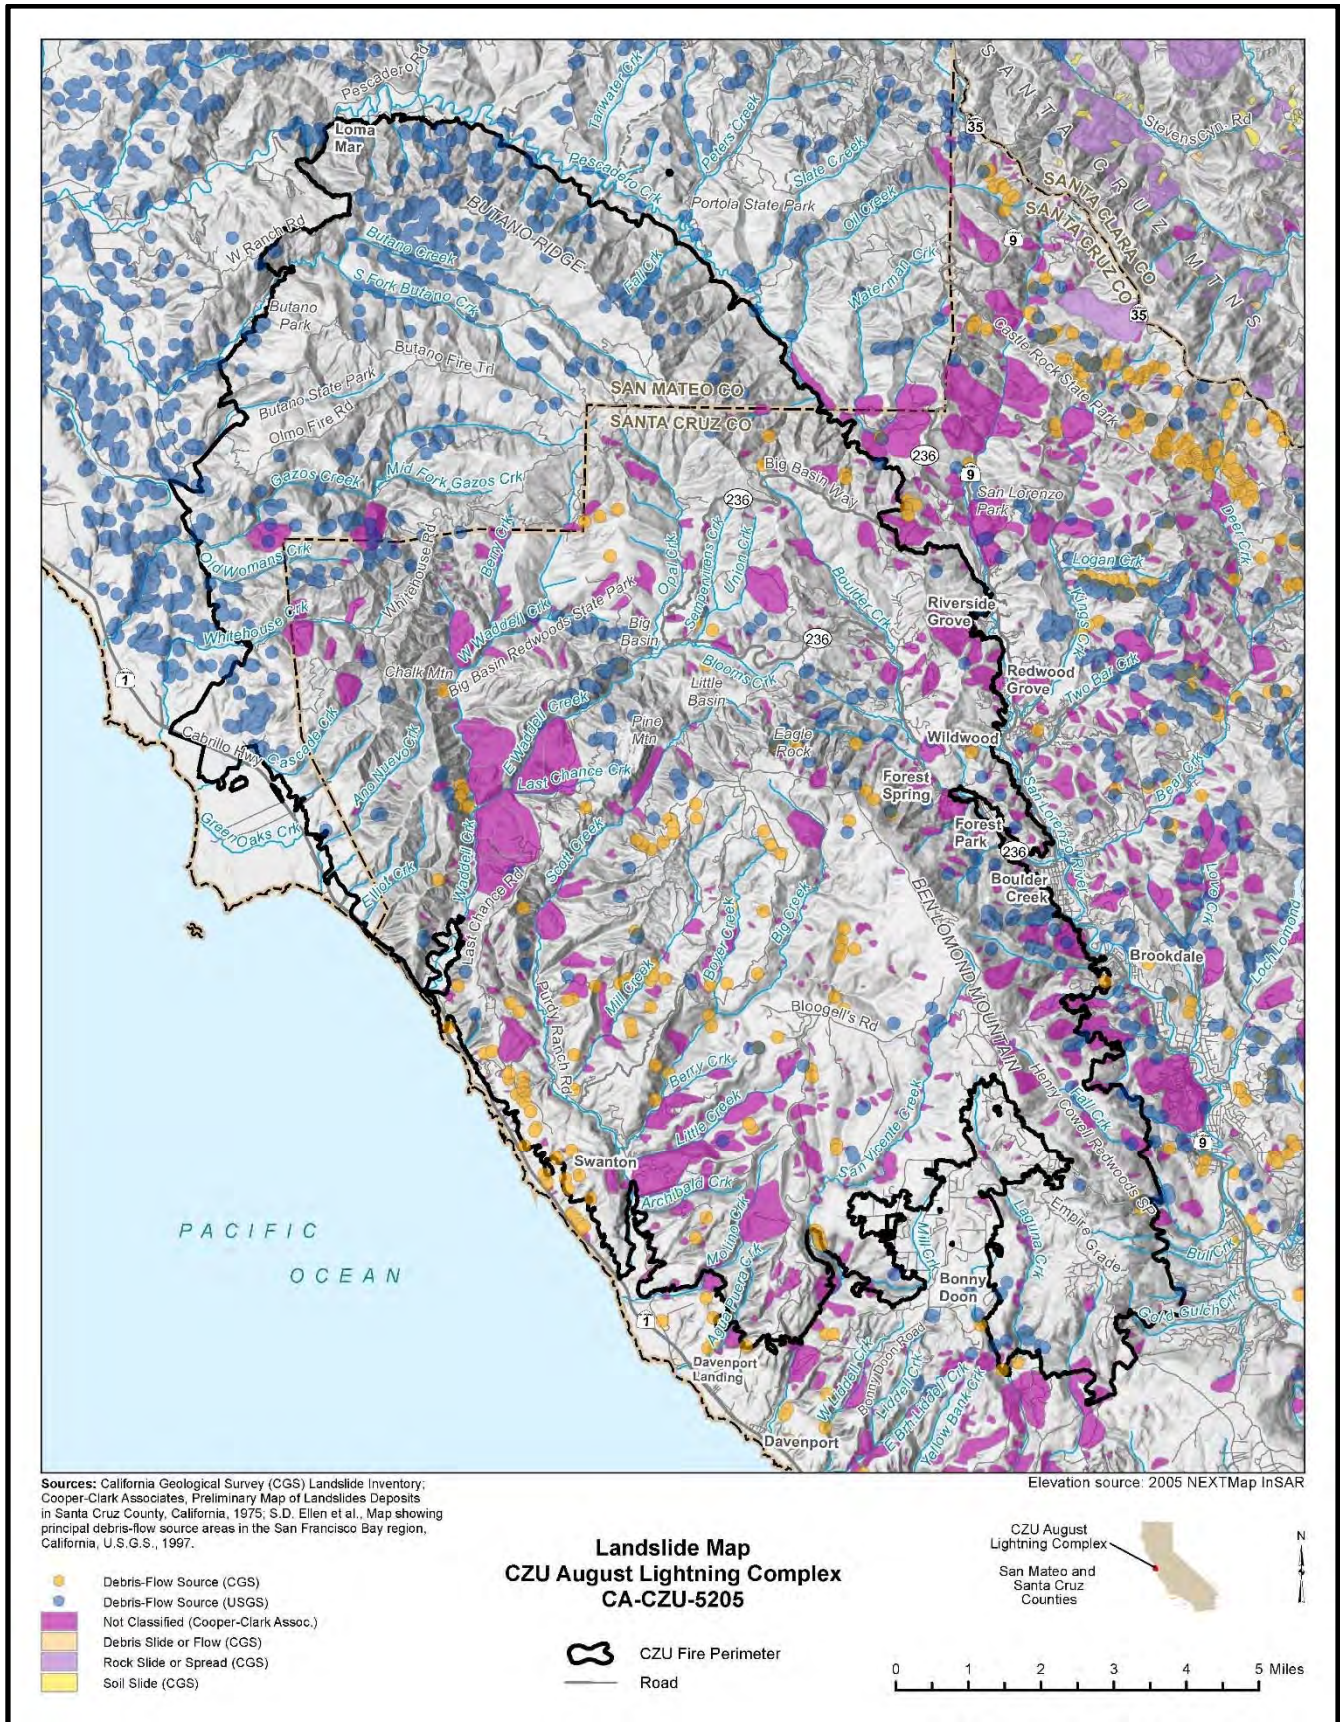
As stated above, shallow landslides and debris flows are a commonly triggered in the Santa Cruz Mountains as a result of heavy and/or intense winter storms (Figure 5). There has not been a significant wildfire of the scale and intensity of the CZU Lightning Complex within the region within recorded history. Observations conducted during this evaluation indicate that many of the basins that drain towards developed areas were burned at high to moderate severity and that much loose and weathered bedrock material was observed perched on steep drainage slopes. USGS modeling indicates moderate to high probabilities of debris flows within some of the basins. It is reasonable to assume potentially adverse effects to shallow slope stability will be exacerbated for the next several winter seasons because of the wildfire.

Figure 5. Landslide map for the CZU Lightning Complex.

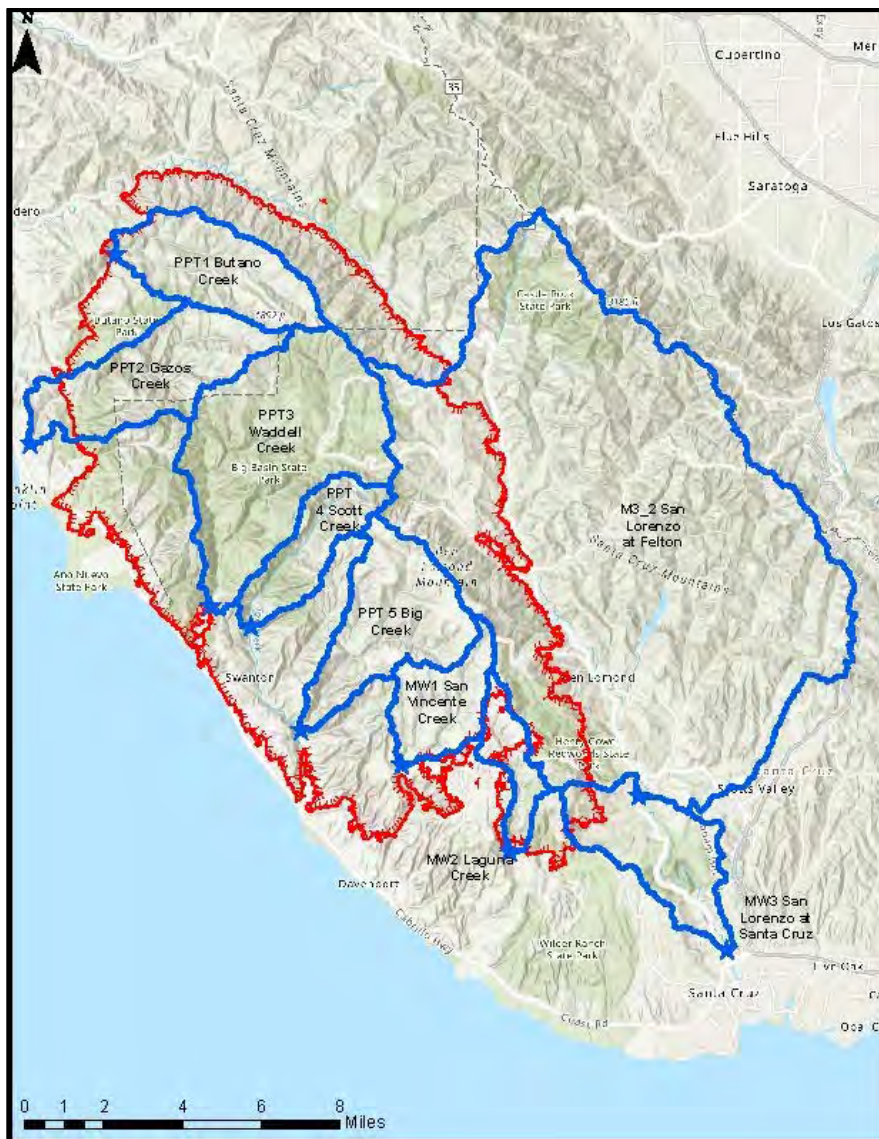
Figure 8. Pour point watersheds for the CZU Lightning Complex. Post-fire peak flows were estimated for Butano, Gazos, Waddell, Scott, and Big Creek. Proportion of watershed area by soil burn severity was extracted for San Vicente Creek, Laguna Creek, and the San Lorenzo River at two locations to inform threats to municipal water supply.

Bulked post-fire flow modifiers for the 2- to 10-year recurrence interval flow are expected to range from 1.4 to 2.7 for the pour points. The highest flow increases are expected to be in the Scott Creek (2.7), Waddell Creek (2.6), and Big Creek (2.6) watersheds. Butano Creek and Gazos Creek are expected to be less affected due to the relatively low proportion of moderate and high soil burn severity. Boulder Creek has a bulked post-fire modifier of 1.4 for the 2- to 10-year recurrence interval flow, suggesting relatively low potential for flooding (Table 7).

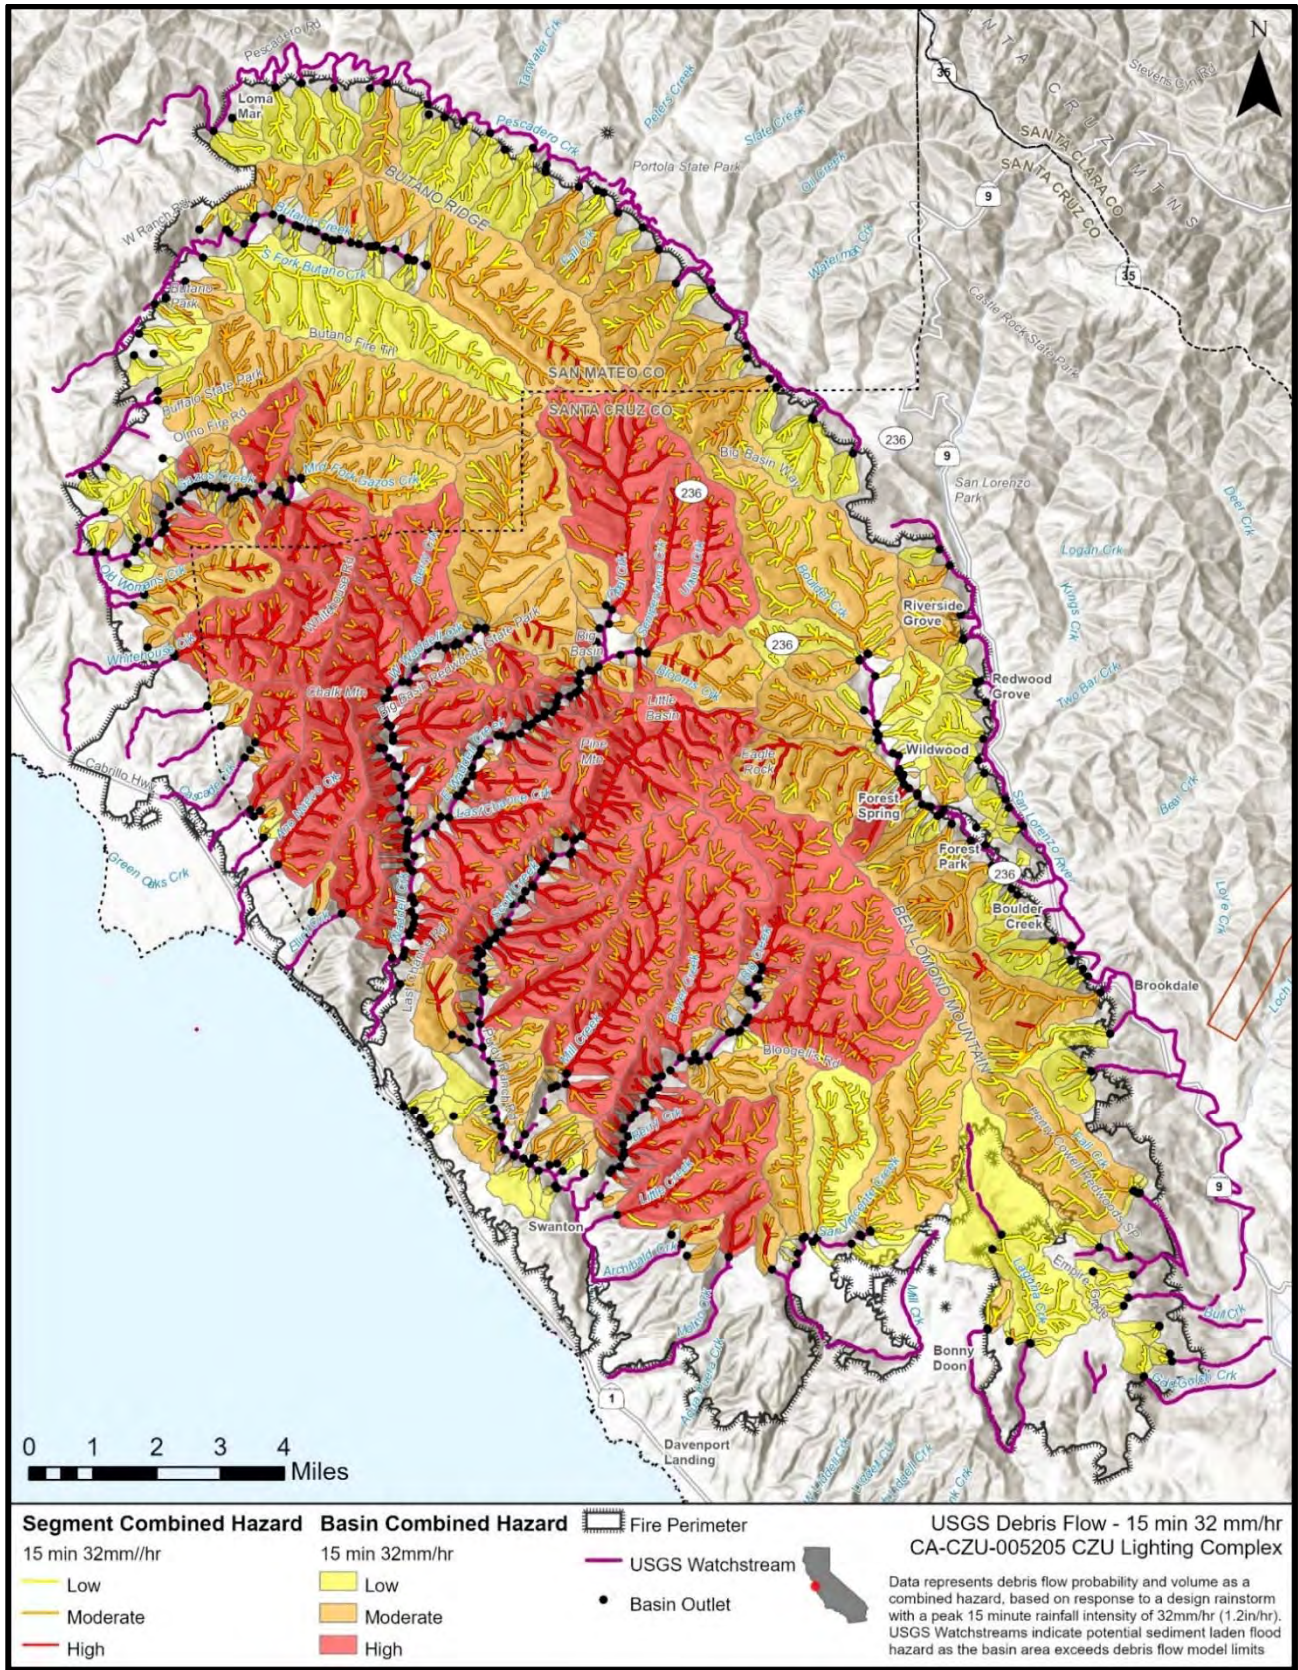
Figure 10 shows the combined hazard for the 15-minute 32 mm hr⁻¹ storm event (i.e., approximately 0.3 inches in 15-minutes). Figure 10 indicates much of the western portion of the fire has a high combined hazard, while much of the SR 9 and 236 corridors have a moderate combined hazard for debris flows. Finally, Figure 11 shows the combined hazard for the 15-minute 40 mm hr⁻¹ storm event (i.e., approximately 0.4 inches in 15-minutes), which is slightly less than the 1-year recurrence interval storm event for areas within and/or downstream of the fire footprint (Table 3). Figure 11 indicates most of the fire has a high and/or moderate combined hazard for debris flows, with multiple high hazard basins occurring within the SR 9 and 236 corridors.

Figure 10. USGS debris flow model results for the 15-min 32 mm hr⁻¹, CZU Lighting Complex.

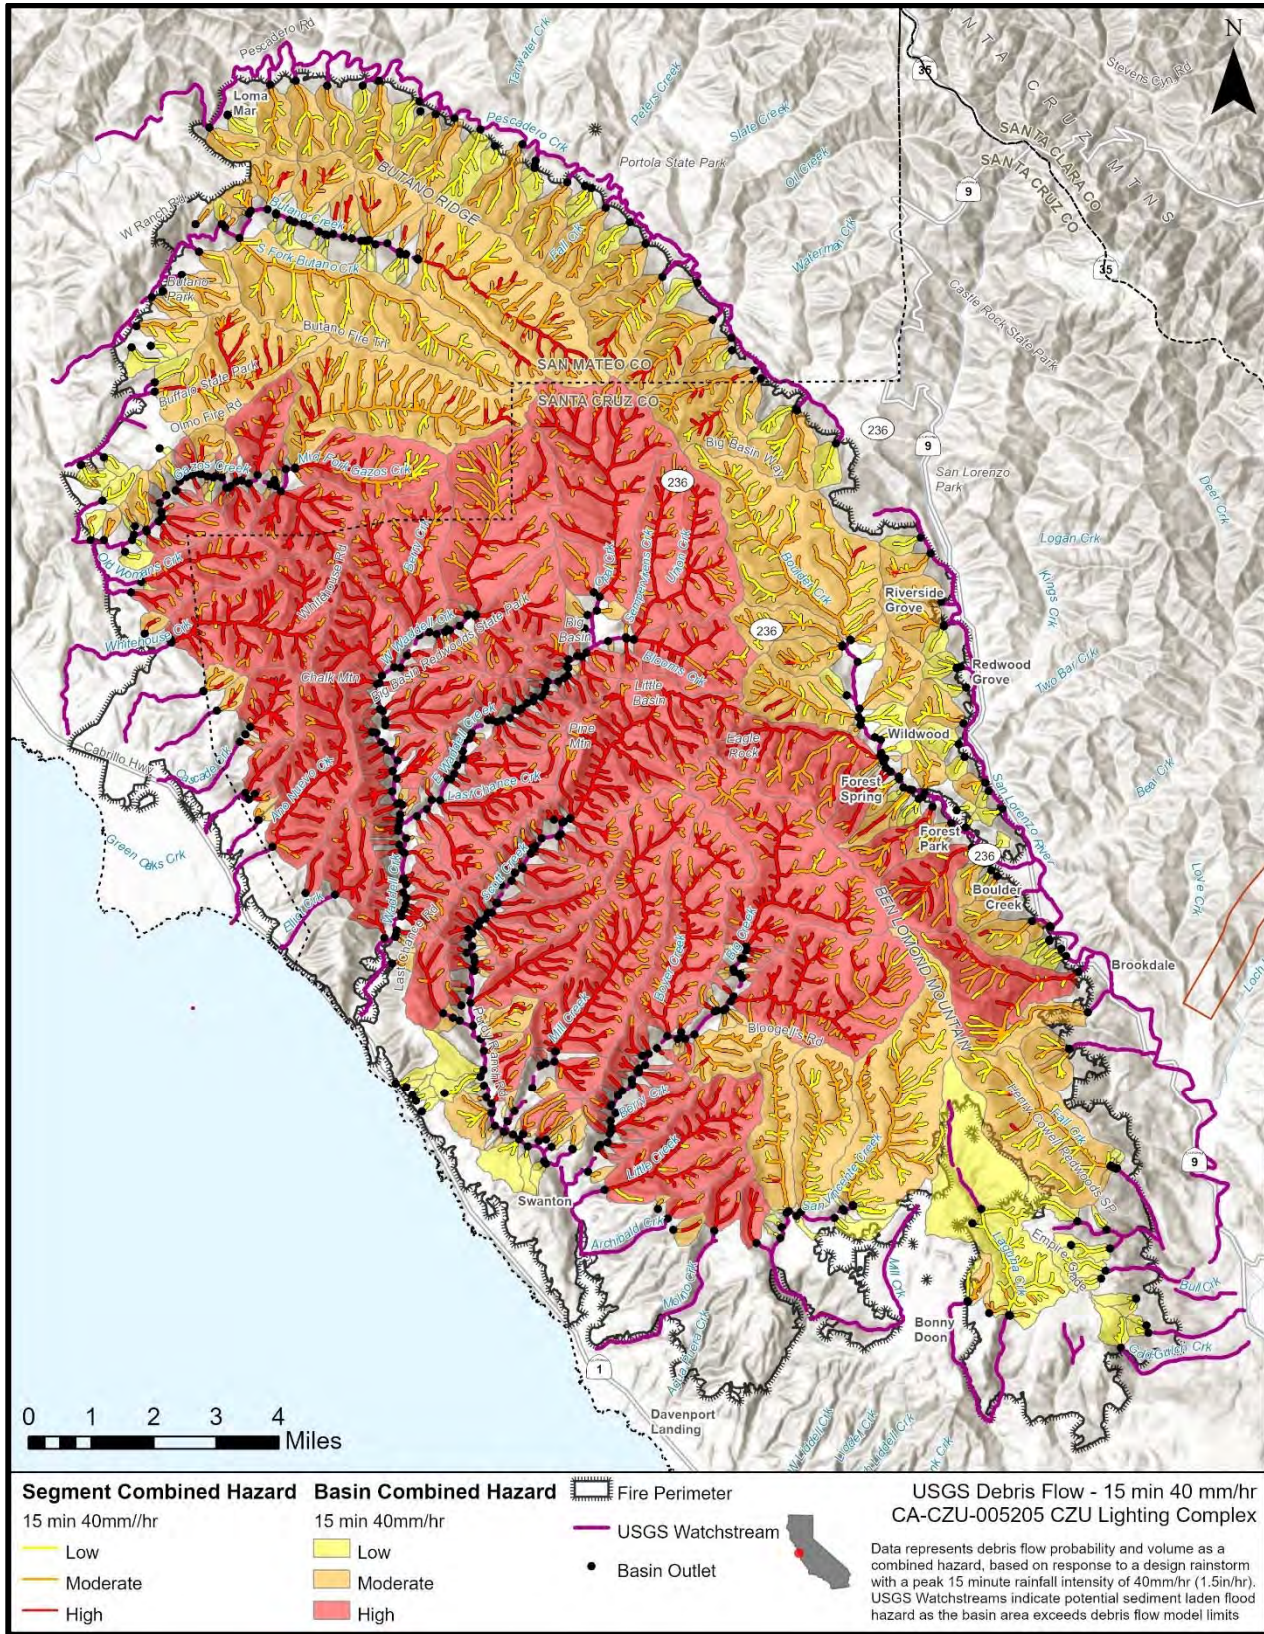
Figure 11. USGS debris flow model results for the 15-min 40 mm hr⁻¹, CZU Lightning Complex.

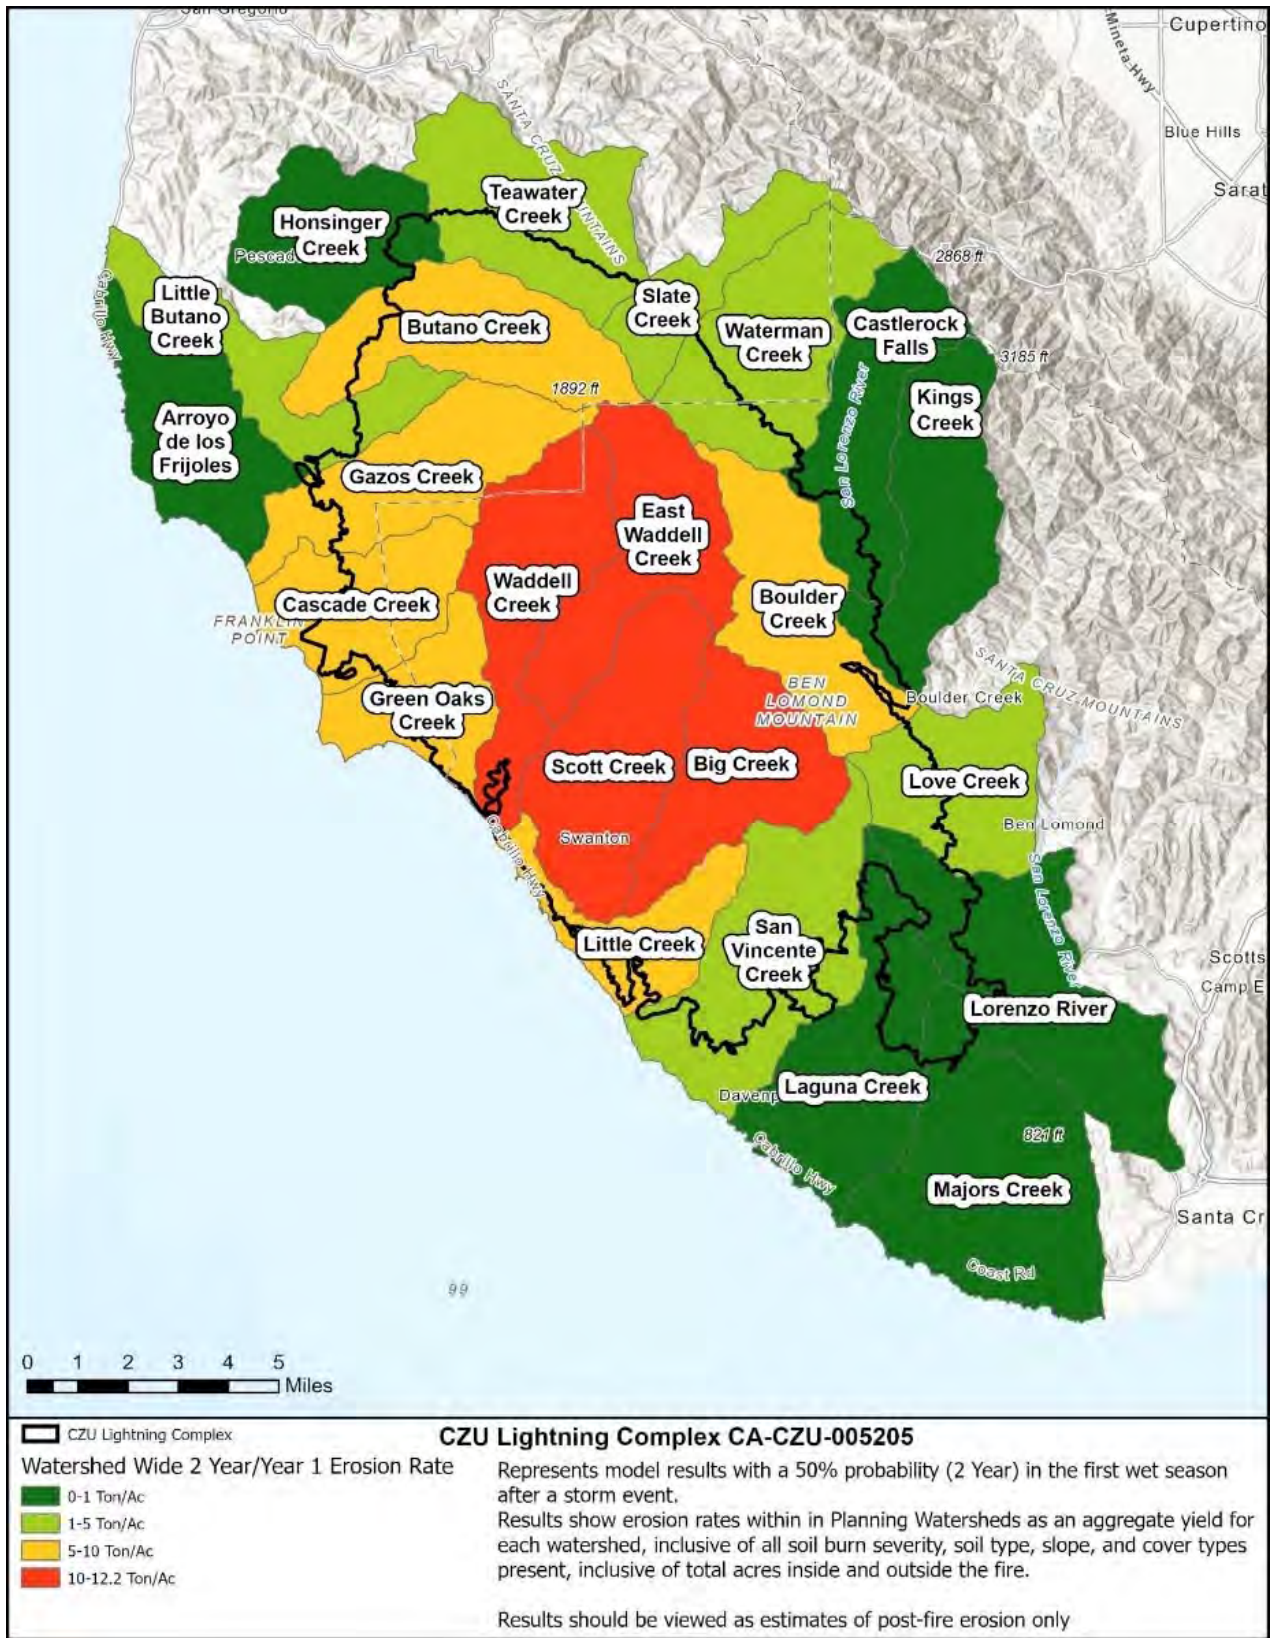
Post-fire surface erosion was modeled using the Erosion Risk Management Tool (ERMiT) from the United State Forest Service's Rocky Mountain Research Station. The ERMiT model run calculated first year sediment production following a 2-year recurrence interval storm event. Figure 13 shows watershed averaged post-fire erosion rates for planning watersheds within the CZU Lightning Complex burned area. Modeling indicates that watershed averaged erosion rates are more than 10 tons per acre for the Waddell Creek, Scott Creek, and Big Creek watersheds. Butano Creek, Gazos Creek, Cascade Creek, Green Oaks Creek, Little Creek, and Boulder Creek have basin averaged erosion rates predicted to be in the range of 5 to 10 tons per acre. Figure 14 shows erosion rates as a percentage of the maximum rate for smaller basins (i.e., approximately 20 acres in size). It can be assumed that for the majority of the burned area, the post-fire erosion rates shown on Figures 13 and 14 are significantly higher than the pre-fire erosion rates. Overall, the firewide median erosion rate is predicted to be 8.6 to 9.4 tons per acre depending upon the scale of the model unit. ERMiT also suggest that the firewide median rate can be reduced by a factor of 5 if mulch is applied at a rate of 2 tons per acre.

Figure 13. Watershed averaged erosion rates (tons per acre) on the CZU Lightning Complex for the first year 2-year storm event predicted using the Erosion Risk Management Tool (ERMIT).

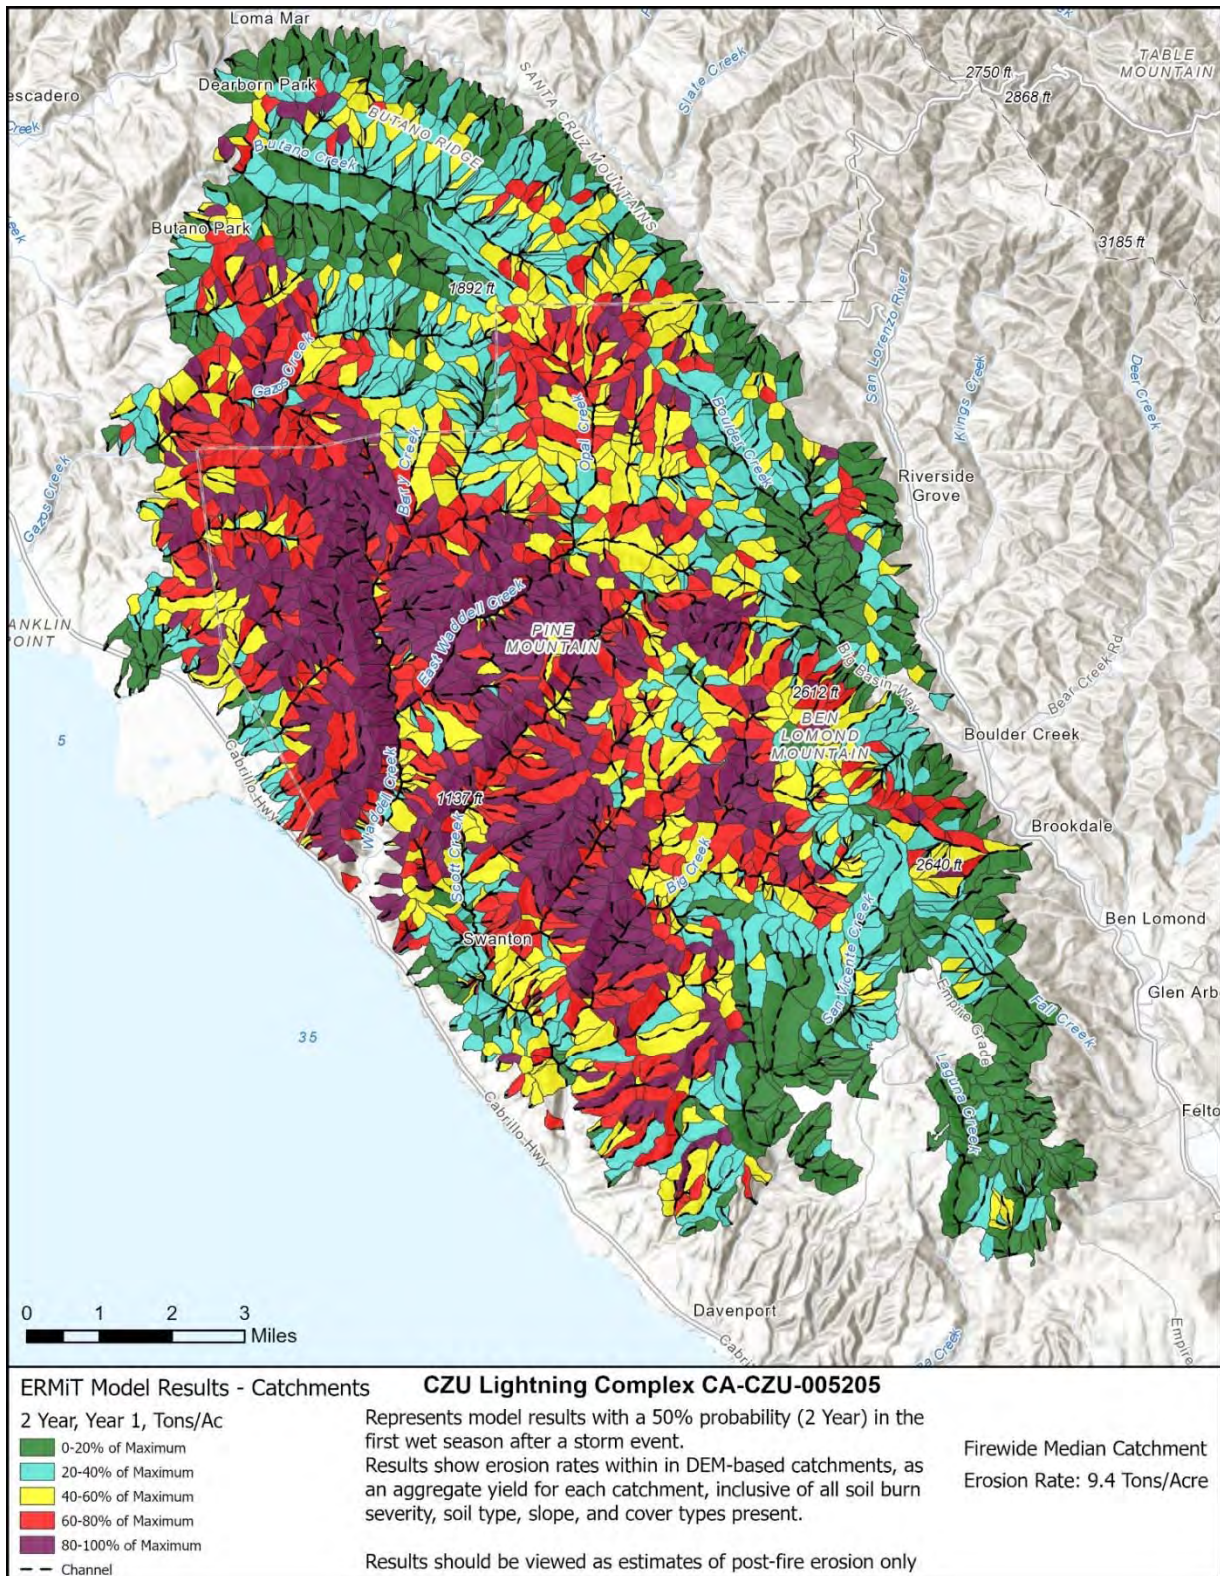
Figure 14. CZU Lightning Complex predicted surface erosion rates for the 2-year storm event using the Erosion Risk Management Tool (ERMiT).

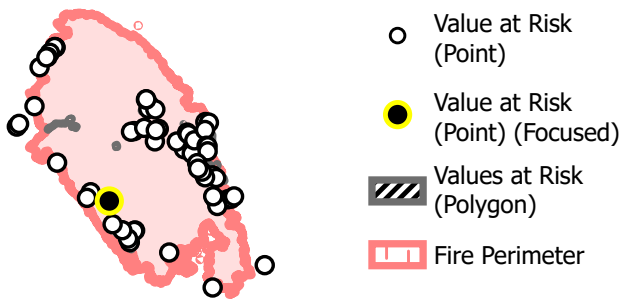
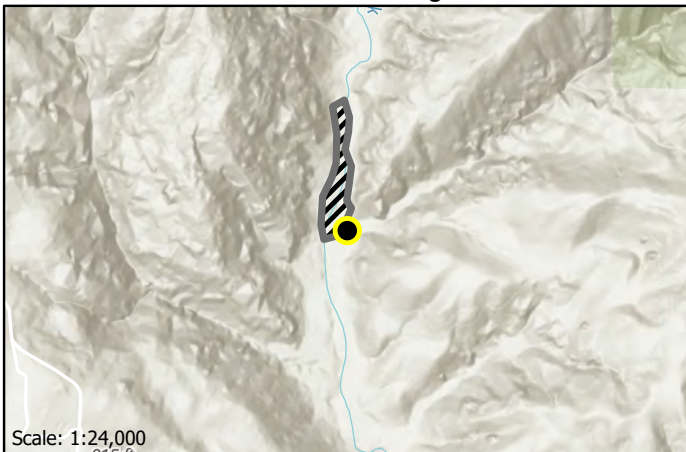
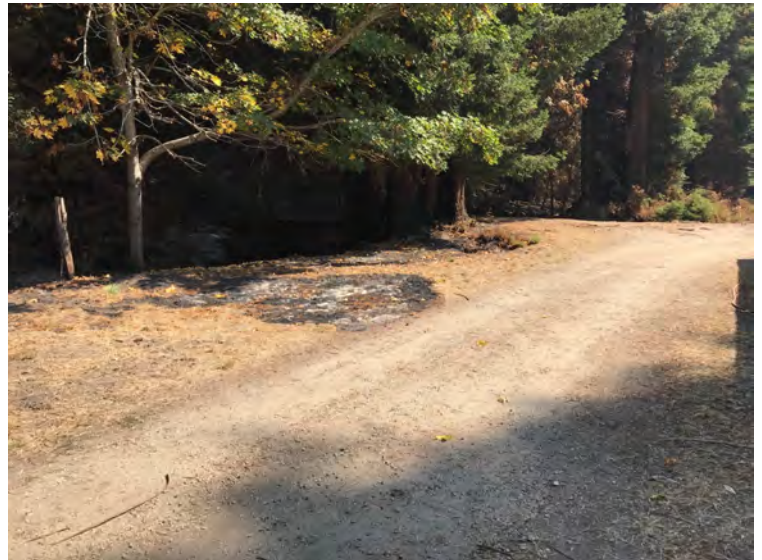
Field Observation or Potential Hazard: Potential for debris flow to leave channel and impact residence. Steep slopes upstream with moderate to high potential for debris flows

Potential Hazard to Life: **low**

Potential Hazard to Property: **low**

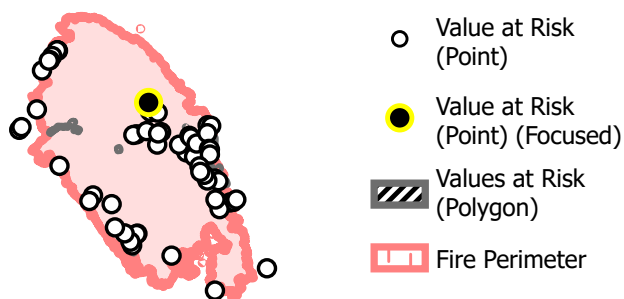
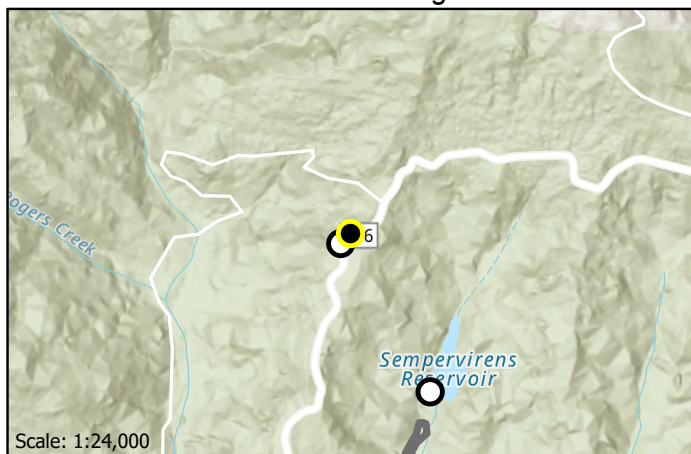
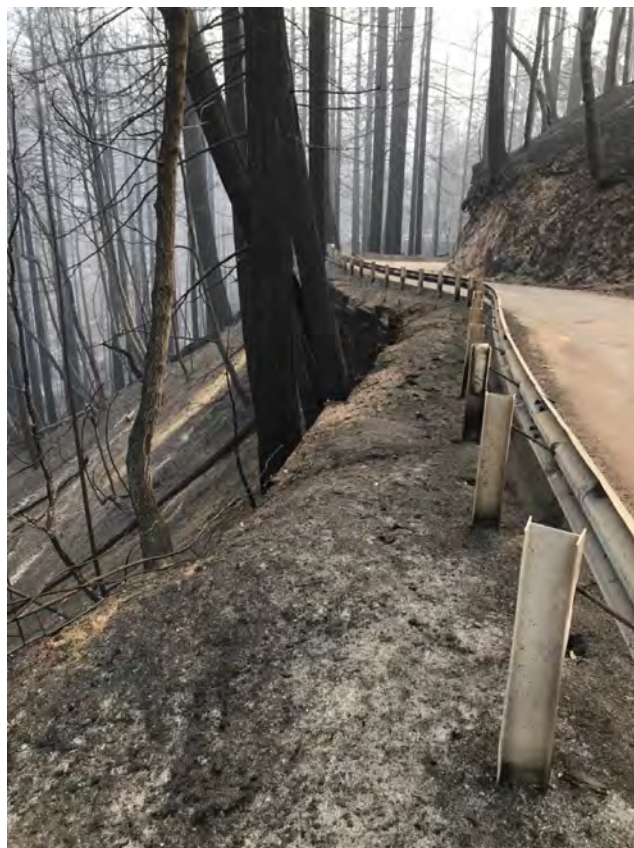
Field Observation or Potential Hazard: Approximately 150' of retaining wall damaged.

Potential Hazard to Life: **low**

Potential Hazard to Property: **moderate**

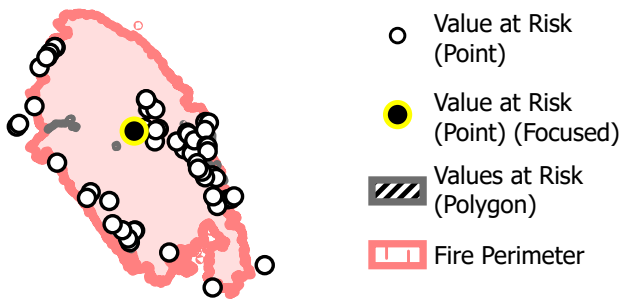
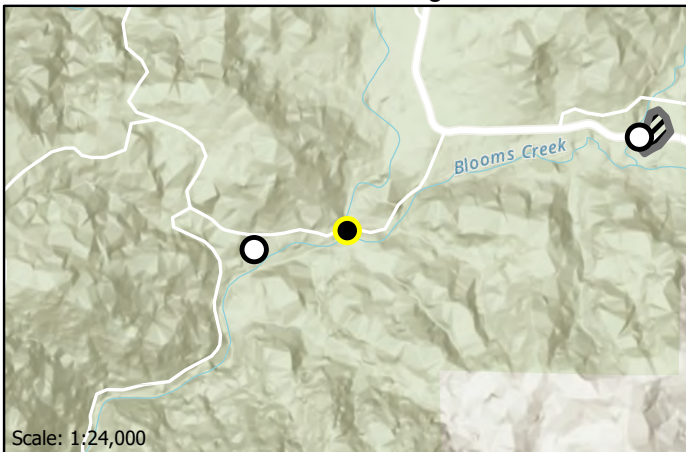
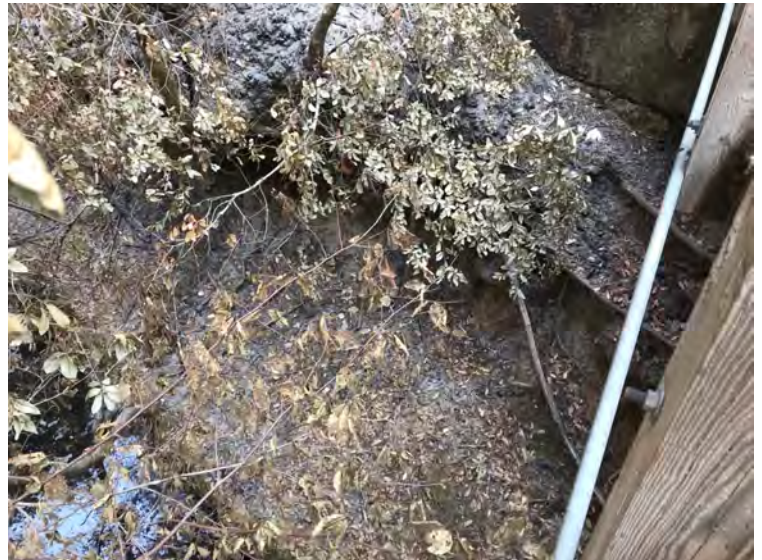
Field Observation Scour along eastern abutment. Landslides visible on hillshade along upstream or Potential Hazard: slopes.

Potential Hazard to Life: **low**

Potential Hazard to Property: **low**

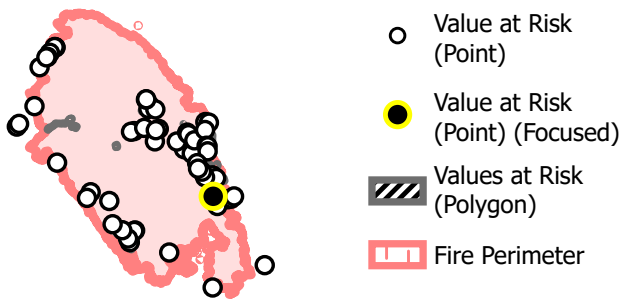
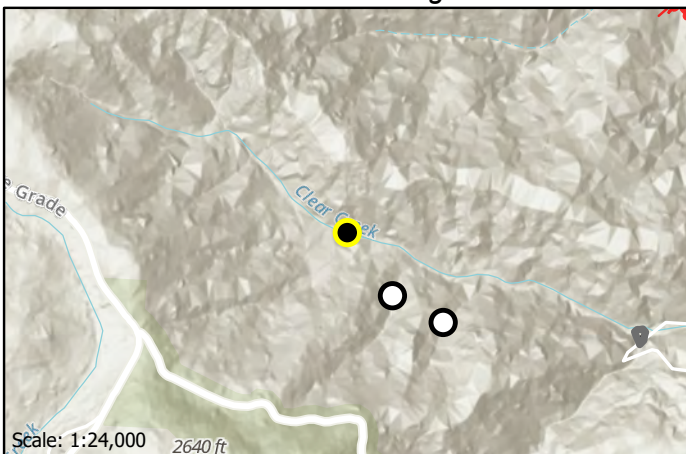
Field Observation impacts to San Lorenzo Valley water intake
or Potential Hazard:

Potential Hazard to Life: **low**

Potential Hazard to Property: **high**

Description: prepare for increased dissolved organics

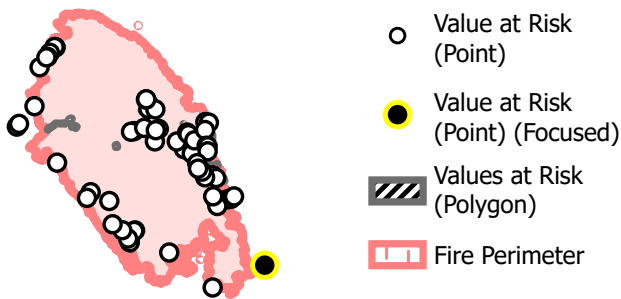
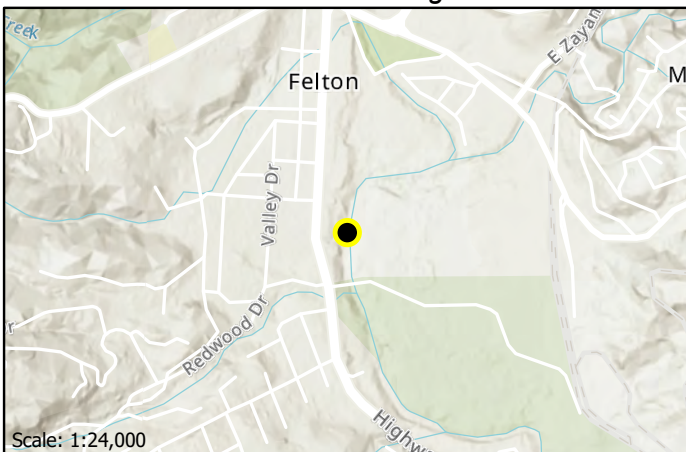
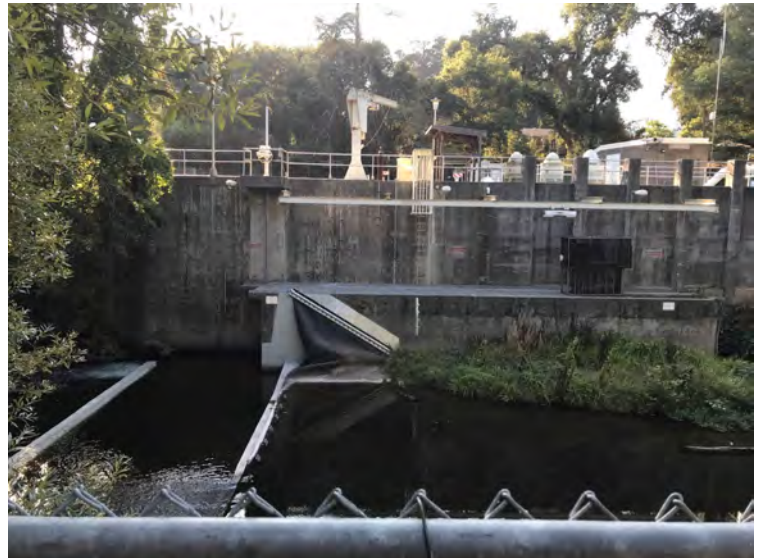
Field Observation Post-fire runoff could result in excessive organic that would impair water or Potential Hazard: treatment.

Potential Hazard to Life: **low**

Potential Hazard to Property: **moderate**

Description: Prepare for increased organics

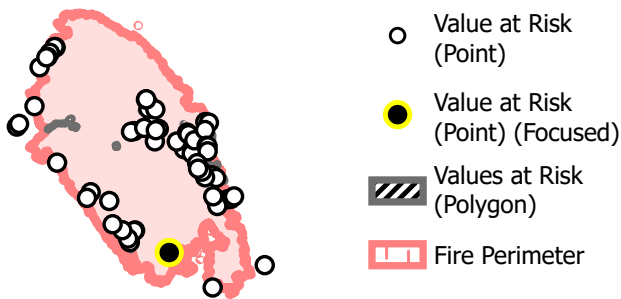
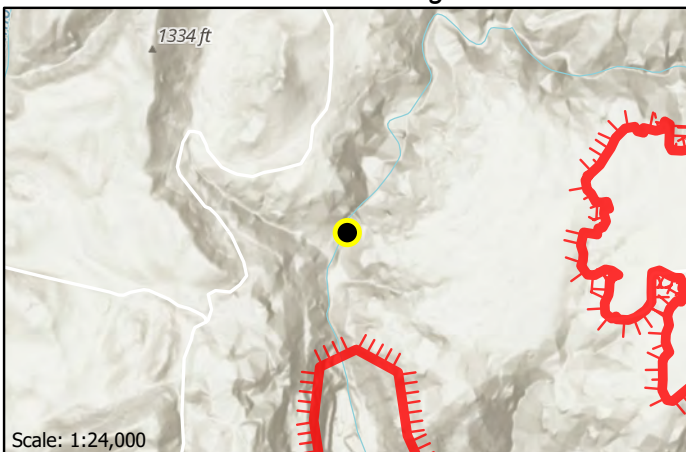
Field Observation or Potential Hazard: Potential for sedimentation, possible impacts to water quality

Potential Hazard to Life: low

Potential Hazard to Property: low

Description: Prepare for increased organics

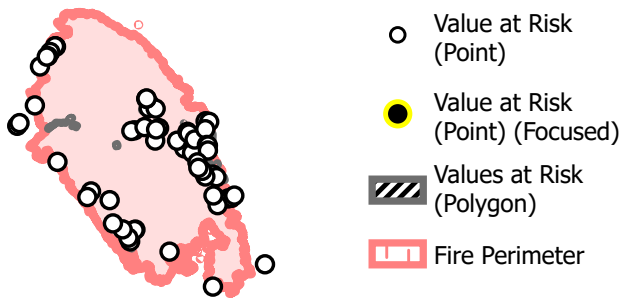
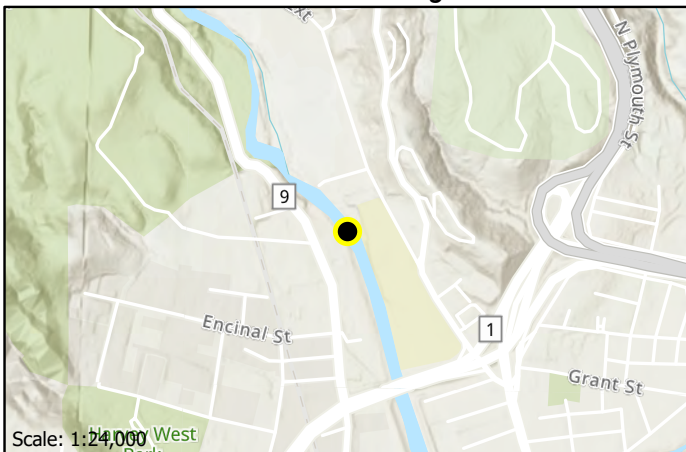
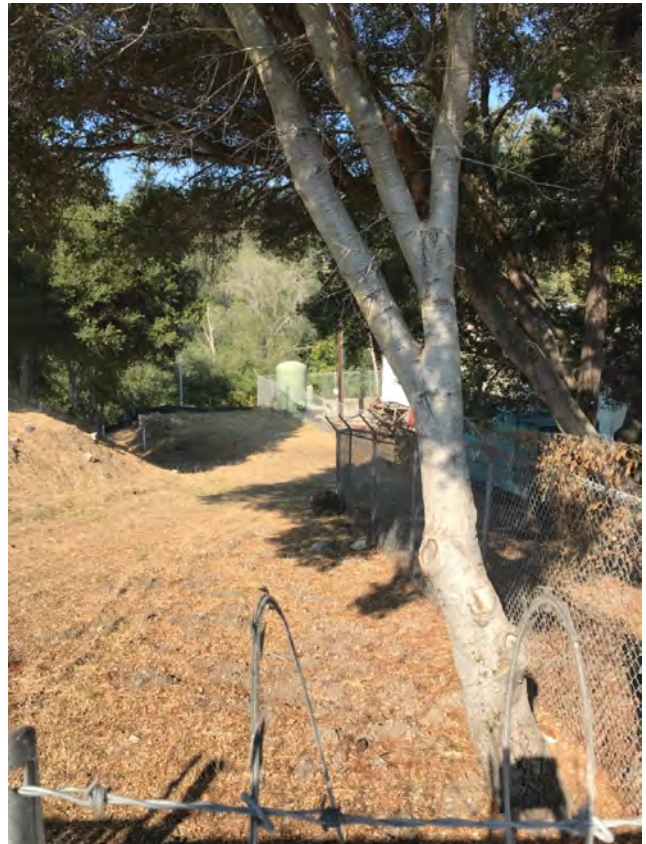
Field Observation Post-fire runoff could result in excessive organic that would impair water or Potential Hazard: treatment.

Potential Hazard to Life: **low**

Potential Hazard to Property: **moderate**

Description: Prepare for increased organics

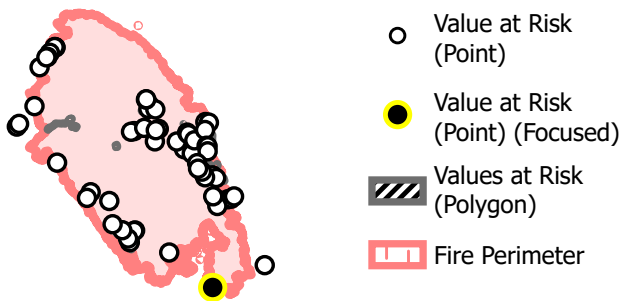
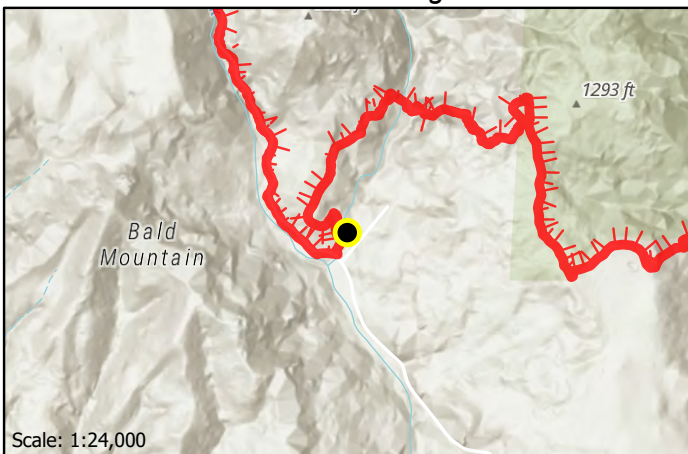
Field Observation or Potential Hazard: Impacts to water quality at City of Santa Cruz water intake

Potential Hazard to Life: **moderate**

Potential Hazard to Property: **low**

Description: Prepare for increased organics

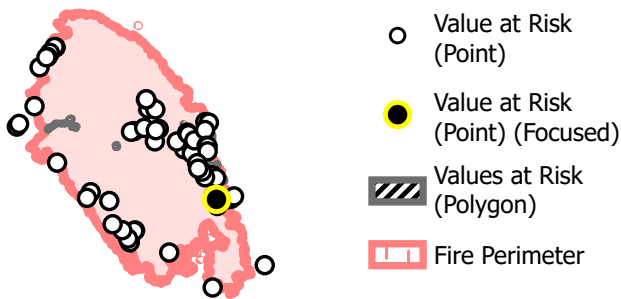
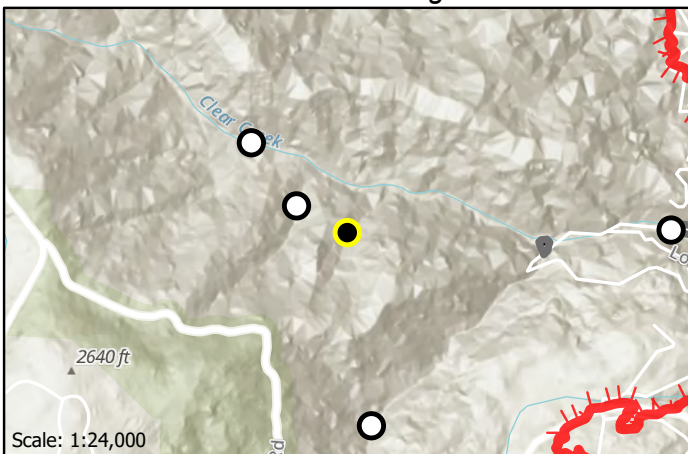
Field Observation Imapcts to San Lorenzo Valley water intake
or Potential Hazard:

Potential Hazard to Life: **low**

Potential Hazard to Property: **high**

Description: prepare for increased dissolve organics

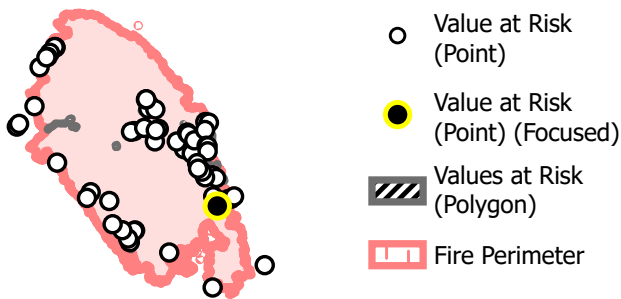
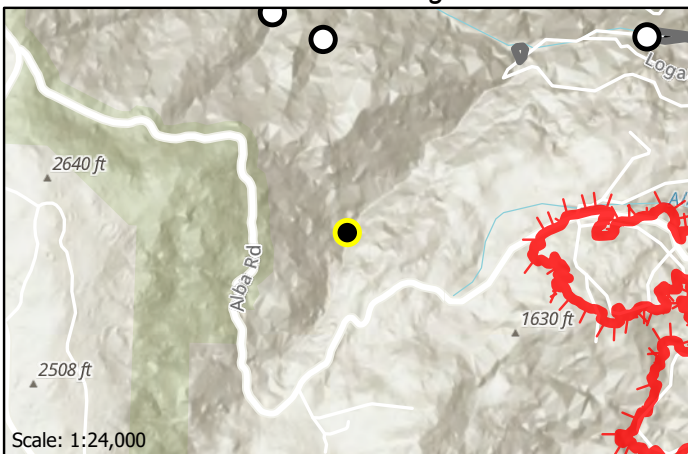
Field Observation impacts to San Lorenzo Valley water intake
or Potential Hazard:

Potential Hazard to Life: **low**

Potential Hazard to Property: **high**

Description: Prepare for increased dissolved organics

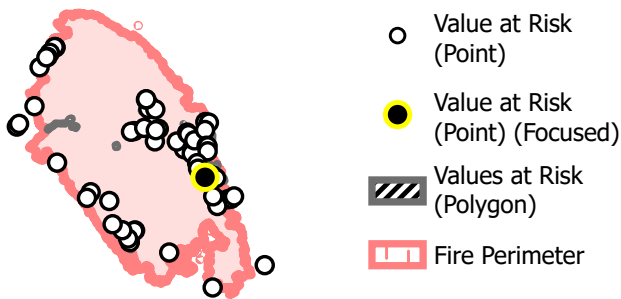
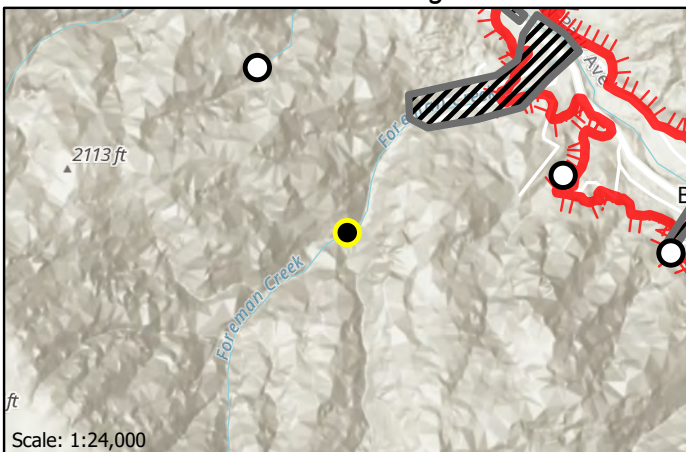
Field Observation impacts to San Lorenzo Valley water intake
or Potential Hazard:

Potential Hazard to Life: **low**

Potential Hazard to Property: **high**

Description: prepare for increased dissolved organics

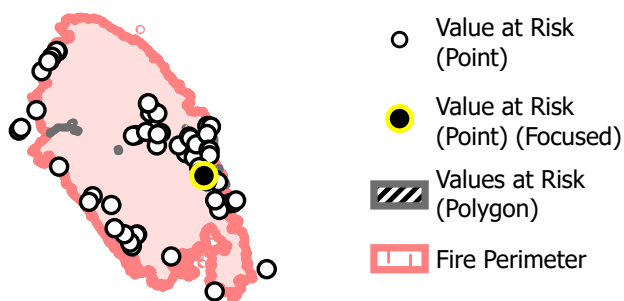
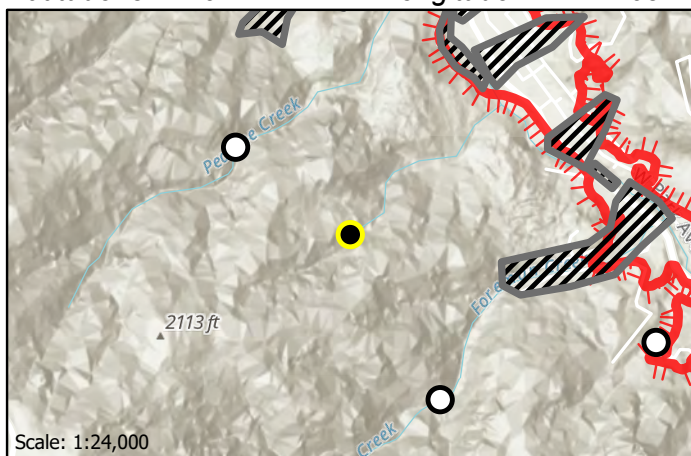
Field Observation impacts to San Lorenzo Valley water intake
or Potential Hazard:

Potential Hazard to Life: **low**

Potential Hazard to Property: **high**

Description: prepare for increased dissolved organics

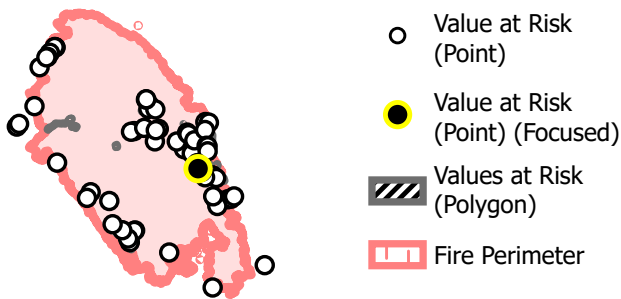
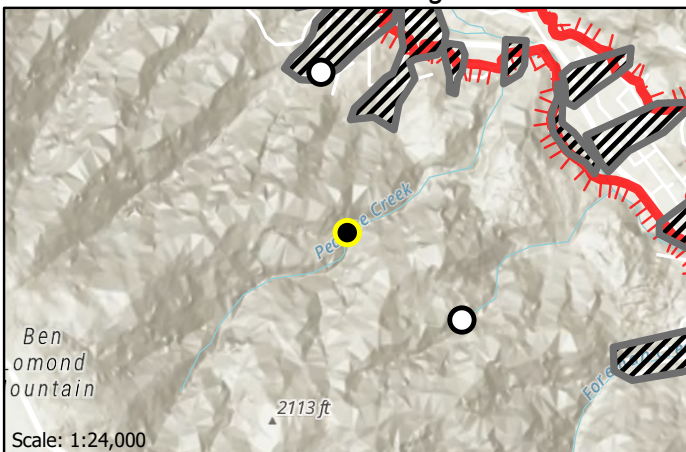
Field Observation impacts to San Lorenzo Valley water intake
or Potential Hazard:

Potential Hazard to Life: **low**

Potential Hazard to Property: **high**

Description: prepare for increased dissolved organics
