Watershed Emergency Response Team Evaluation

CZU LIGHTNING COMPLEX

CA-CZU-005205

October 1, 2020

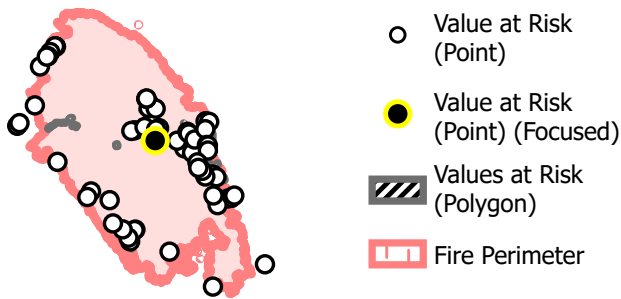
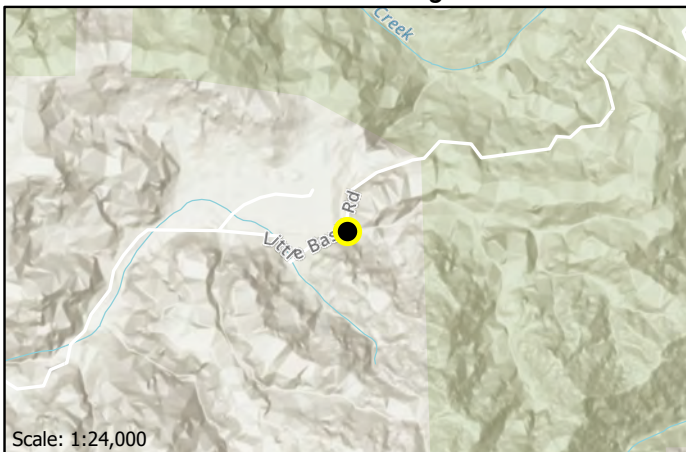
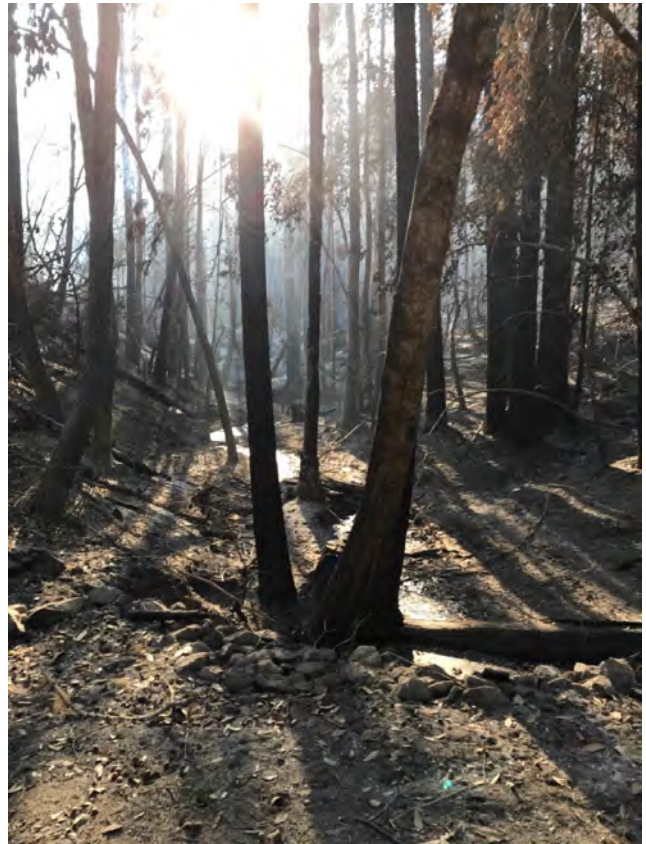
Field Observation or Potential Hazard: Culvert along Little Basin Road has potential plug and washout. Drainage contains moderate to steep slopes, with a moderate to high debris flow potential. Rockfall also observed along the road in the vicinity of the crossing.

Potential Hazard to Life: **high**

Potential Hazard to Property: **low**

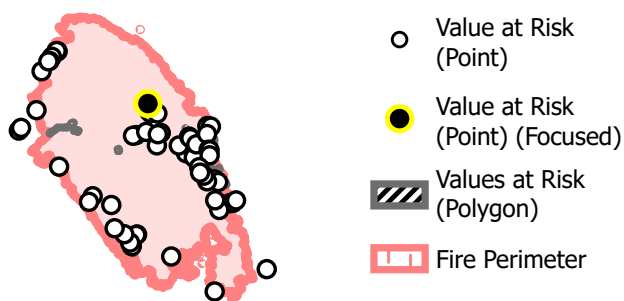
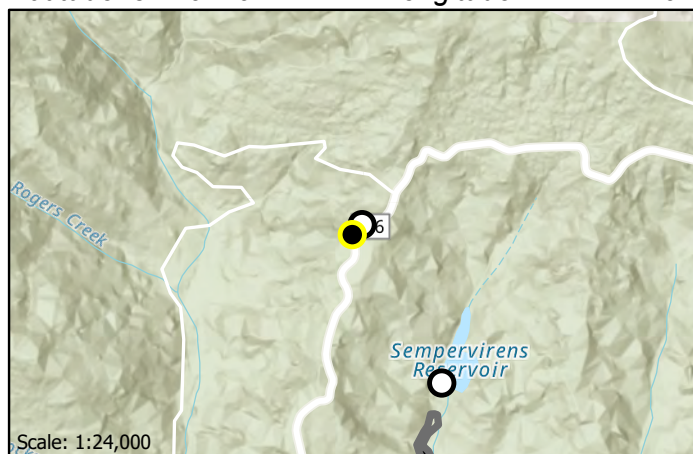
Field Observation Approximately 150 feet of retaining wall is damaged
or Potential Hazard:

Potential Hazard to Life: **low**

Potential Hazard to Property: **moderate**

Description: Further evaluation should be made by a PE or PG

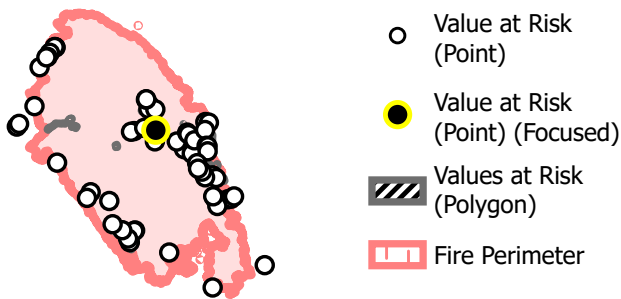
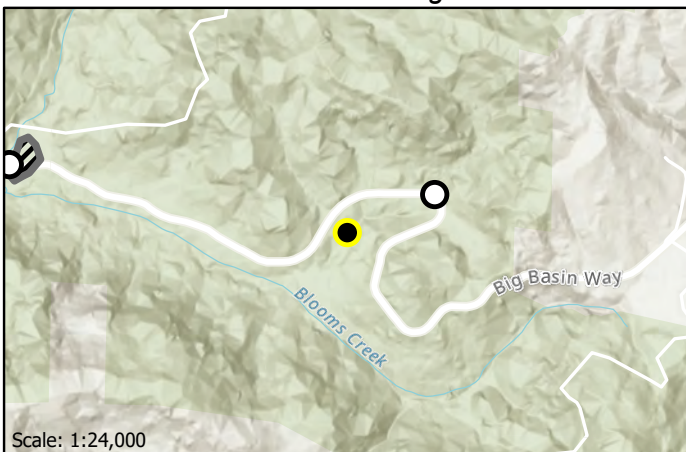
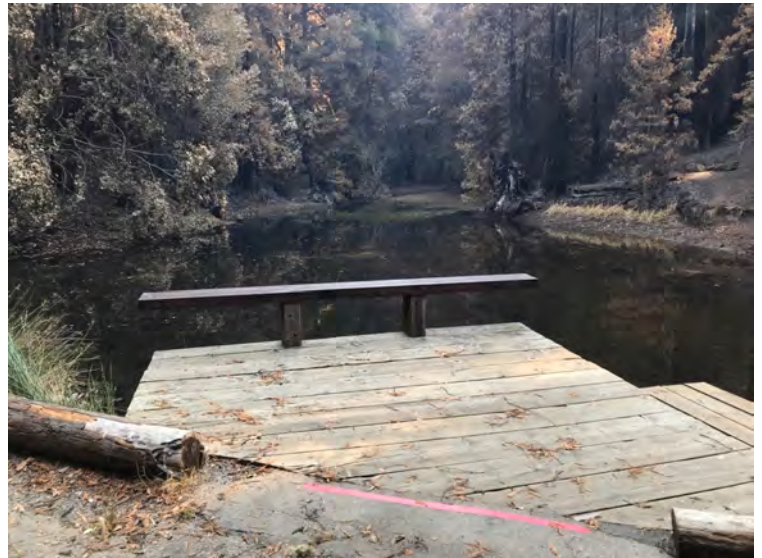
Field Observation or Potential Hazard: Retention pond along paved access road has potential to overtop and divert towards residence. Moderate to steep slopes upstream, with a moderate to high potential for debris flows.

Potential Hazard to Life: **moderate**

Potential Hazard to Property: **moderate**

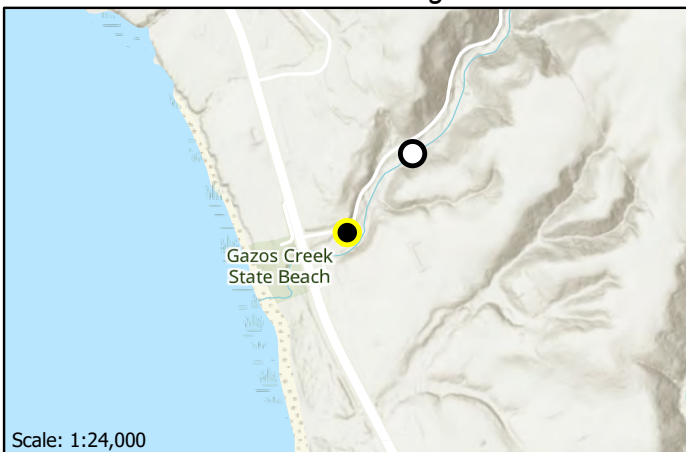
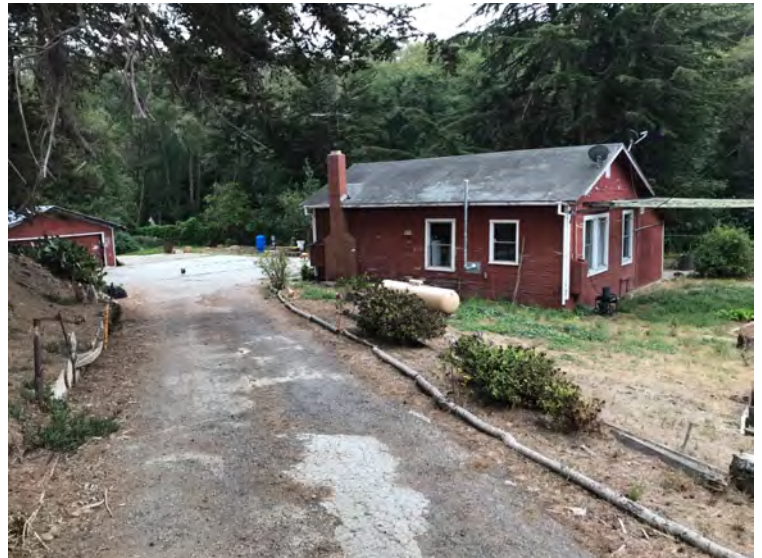
Field Observation or Potential Hazard: House within floodplain, large portion of upstream watershed located within burn area.

Potential Hazard to Life: **moderate**

Potential Hazard to Property: **moderate**

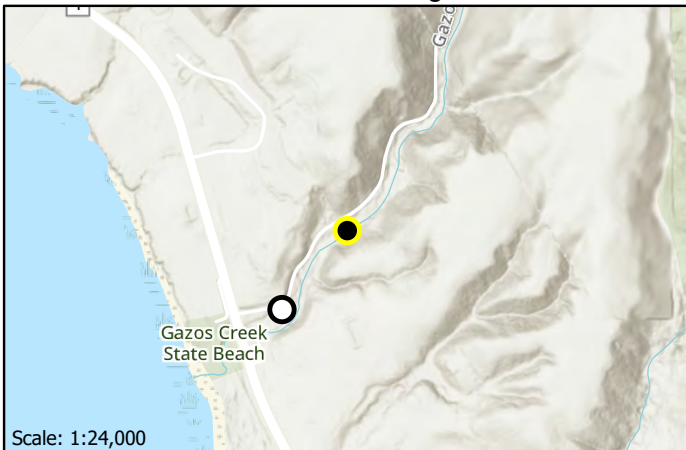
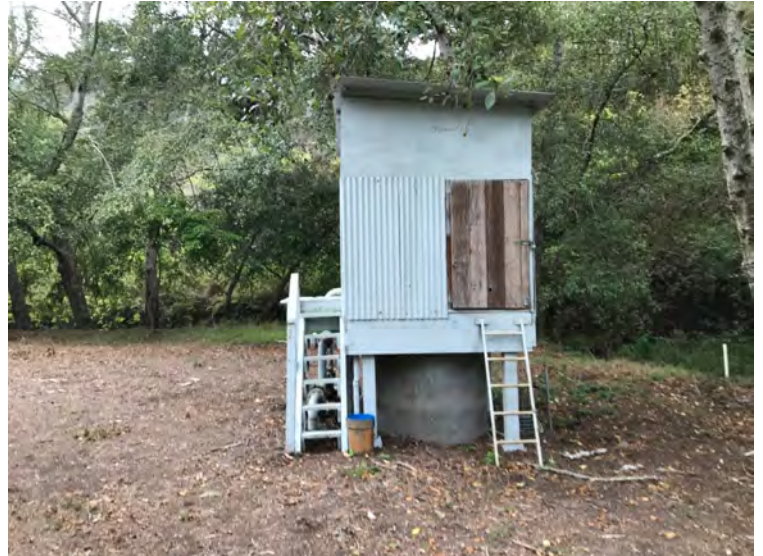
Field Observation Well house and associated equipment within floodplain. Large portion of
or Potential Hazard: upstream watershed located in burn area.

Potential Hazard to Life: **low**

Potential Hazard to Property: **moderate**

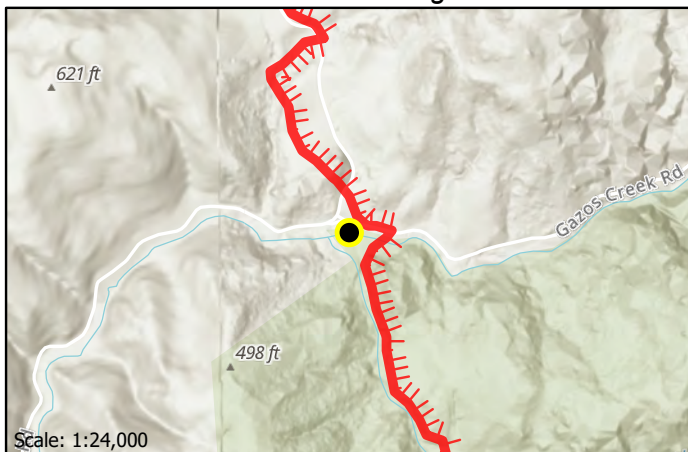
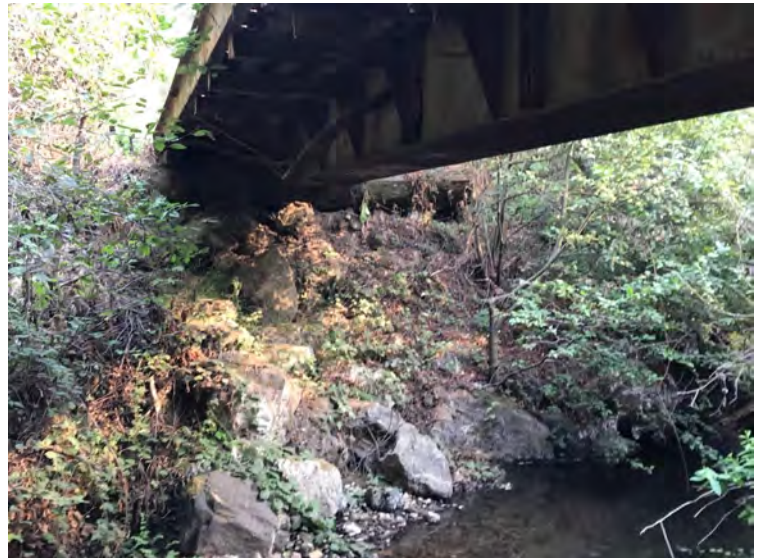
Field Observation Flooding/debris jam has potential to overtop bridge. Bridge founded on sill logs or *Potential Hazard:* located immediately above channel slope along northern abutment.

Potential Hazard to Life: **low**

Potential Hazard to Property: **moderate**

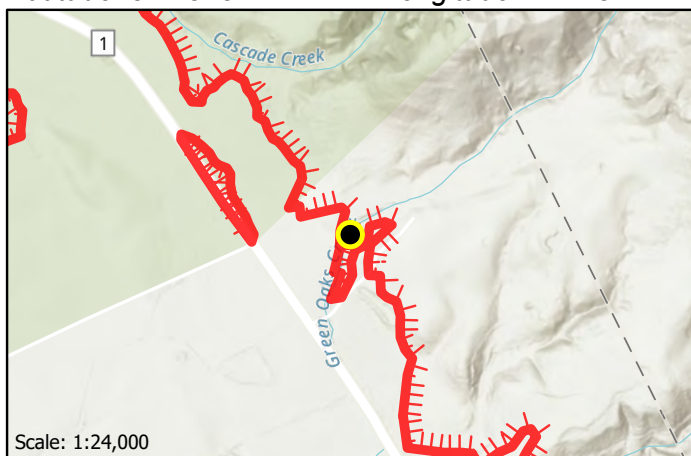
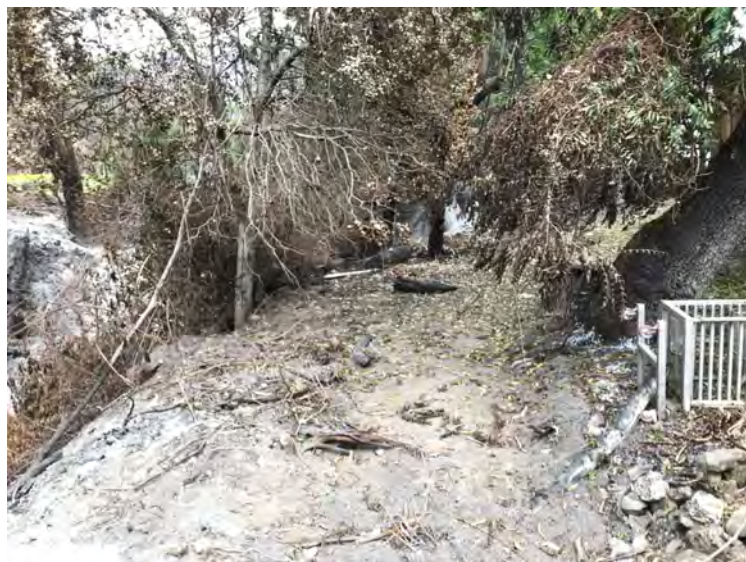
Field Observation Upstream watercourse mapped as a moderate to high potential for debris flows.
or Potential Hazard: Watercourse contains large amounts of debris. Classroom buildings within lower portion of the property are located adjacent to watercourse.

Potential Hazard to Life: **low**

Potential Hazard to Property: **moderate**

Description: Temporary Closure

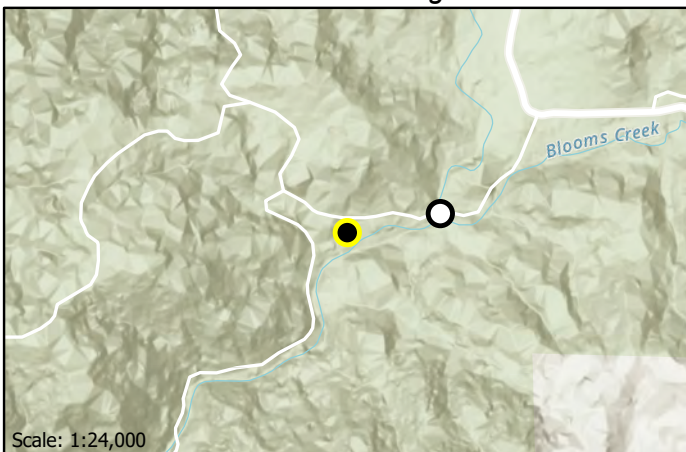
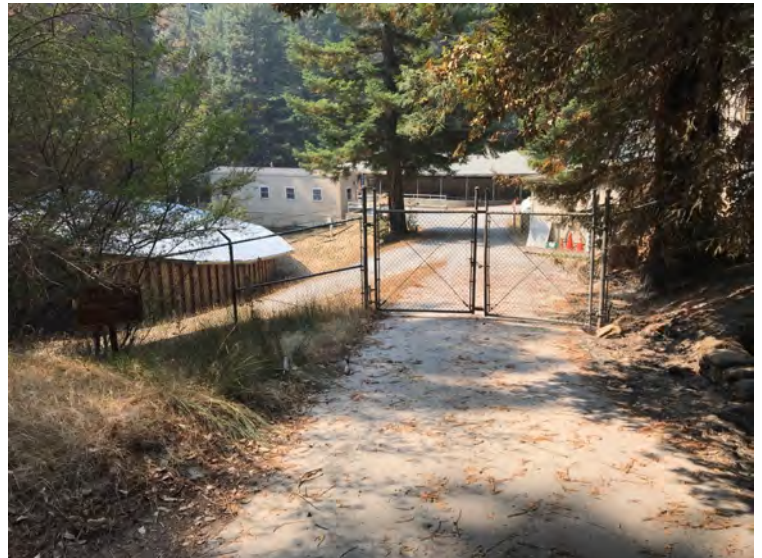
Field Observation Moderate to steep slopes above with moderate burn severity, potential for
or Potential Hazard: shallow debris slides to impact facility

Potential Hazard to Life: **low**

Potential Hazard to Property: **moderate**

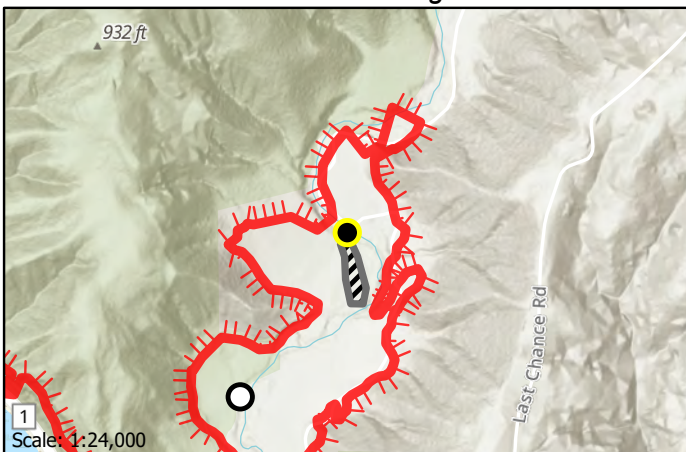
Field Observation Flooding could impact the bridge, large watershed upstream.
or Potential Hazard:

Potential Hazard to Life: **low**

Potential Hazard to Property: **moderate**

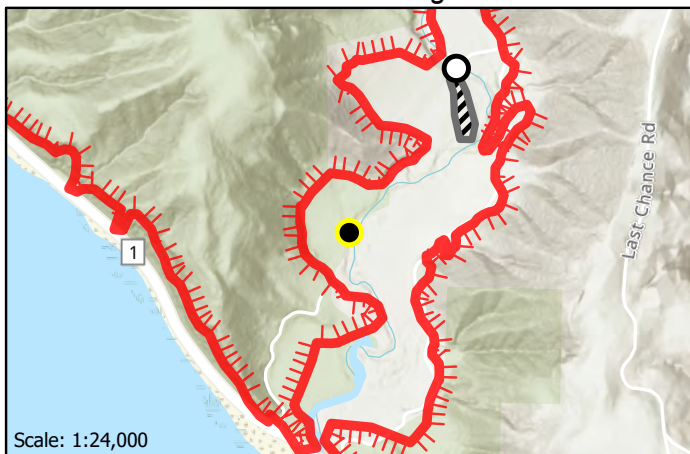
Field Observation or Potential Hazard: Flooding could impact the bridge, large watershed upstream.

Potential Hazard to Life: **low**

Potential Hazard to Property: **moderate**

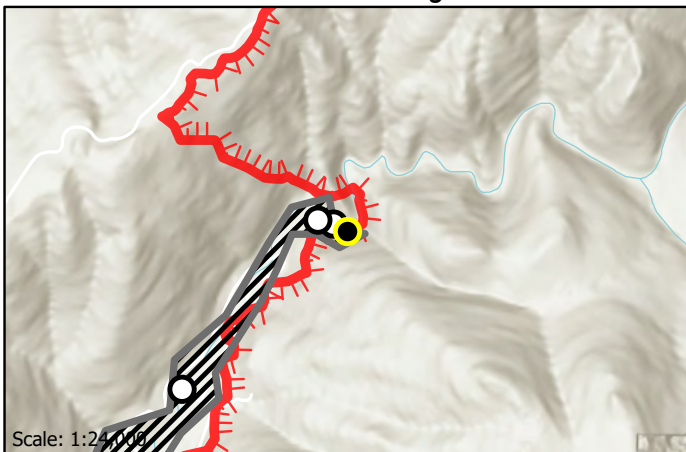
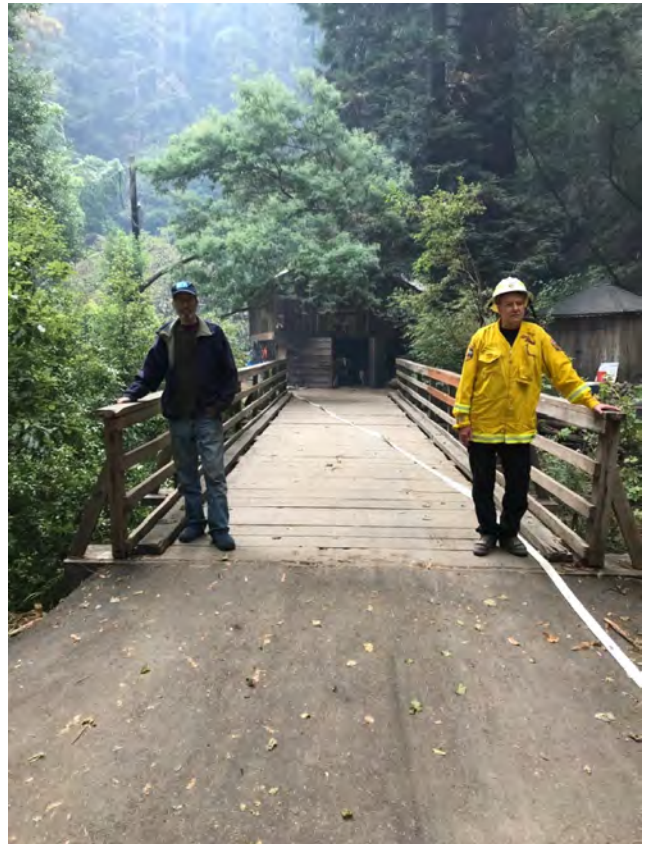
Field Observation Flooding could impact bridge. Large portion of upstream watershed located in
Potential Hazard: burn area.

Potential Hazard to Life: **low**

Potential Hazard to Property: **moderate**

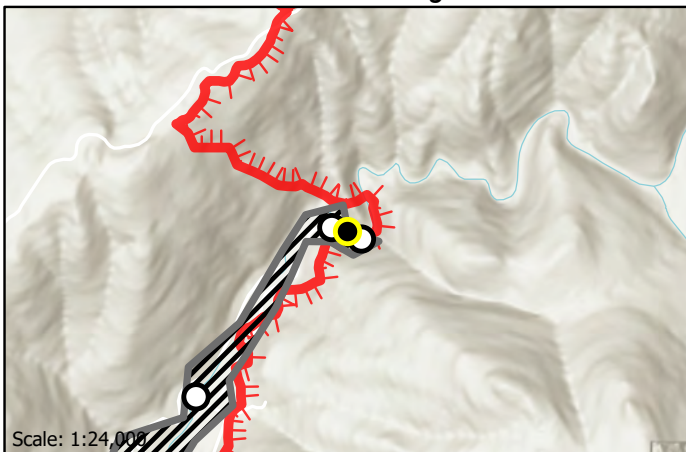
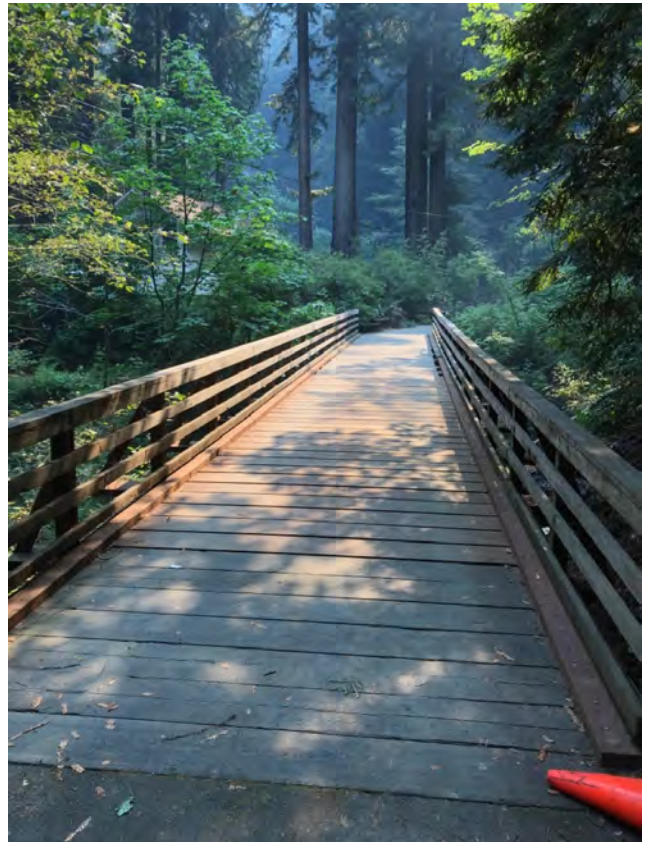
Field Observation Flooding could impact bridge. Large portion of upstream watershed located in
Potential Hazard: burn area.

Potential Hazard to Life: **low**

Potential Hazard to Property: **moderate**

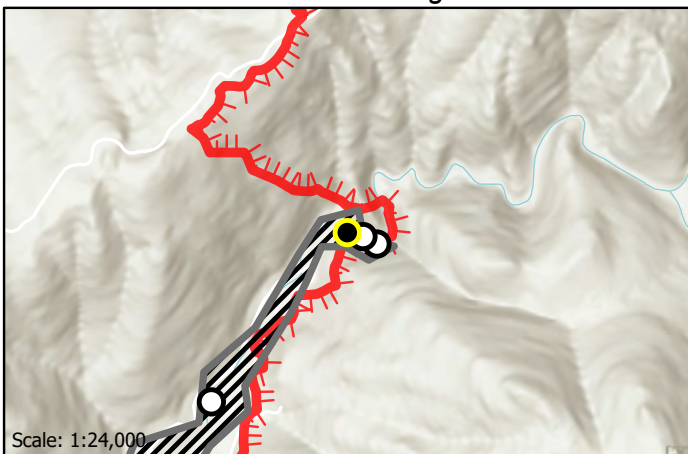
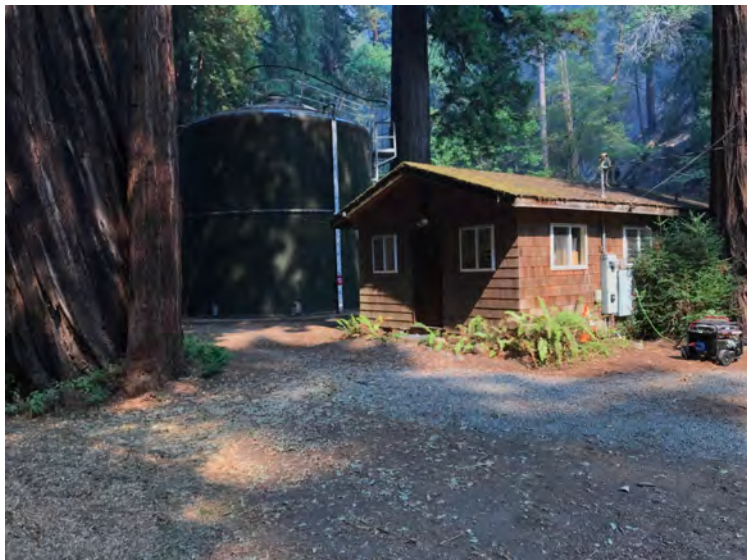
Field Observation Community water tanks, pump house and purification system within floodplain
or Potential Hazard:

Potential Hazard to Life: **low**

Potential Hazard to Property: **moderate**

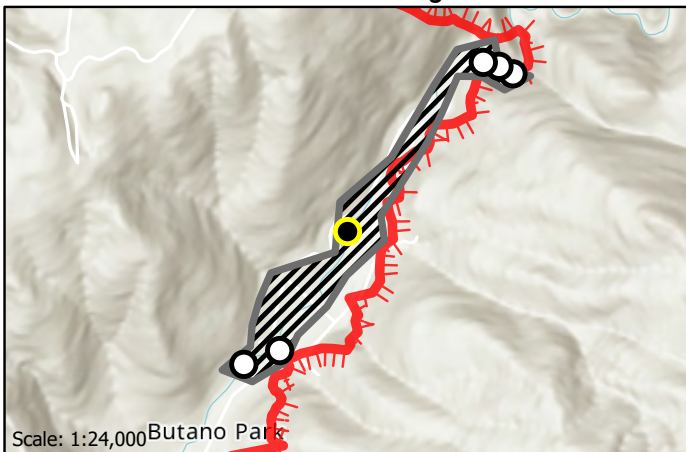
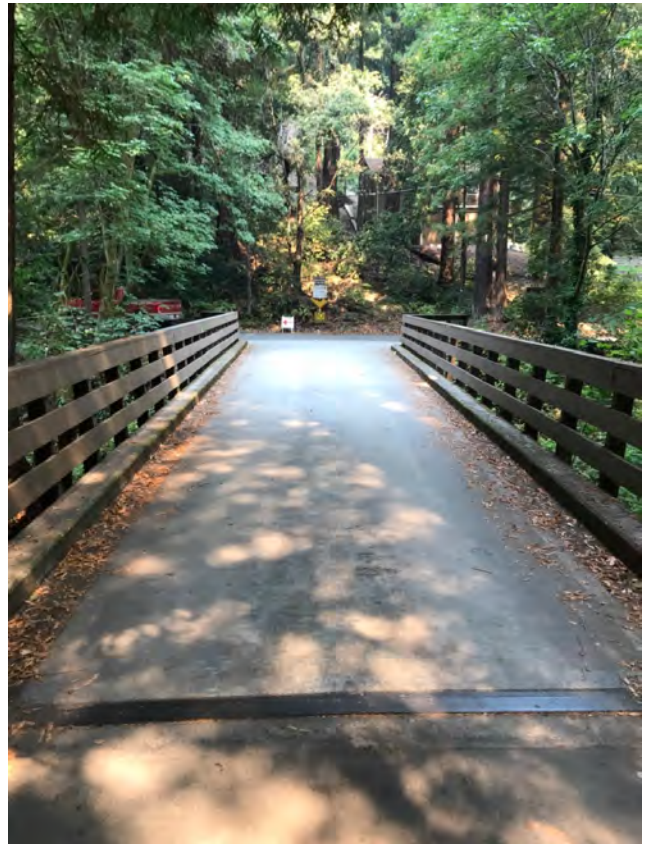
Field Observation or Potential Hazard: Flooding could impact bridge. Scour observed along abutments.

Potential Hazard to Life: **low**

Potential Hazard to Property: **moderate**

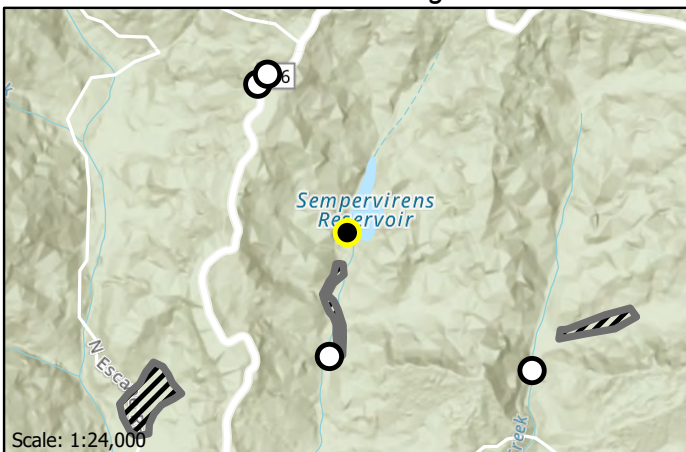
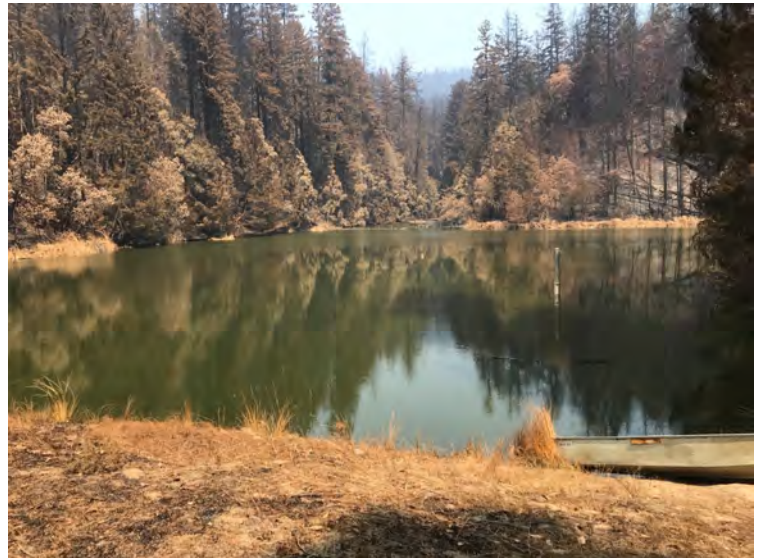
Field Observation Flooding and debris flows could impact dam. Slopes upstream with moderate to high burn severity and visible landslides on hillshade imagery. Existing 12" diameter drainage pipe along east side of embankment is damaged. Spillway outlet prone to plugging.

Potential Hazard to Life: **low**

Potential Hazard to Property: **moderate**

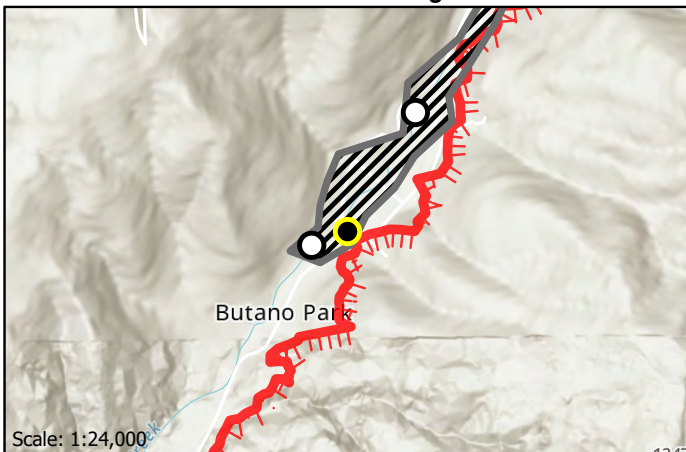
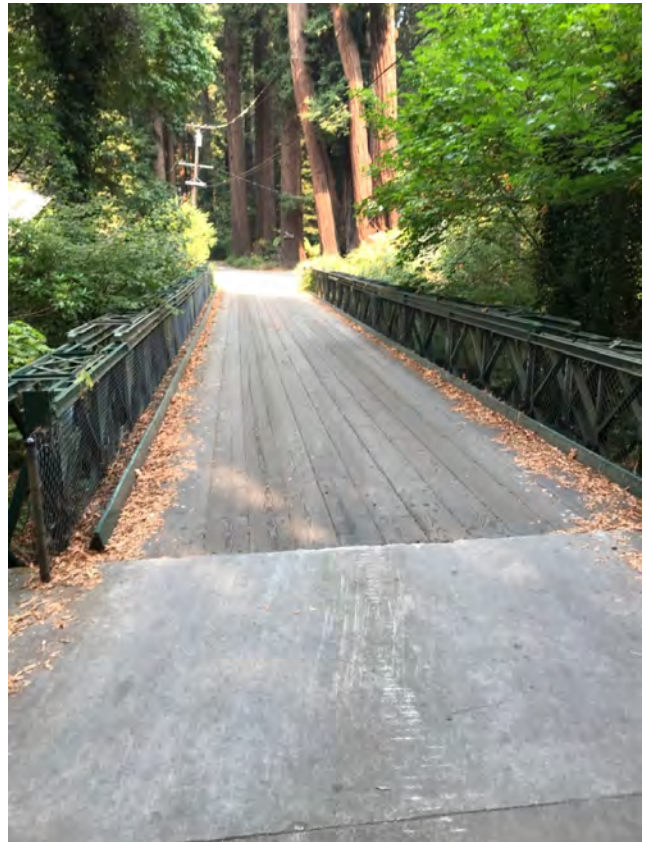
Field Observation: Flooding could impact bridge. Large portion of upstream watershed located in
or Potential Hazard: burn area.

Potential Hazard to Life: **low**

Potential Hazard to Property: **moderate**

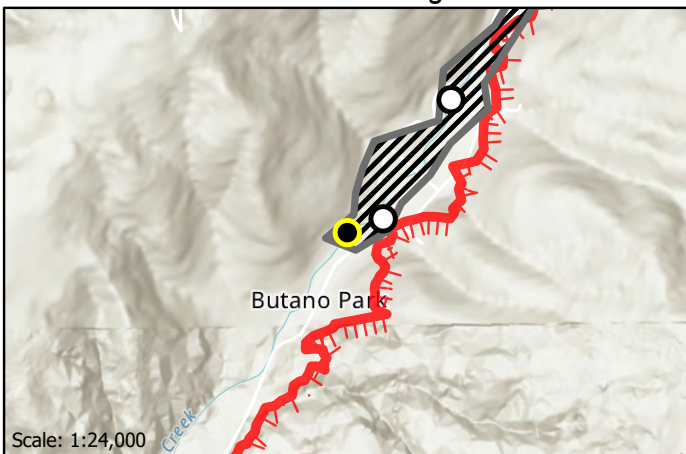
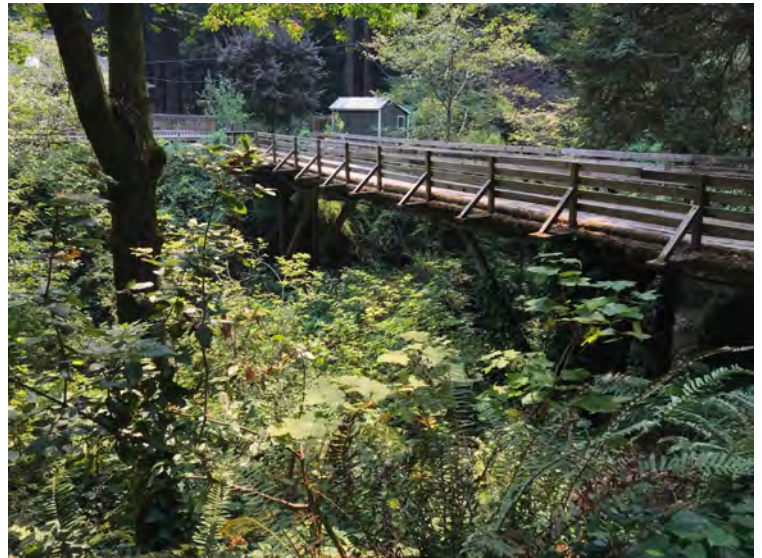
Field Observation Flooding could impact bridge. Vertically stacked log abutments functioning as
Potential Hazard: retaining wall along eastern abutment.

Potential Hazard to Life: **low**

Potential Hazard to Property: **moderate**

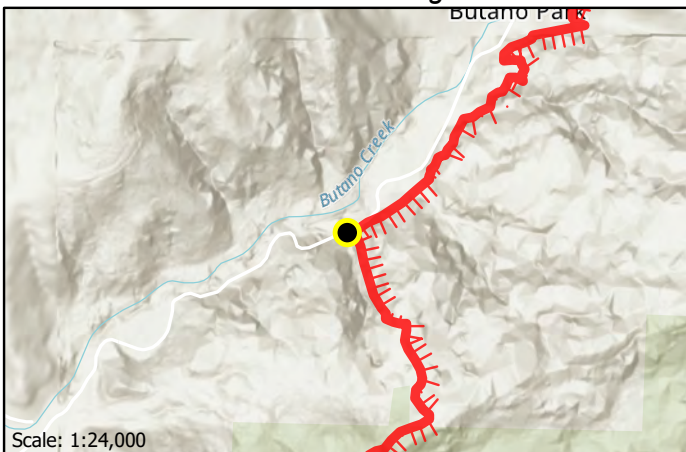
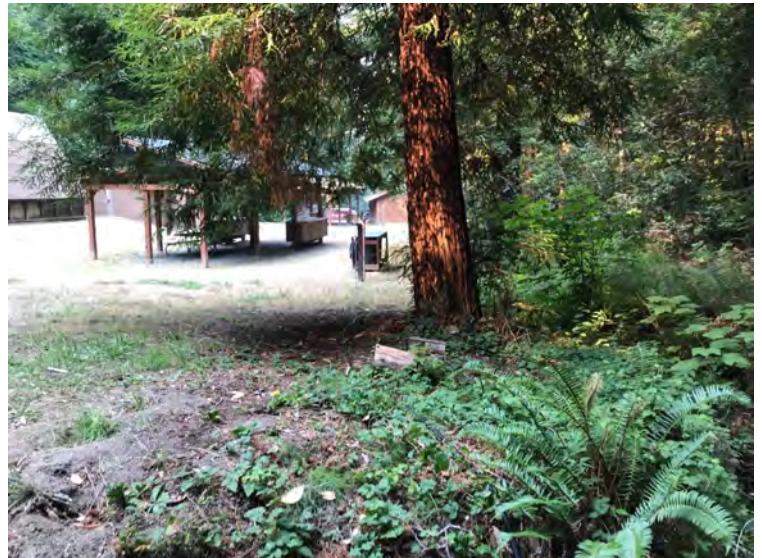
Field Observation Debris flow has potential to impact structures and pump house for campground.
or Potential Hazard:

Potential Hazard to Life: **moderate**

Potential Hazard to Property: **moderate**

Description: Temporary Closure

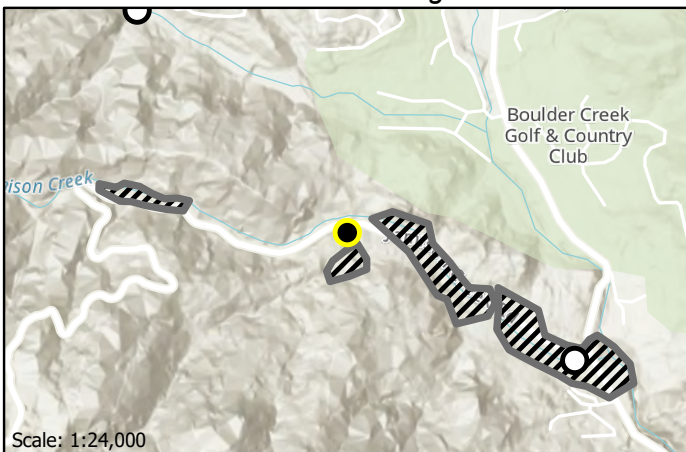
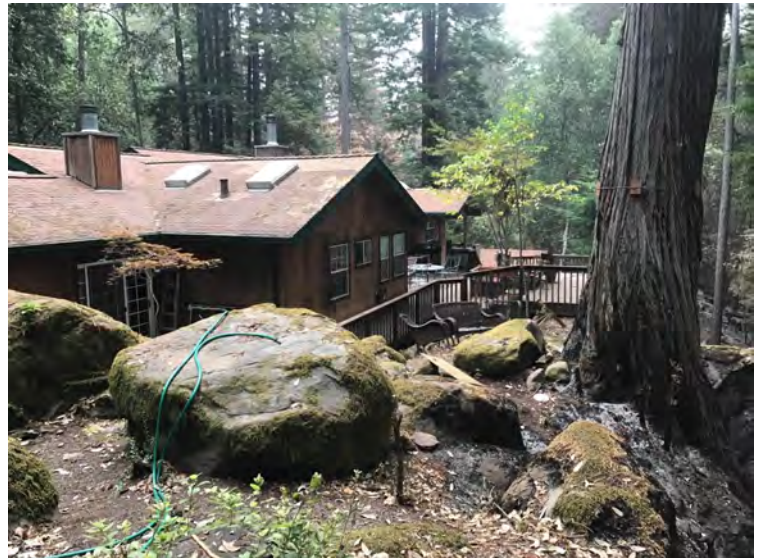
Field Observation House located along tributary to Jamison Creek. Evidence of past debris flow or *Potential Hazard*: activity, including large boulders within channel and adjacent to structure.

Potential Hazard to Life: **high**

Potential Hazard to Property: **high**

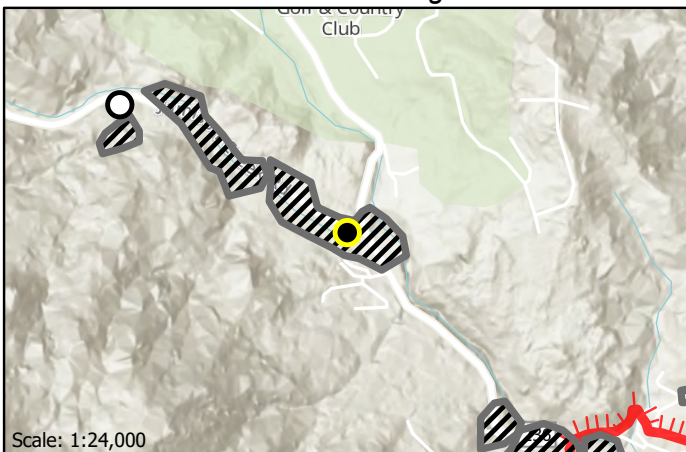
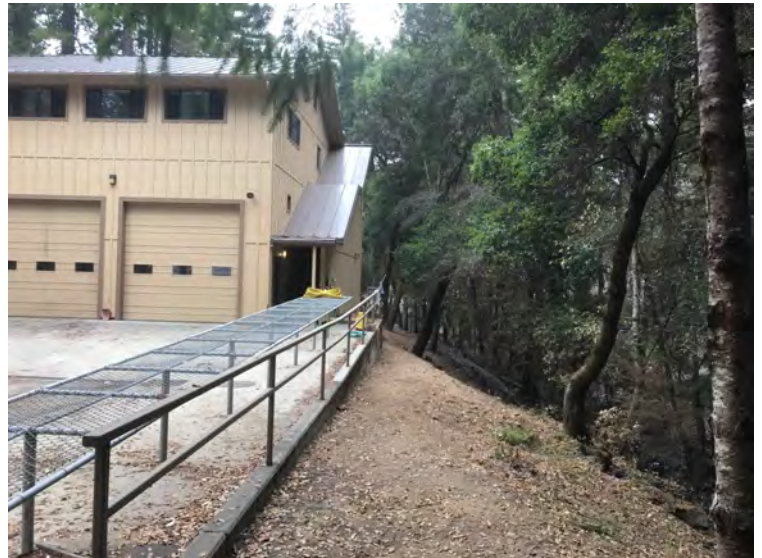
Field Observation CALFIRE Jamison Creek Station located along Jameson Creek. Within alluvial
or Potential Hazard: fan at bottom of creek. Box culvert at highway 236 is SW of building.

Potential Hazard to Life: **moderate**

Potential Hazard to Property: **moderate**

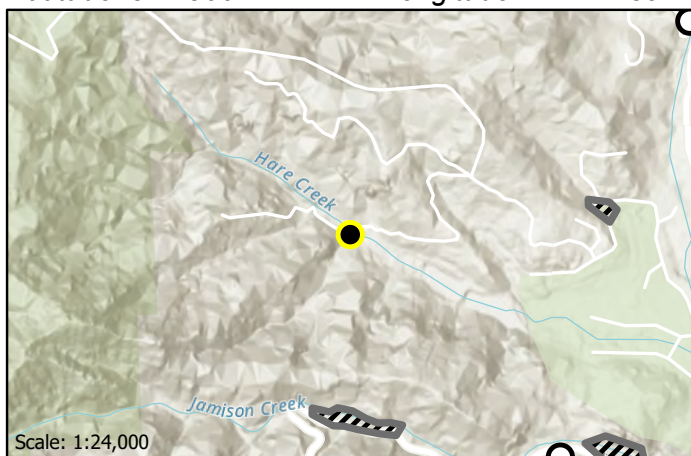
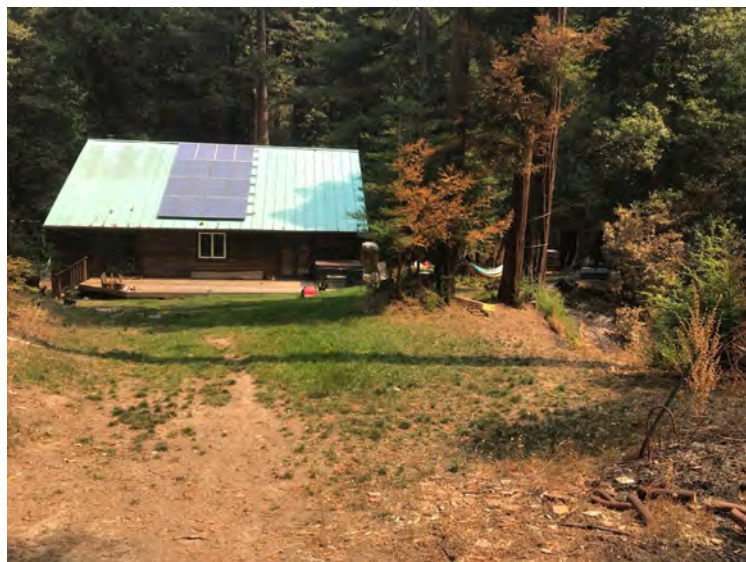
Field Observation House located on fan at base of steep watercourse. Multiple debris slides or *Potential Hazard*: mapped upstream.

Potential Hazard to Life: **moderate**

Potential Hazard to Property: **moderate**

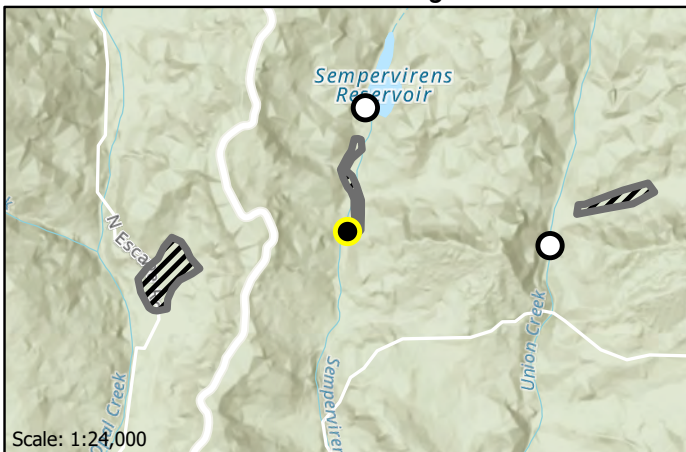
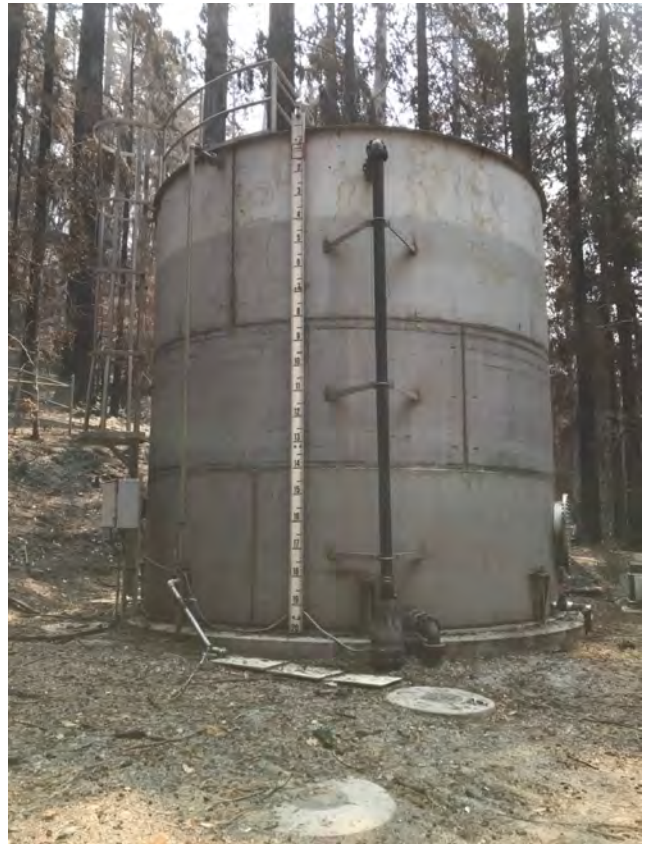
Field Observation 90 degree turn in creek observed approximately 80' upstream of the tank.
or Potential Hazard: Potential for water and debris to leave the main channel and flow towards tank.

Potential Hazard to Life: **low**

Potential Hazard to Property: **moderate**

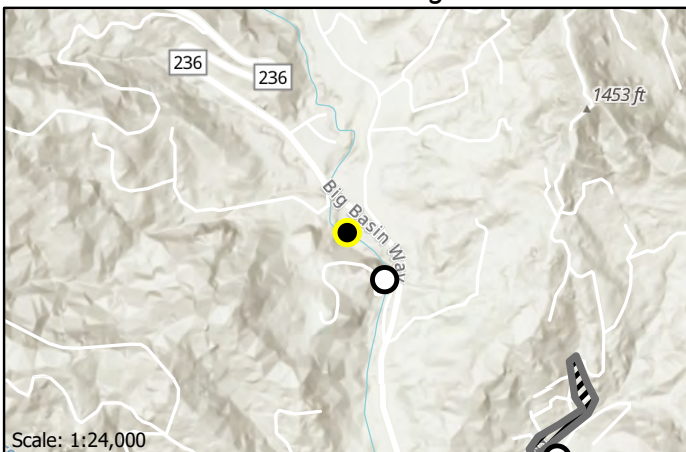
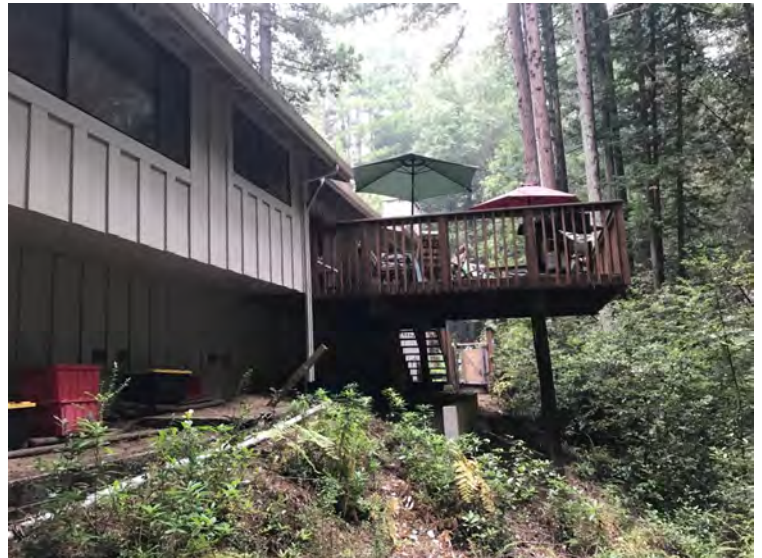
Field Observation House and deck located immediately adjacent to Boulder Creek. Deck post or Potential Hazard: rotated.

Potential Hazard to Life: **low**

Potential Hazard to Property: **moderate**

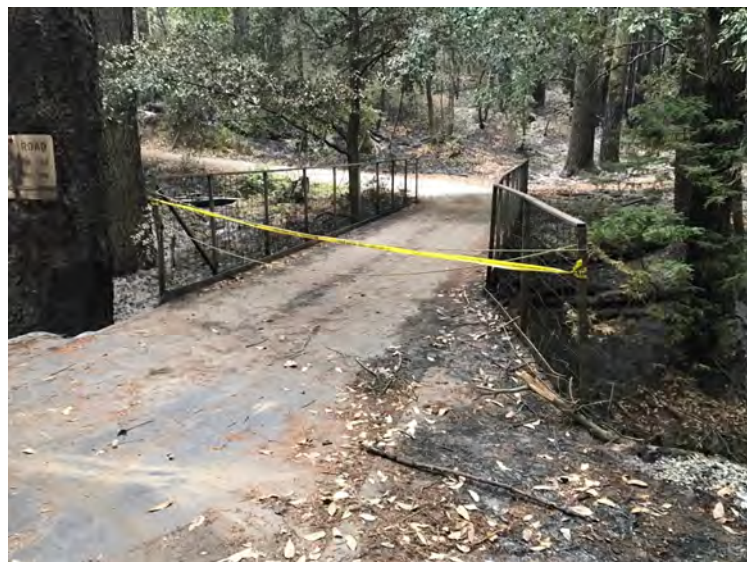
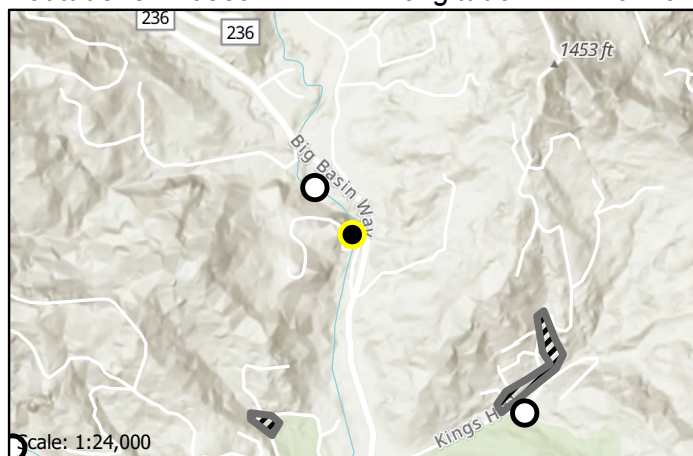
Feature: **Burned structure and rail car bridge.**

Field Observation or Potential Hazard: Potential for flooding impacts to temporary housing site. Apparent former structure and shipping container located within bank full flood plain of Boulder Creek. Also, rail car bridge.

Potential Hazard to Life: **low**

Potential Hazard to Property: **moderate**

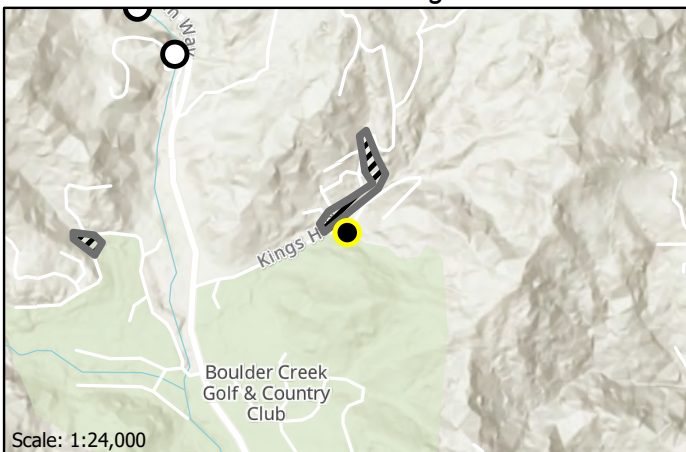
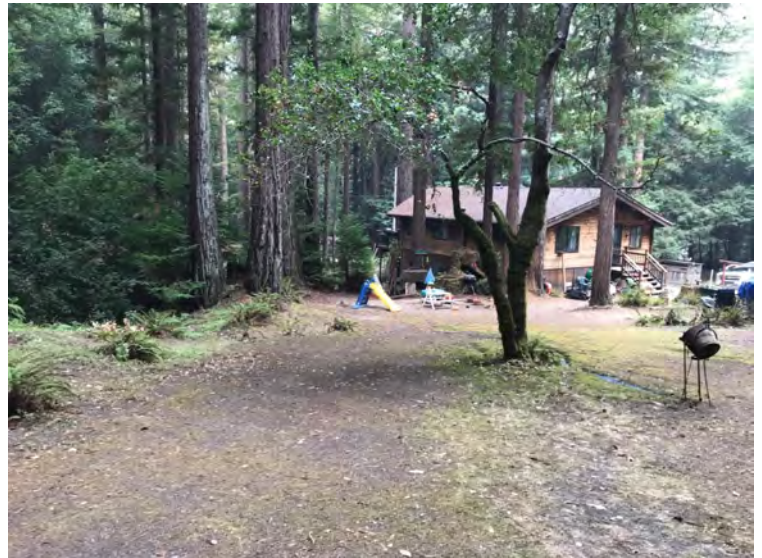
Field Observation or Potential Hazard: House located adjacent to small channel. Channel mapped as low debris flow probability.

Potential Hazard to Life: **low**

Potential Hazard to Property: **moderate**

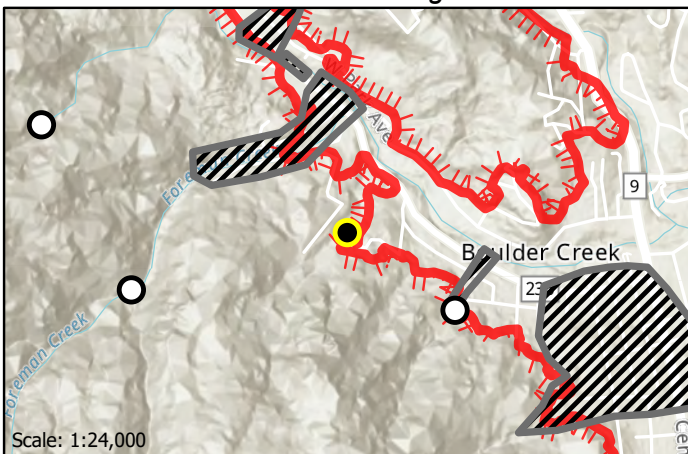
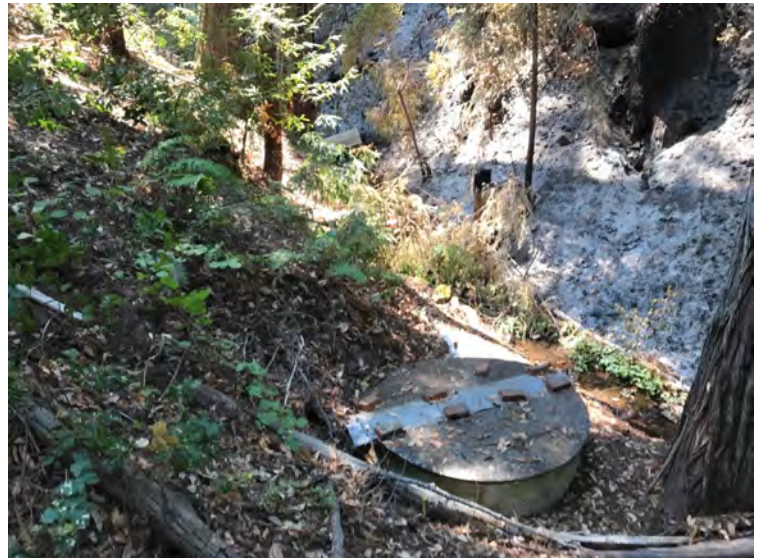
Field Observation Well box located in Creek. Creek identified as low probability debris flow.
or Potential Hazard:

Potential Hazard to Life: **low**

Potential Hazard to Property: **moderate**

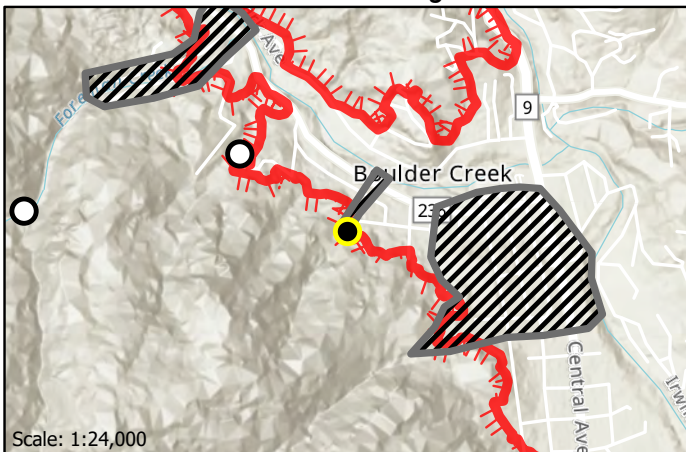
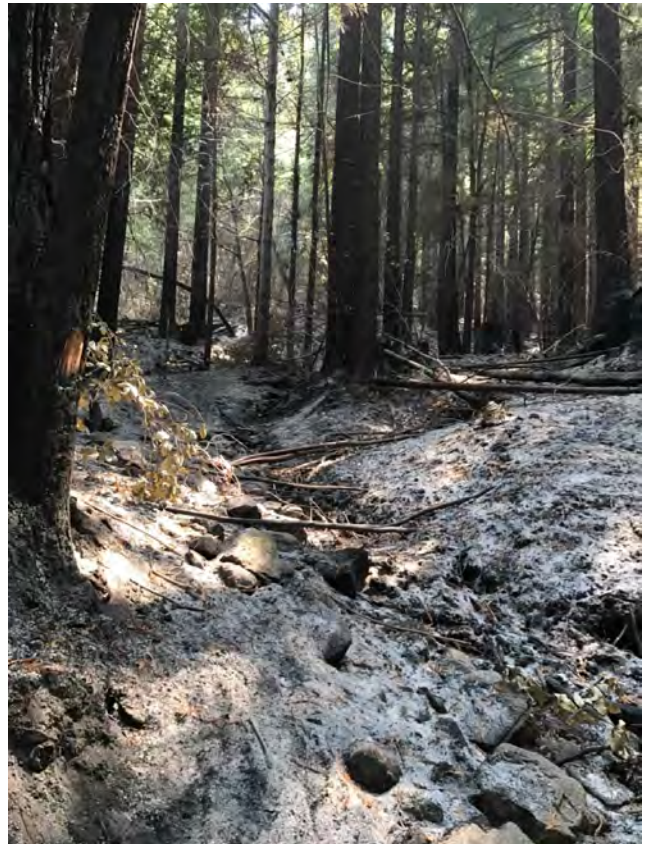
Field Observation or Potential Hazard: House located adjacent to modeled debris flow channel segment. Model shows low potential. Possible small avulsion upstream of house. Homeowner constructed berm to channel flow away from house

Potential Hazard to Life: **low**

Potential Hazard to Property: **moderate**

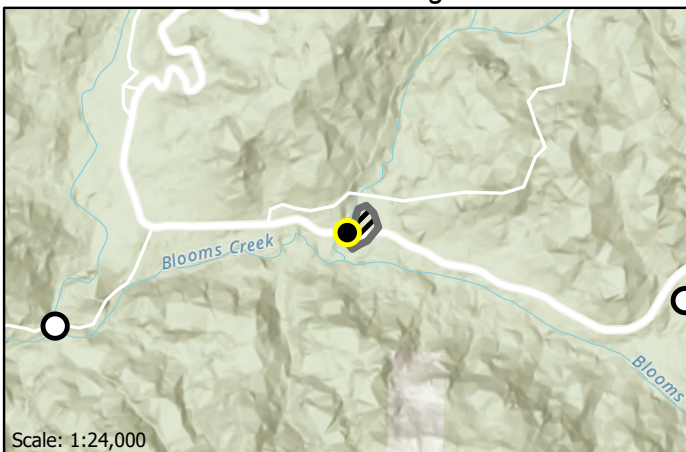
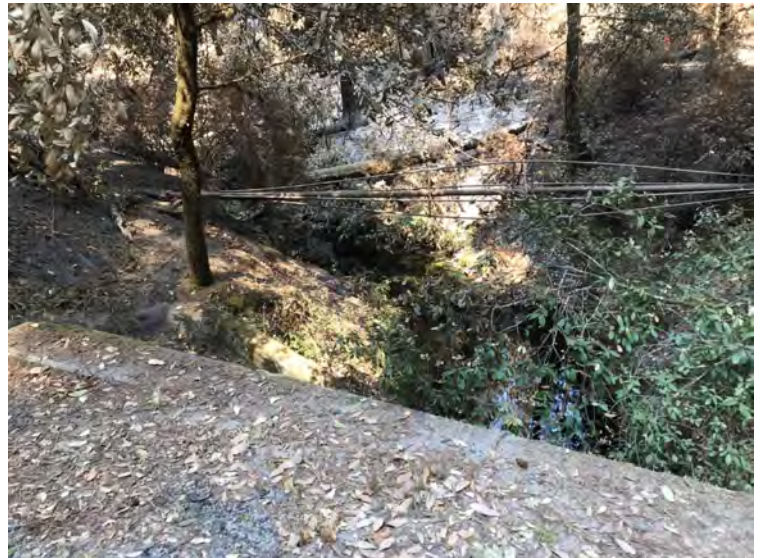
Field Observation Choke point, 10-foot diameter arched culvert appears to be chokepoint for
or Potential Hazard: upstream watershed. Potential to plug with woody debris, overtop and washout road prism.

Potential Hazard to Life: **low**

Potential Hazard to Property: **moderate**

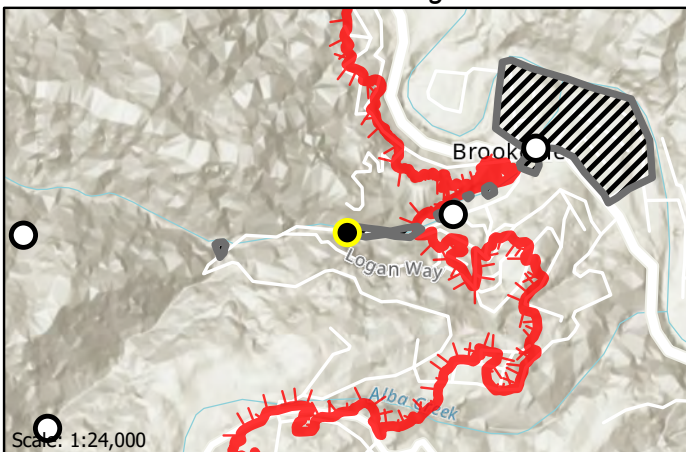
Field Observation or Potential Hazard: Existing house and driveway bridge

Potential Hazard to Life: **high**

Potential Hazard to Property: **high**
