Watershed Emergency Response Team Evaluation

CZU LIGHTNING COMPLEX

CA-CZU-005205

October 1, 2020

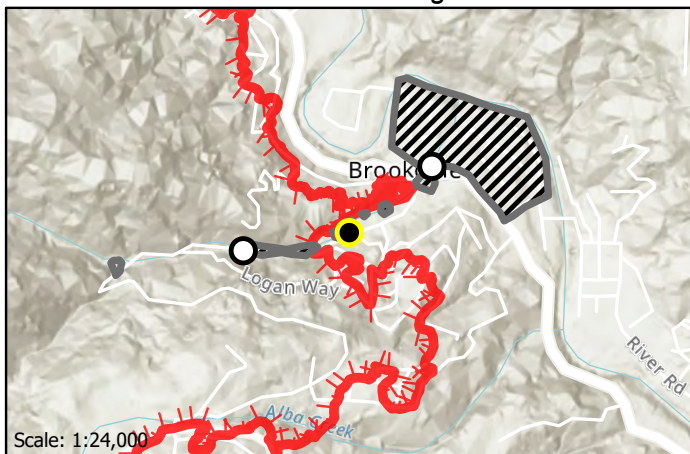
Field Observation Existing house
or Potential Hazard:

Potential Hazard to Life: **high**

Potential Hazard to Property: **high**

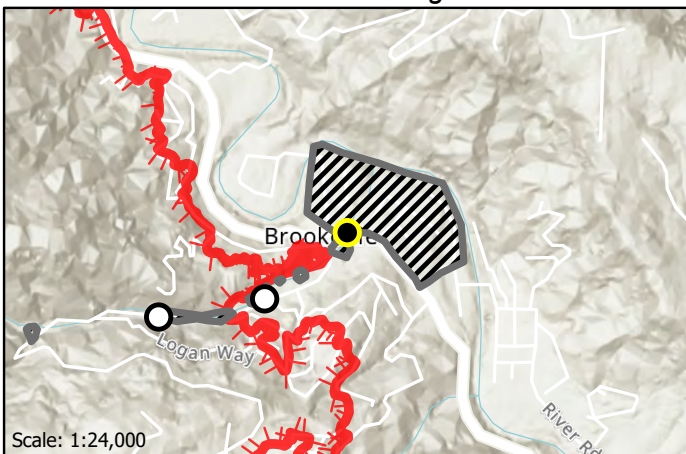
Field Observation or Potential Hazard: Highway 9 bridge

Potential Hazard to Life: **low**

Potential Hazard to Property: **moderate**

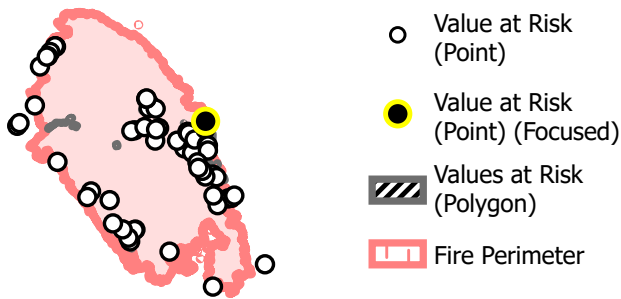
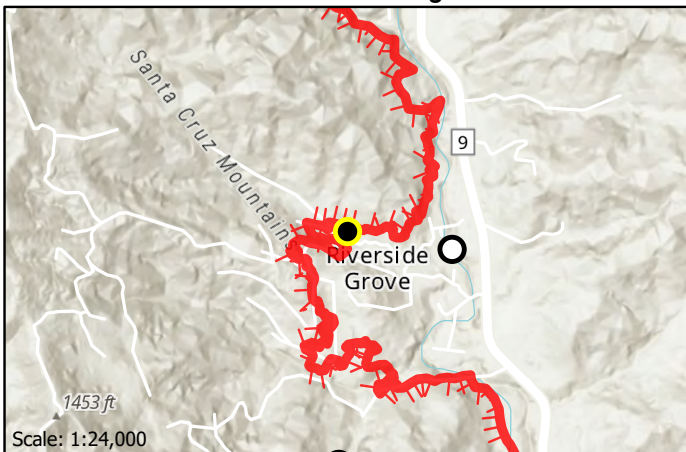
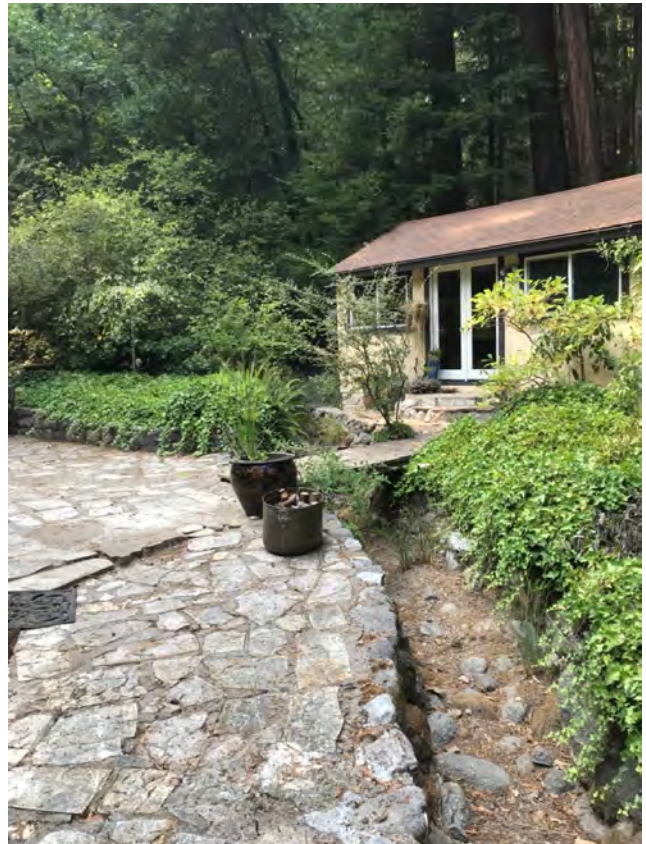
Field Observation or Potential Hazard: House located adjacent to watercourse. Stream is channelized through property. Potential for clogging and flooding.

Potential Hazard to Life: **low**

Potential Hazard to Property: **moderate**

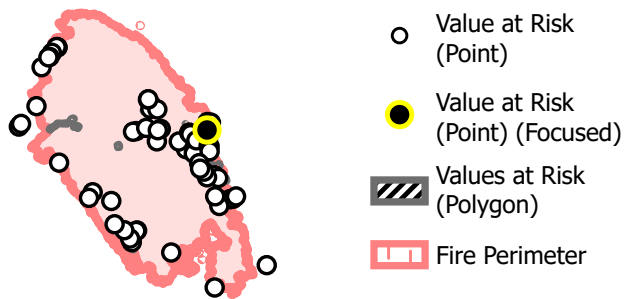
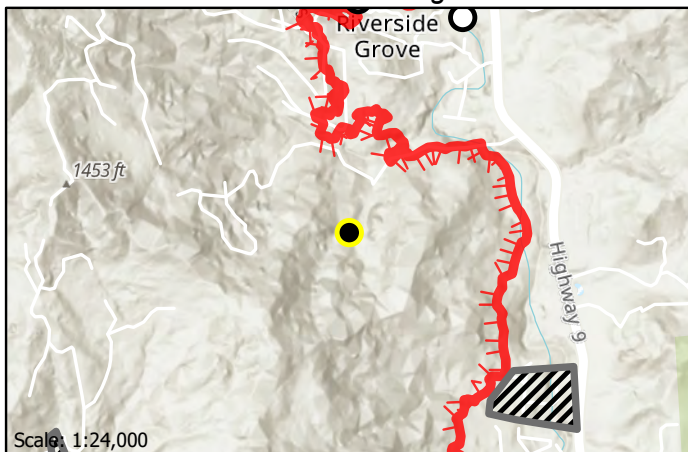
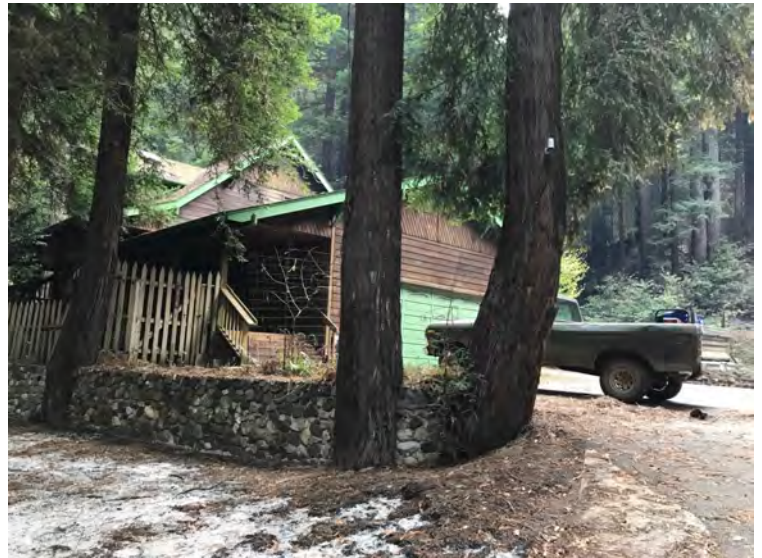
Field Observation or Potential Hazard: House located at mouth of canyon.

Potential Hazard to Life: **moderate**

Potential Hazard to Property: **moderate**

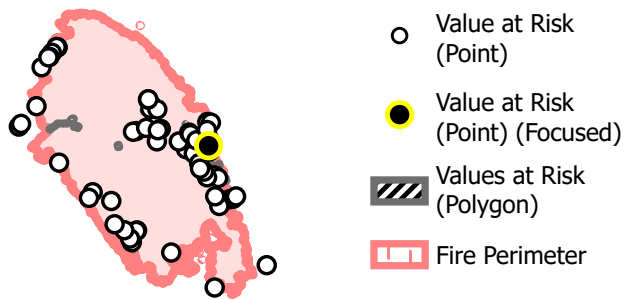
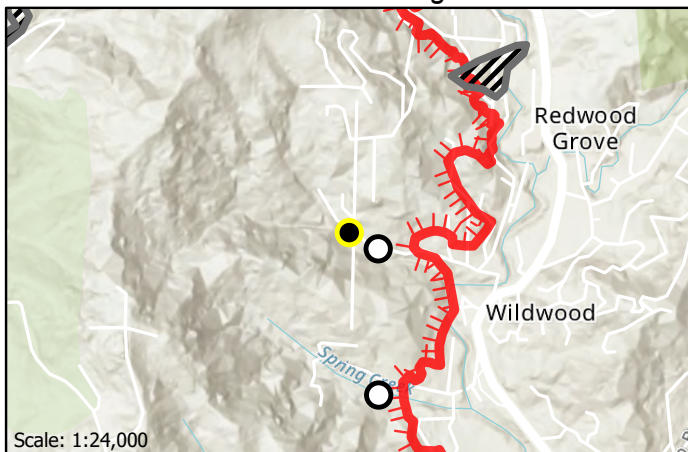
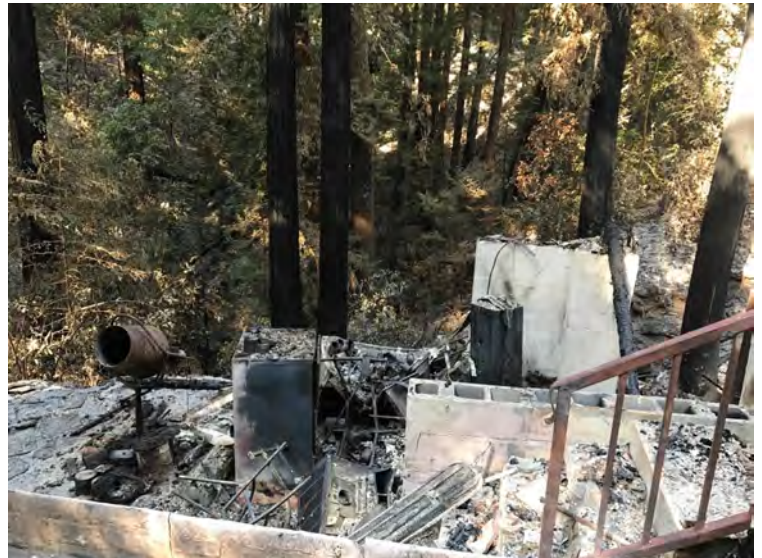
Field Observation Potential for debris flow to impact temporary housing site. Burned house
or Potential Hazard: located immediately adjacent to watercourse with a low probability for debris flow.

Potential Hazard to Life: **moderate**

Potential Hazard to Property: **low**

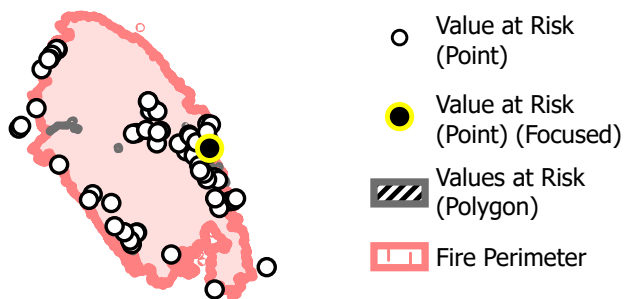
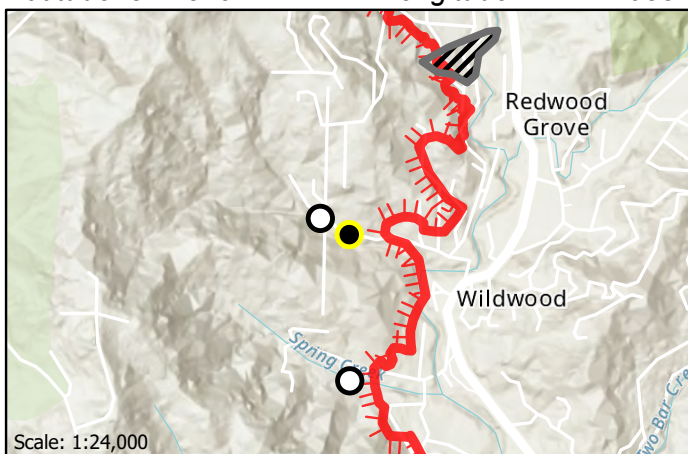
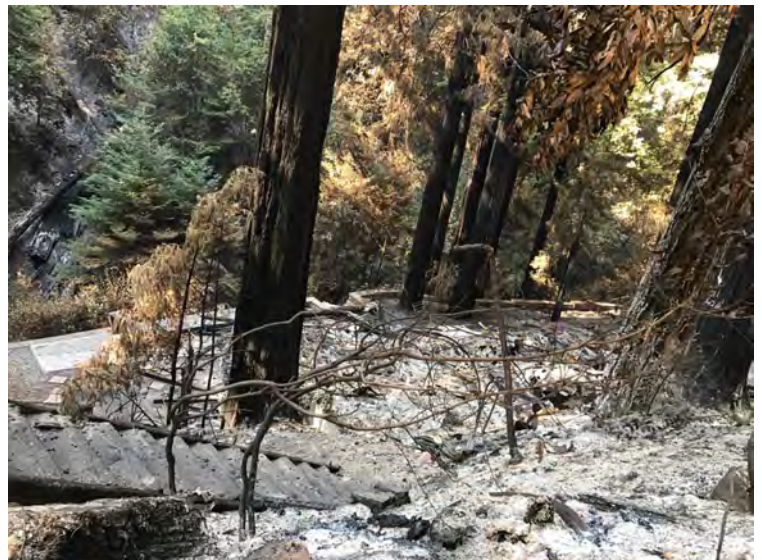
Field Observation Potential for debris flow to impact temporary housing site. Burned house
or Potential Hazard: located immediately adjacent to watercourse with a low probability for debris flow.

Potential Hazard to Life: **moderate**

Potential Hazard to Property: **low**

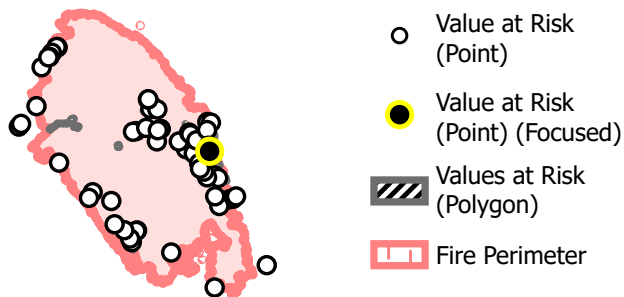
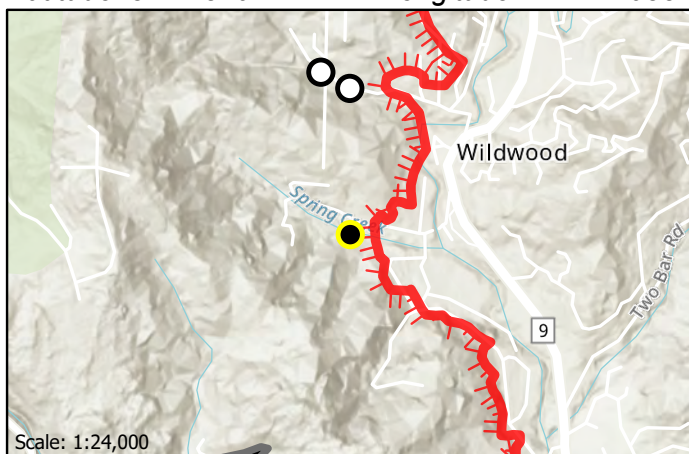
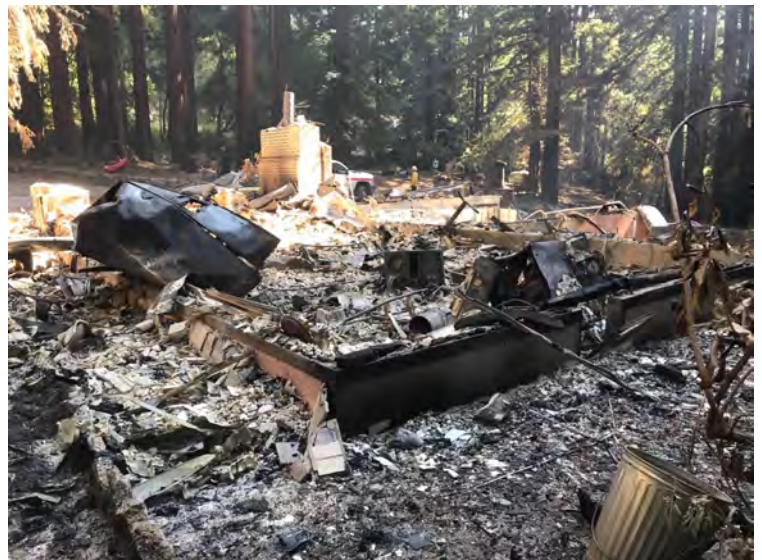
Field Observation Potential for debris flow to impact temporary housing site. Burned house
or Potential Hazard: located immediately adjacent to watercourse with a low probability for debris flow.

Potential Hazard to Life: **moderate**

Potential Hazard to Property: **moderate**

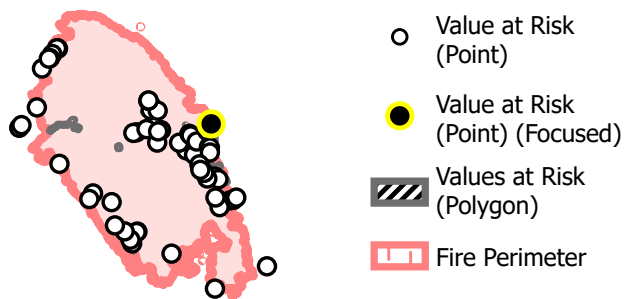
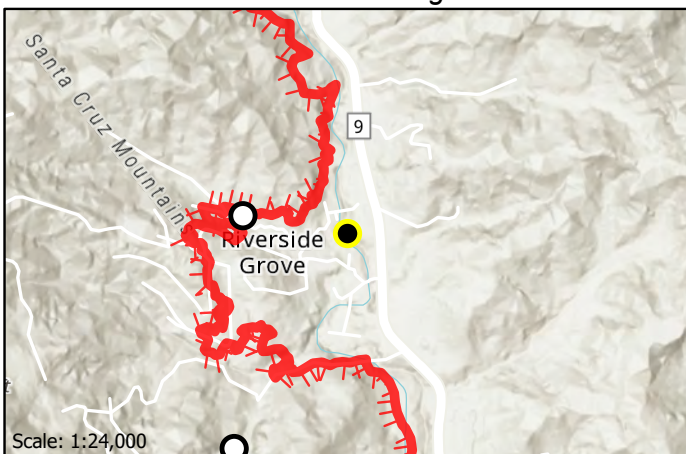
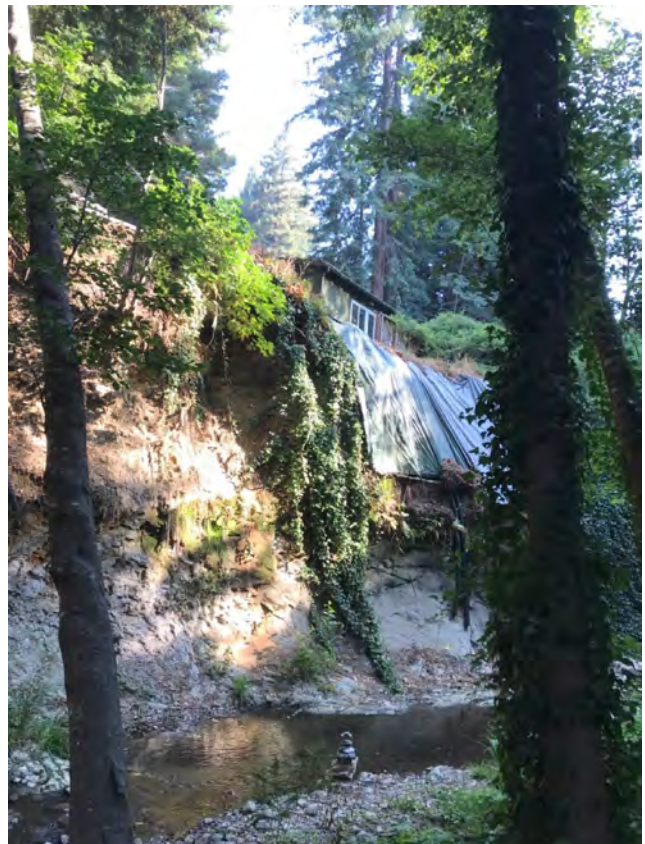
Field Observation or Potential Hazard: House located above bend in San Lorenzo River. Existing channel scour is endangering house.

Potential Hazard to Life: **moderate**

Potential Hazard to Property: **moderate**

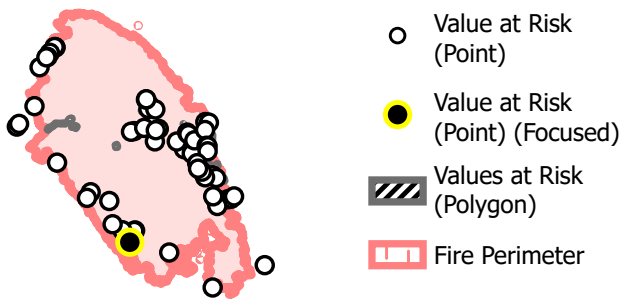
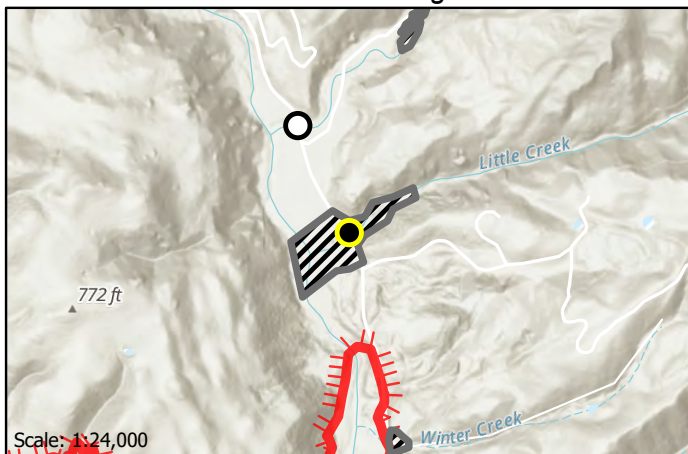
Field Observation Bridge appears to be choke point for debris and sediment. Woody debris could
Potential Hazard: block bridge

Potential Hazard to Life: **low**

Potential Hazard to Property: **moderate**

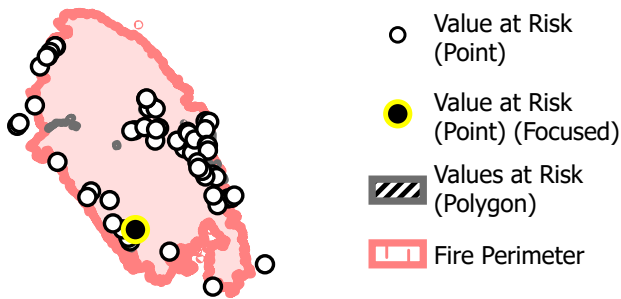
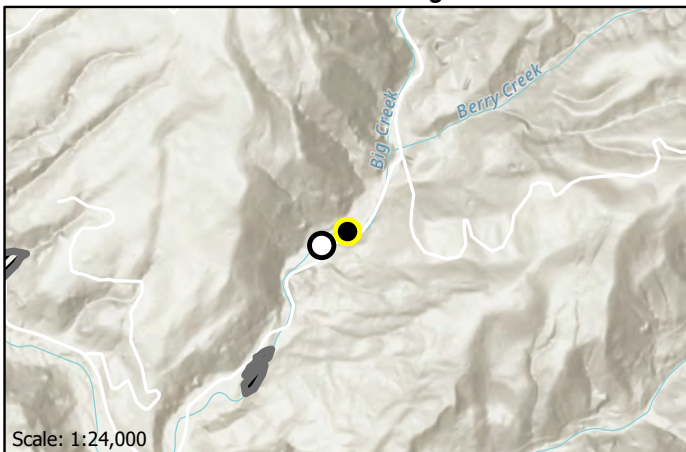
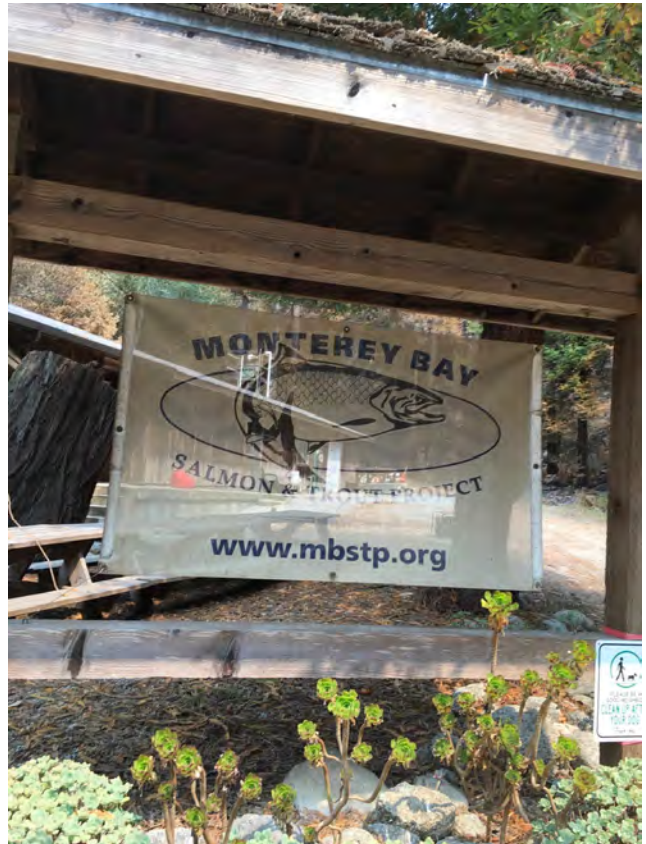
Field Observation or Potential Hazard: **Flooding impact to fish hatchery and structures**

Potential Hazard to Life: **moderate**

Potential Hazard to Property: **high**

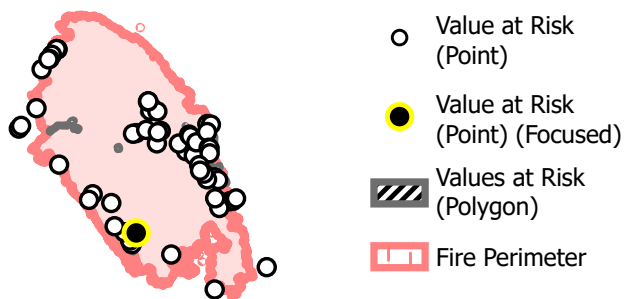
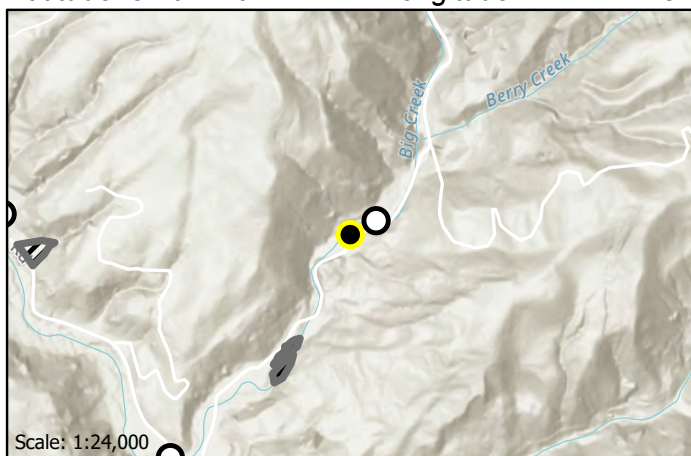
Field Observation Potential for flooding to impact temporary housing site. Existing structures or Potential Hazard: destroyed.

Potential Hazard to Life: **moderate**

Potential Hazard to Property: **moderate**

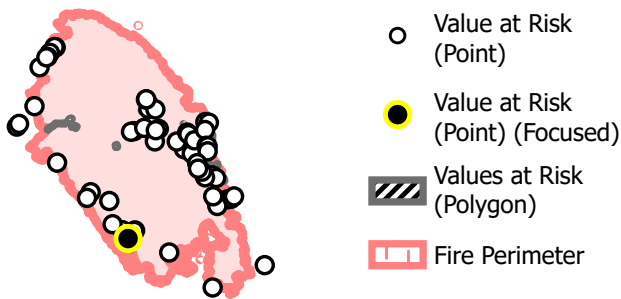
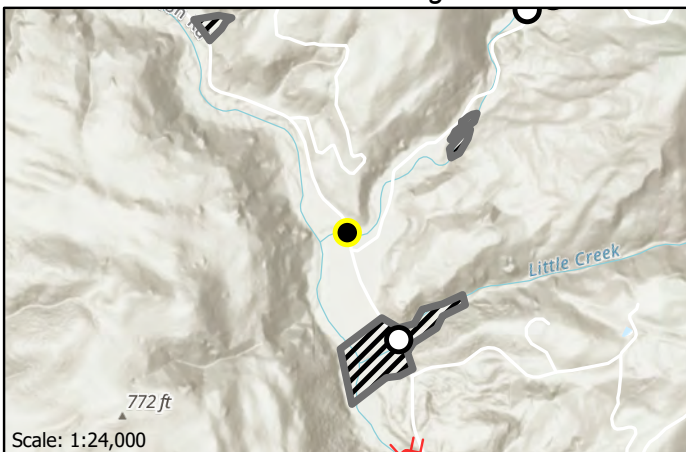
Field Observation Bridge within floodplain. Large watershed upstream with a mapped moderate to
or Potential Hazard: high potential for debris flows. Numerous landslides visible adjacent to
watercourse and tributaries on LiDAR imagery.

Potential Hazard to Life: **low**

Potential Hazard to Property: **moderate**

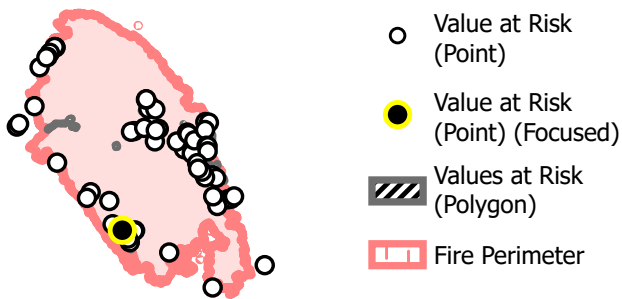
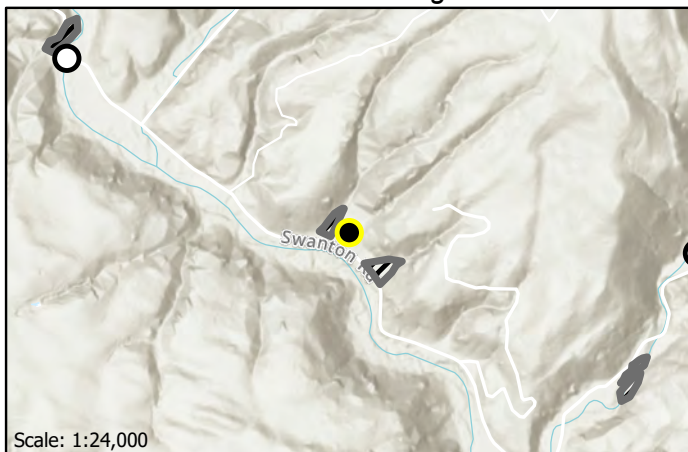
Field Observation House in potential debris flow / flood path.
or Potential Hazard:

Potential Hazard to Life: **high**

Potential Hazard to Property: **high**

Description: K rail

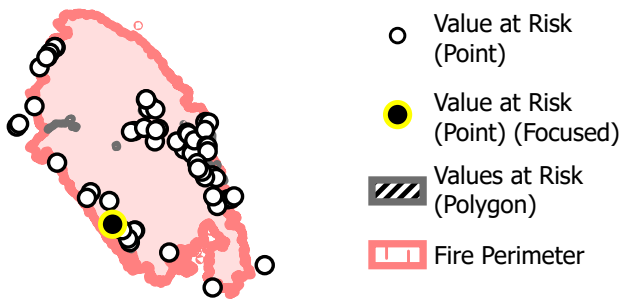
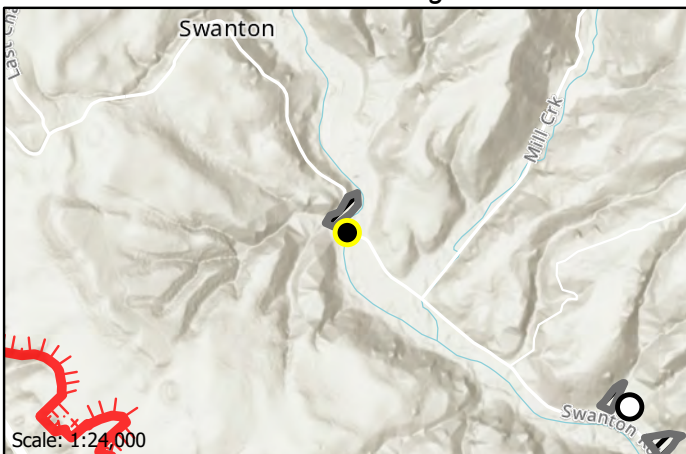
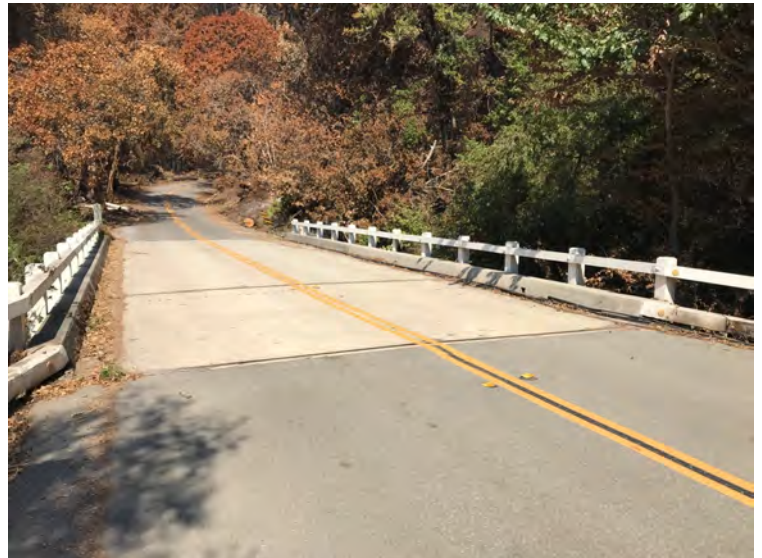
Field Observation or Potential Hazard: Flooding could impact bridge, large watershed upstream.

Potential Hazard to Life: **low**

Potential Hazard to Property: **moderate**

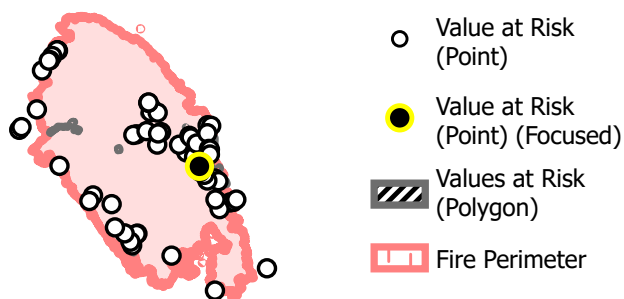
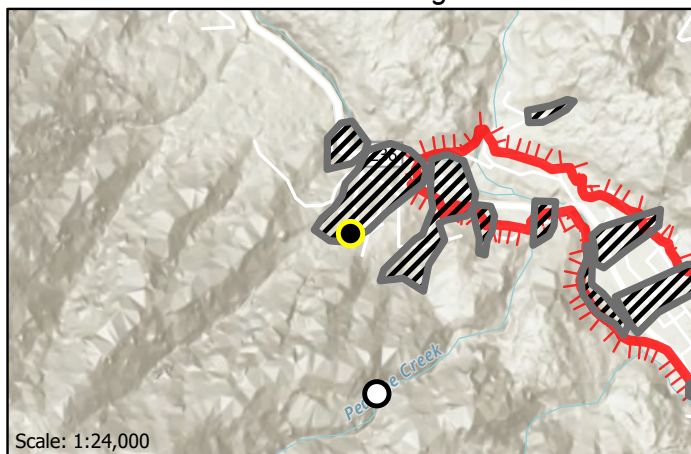
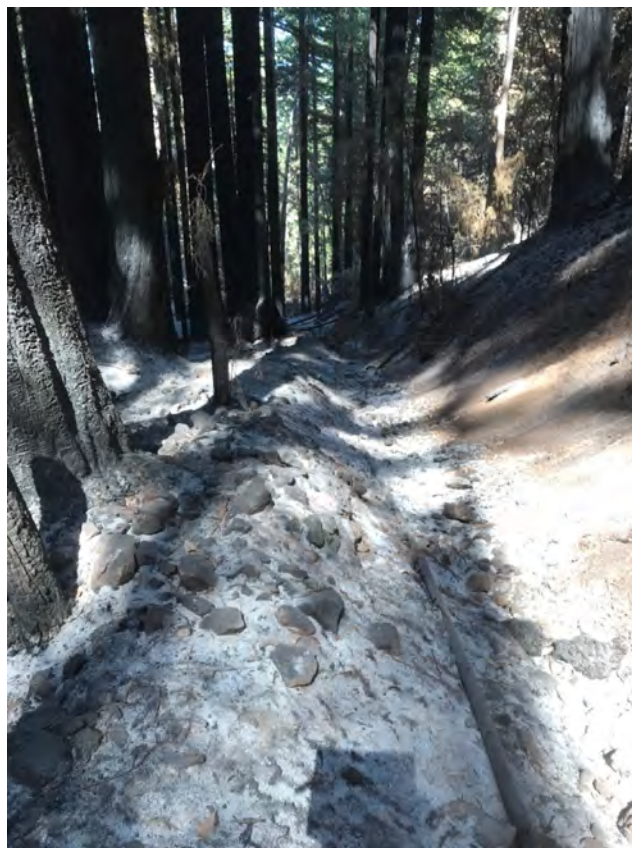
Field Observation or Potential Hazard: Local water district pump house and intake lines. Intake pipe observed extending upstream. Pipe located within active debris flow channel.

Potential Hazard to Life: **low**

Potential Hazard to Property: **high**

Description: Prepare for increased organics

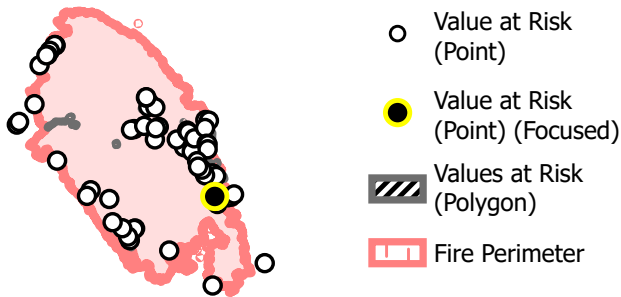
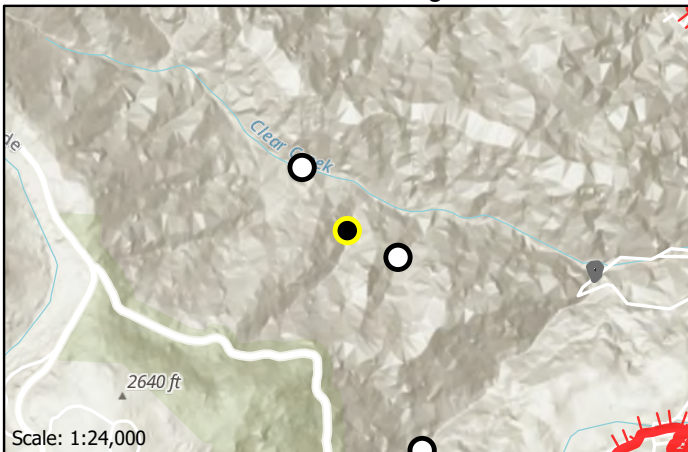
Field Observation or Potential Hazard: Impacts to intake, water quality

Potential Hazard to Life: **low**

Potential Hazard to Property: **high**

Description: Prepare for increased organics

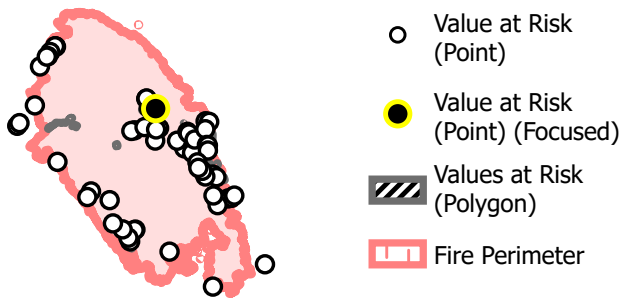
Field Observation or Potential Hazard: Flooding/Debris Flow could impact the crossing. Culvert undersized, large amount of fill (>20 feet). Inlet is highly corroded. Landslides visible on LiDAR images along upstream slopes. Recommend culvert be replaced and sized appropriately.

Potential Hazard to Life: **low**

Potential Hazard to Property: **moderate**

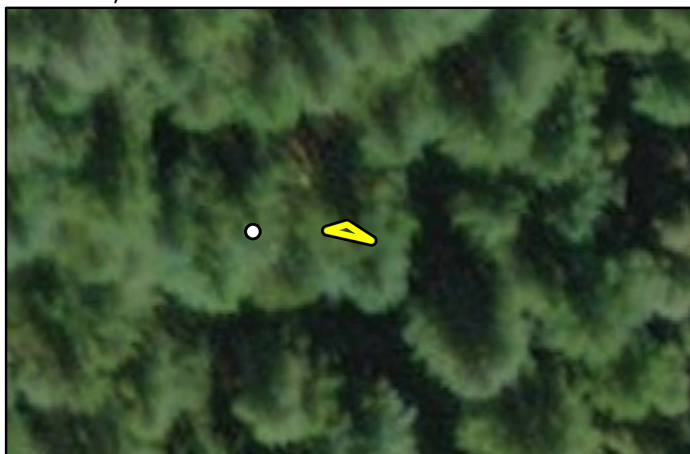
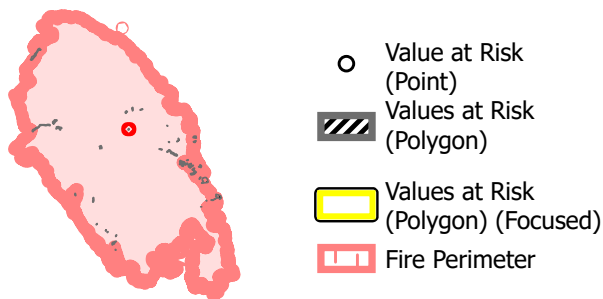
Field Observation Campground located on floodplain upstream of choke point along highway 236
or Potential Hazard:

Potential Hazard to Life: **moderate**

Potential Hazard to Property: **low**

Description: Temporary Closure

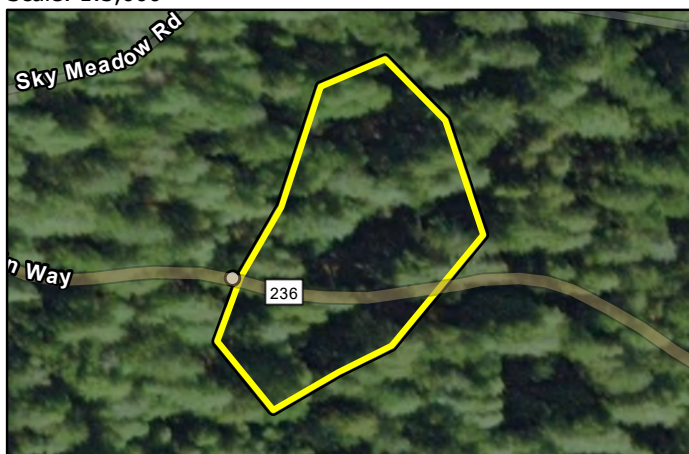
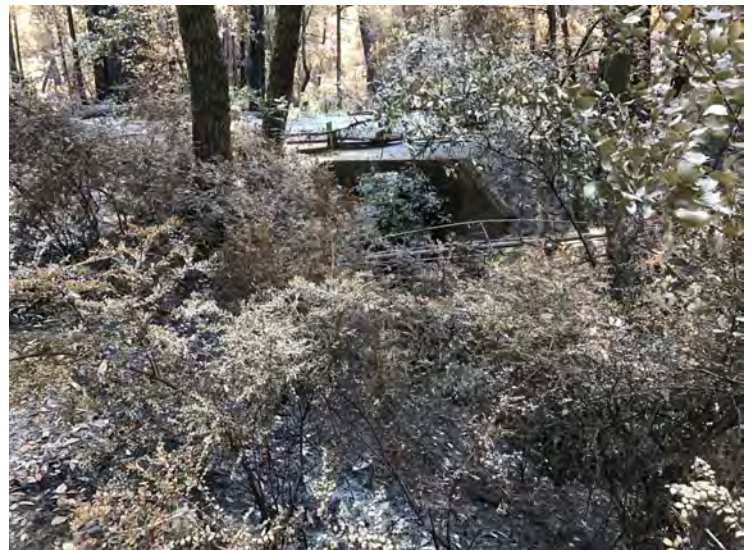
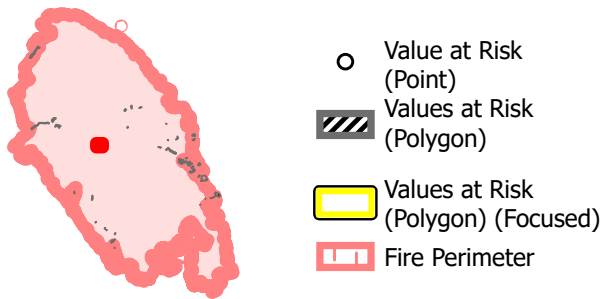
Field Observation Unable to access property. Homes located at the bottom of two drainages with
or Potential Hazard: a high potential for debris flows. Addition determinations and observations should be made by a PG or PE.

Potential Hazard to Life: **moderate**

Potential Hazard to Property: **moderate**

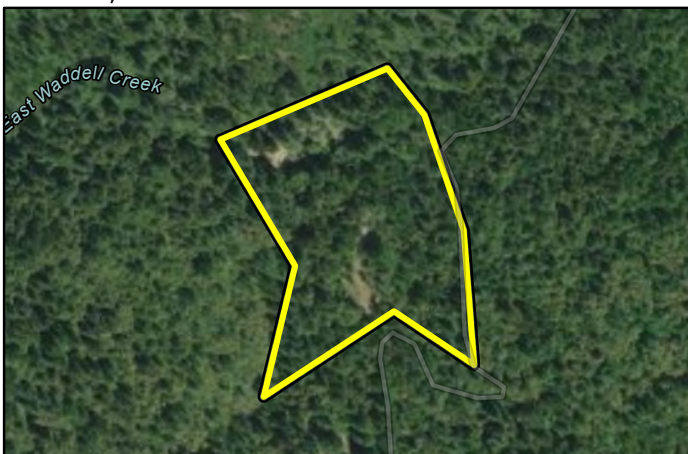
Field Observation Flooding could impact several homes within floodplain.
or Potential Hazard:

Potential Hazard to Life: **low**

Potential Hazard to Property: **moderate**

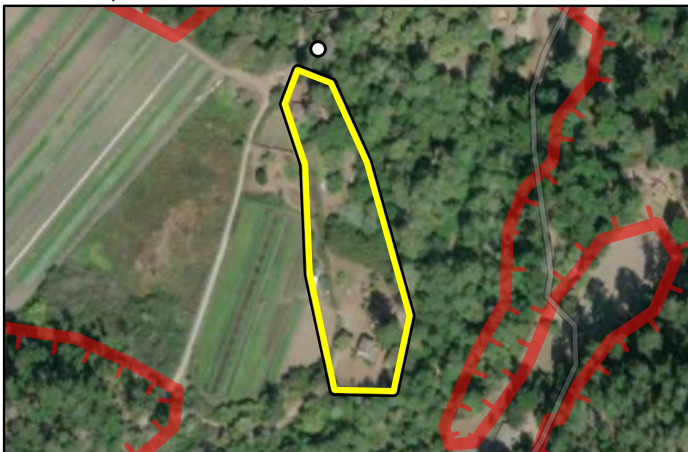
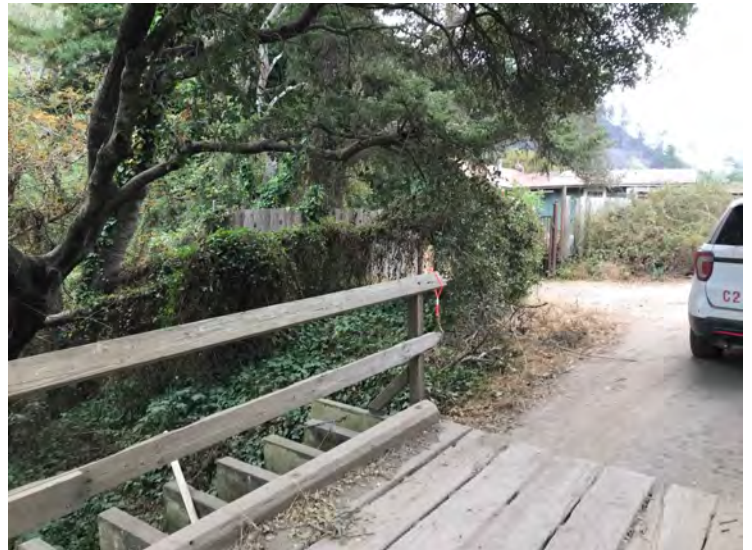
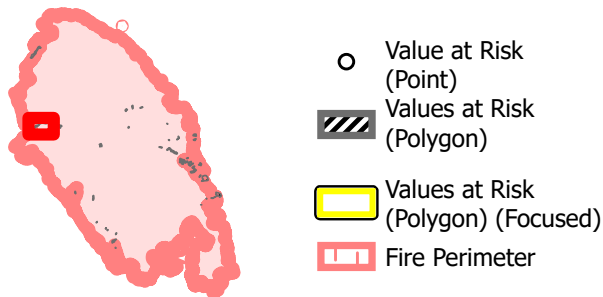
Field Observation Adjacent slopes are steep and appear prone to debris slides/flows. Rockfall or Potential Hazard: hazard also present.

Potential Hazard to Life: **high**

Potential Hazard to Property: **moderate**

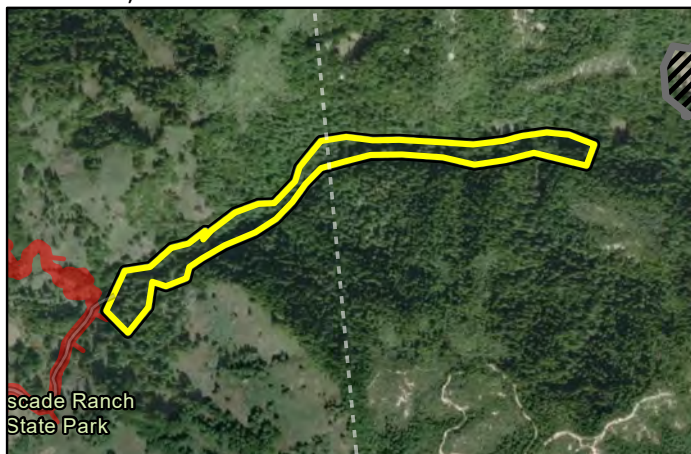
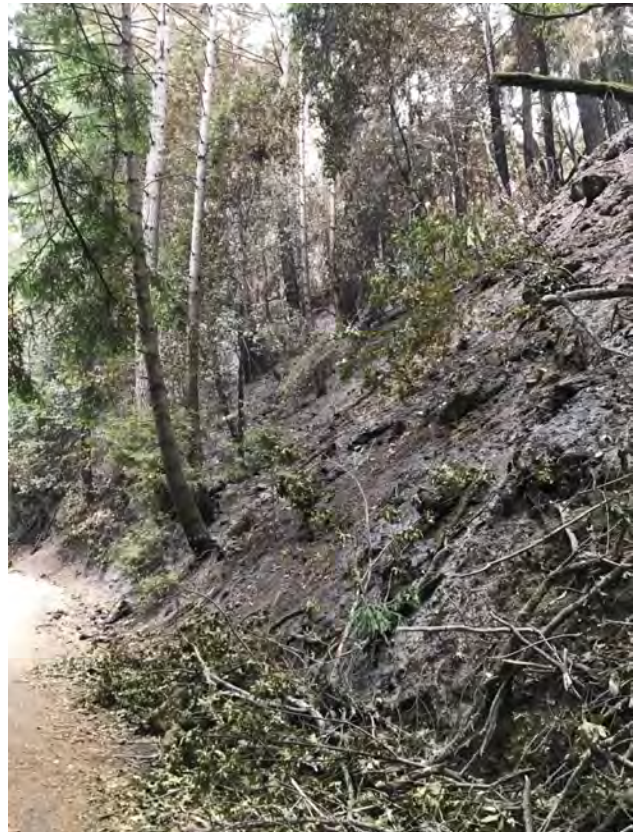
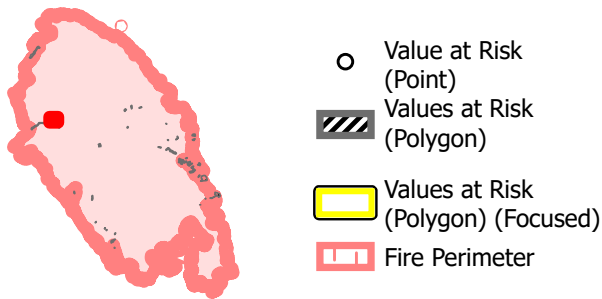
Field Observation Debris flow, homes located on alluvial fan deposits visible on hillshade imagery.
or Potential Hazard: Additional determination and observations should be made by a PG or PE.

Potential Hazard to Life: **moderate**

Potential Hazard to Property: **moderate**

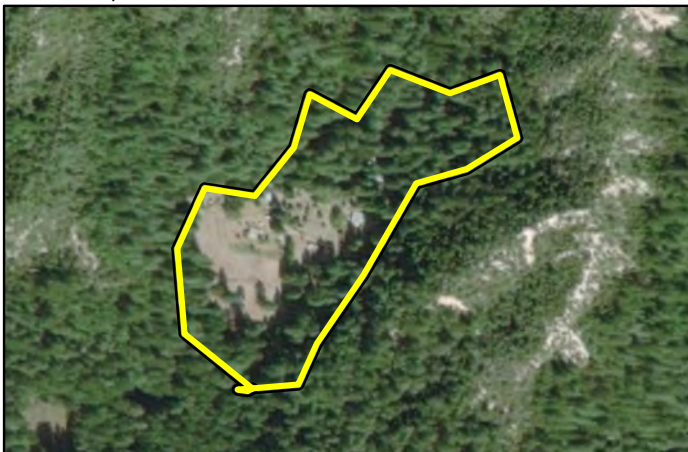
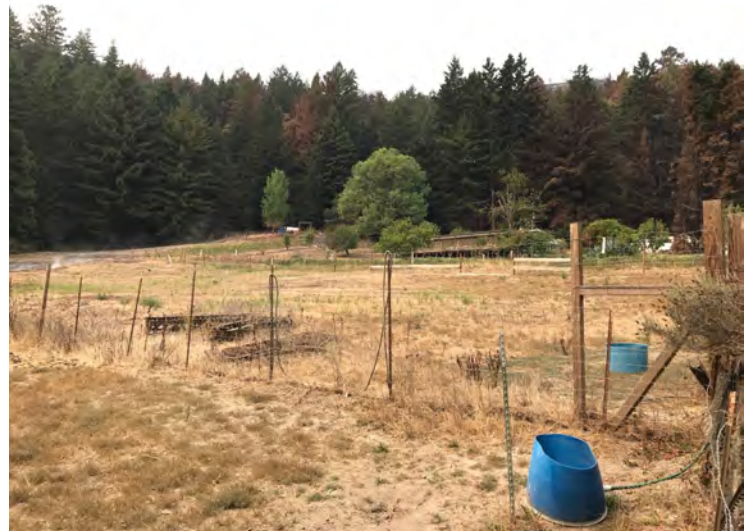
Field Observation Debris flow, homes located on alluvial fan deposits visible on hillshade imagery.
or Potential Hazard: Additional determination and observations should be made by a PG or PE.

Potential Hazard to Life: **moderate**

Potential Hazard to Property: **moderate**

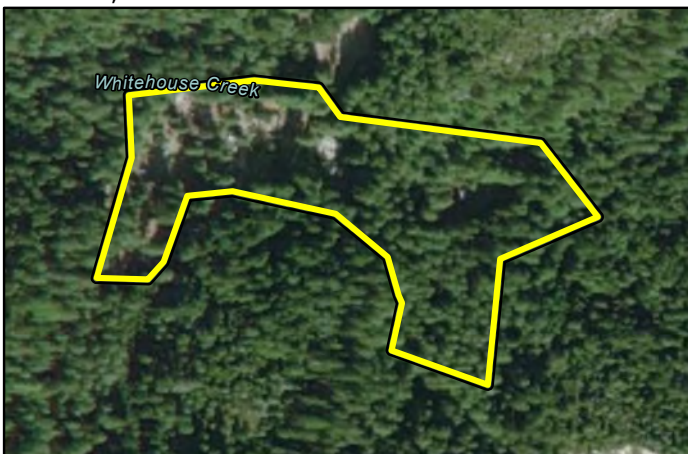
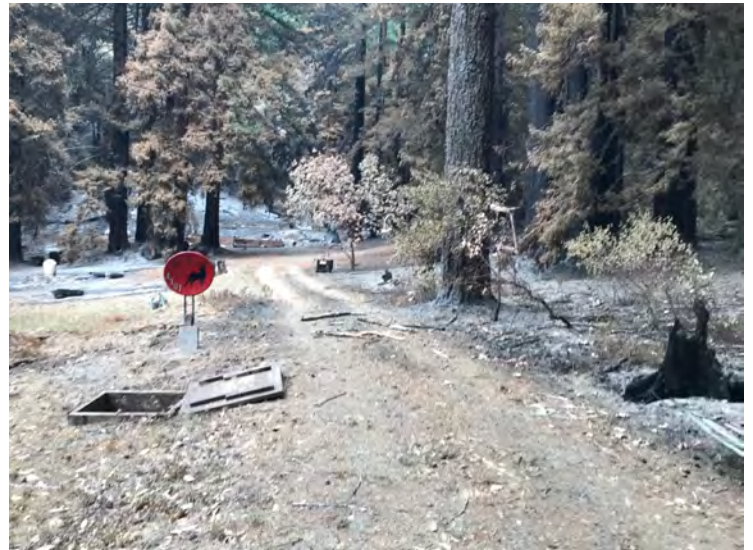
Field Observation Numerous residences within floodplain. Homes along southern side are
or Potential Hazard: adjacent to moderate to steep slopes with potential for debris flows.

Potential Hazard to Life: **moderate**

Potential Hazard to Property: **high**

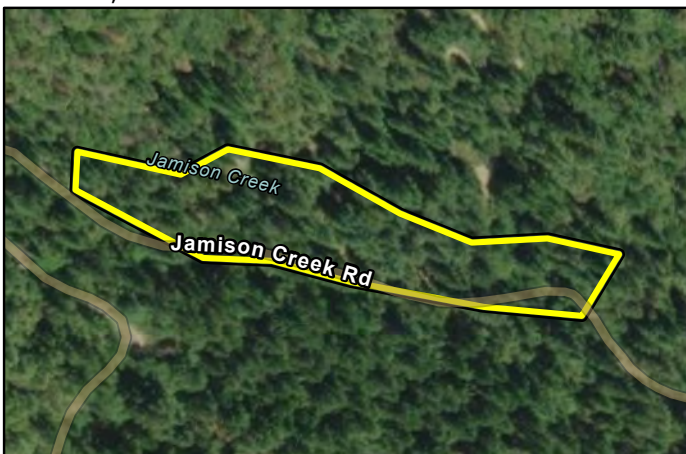
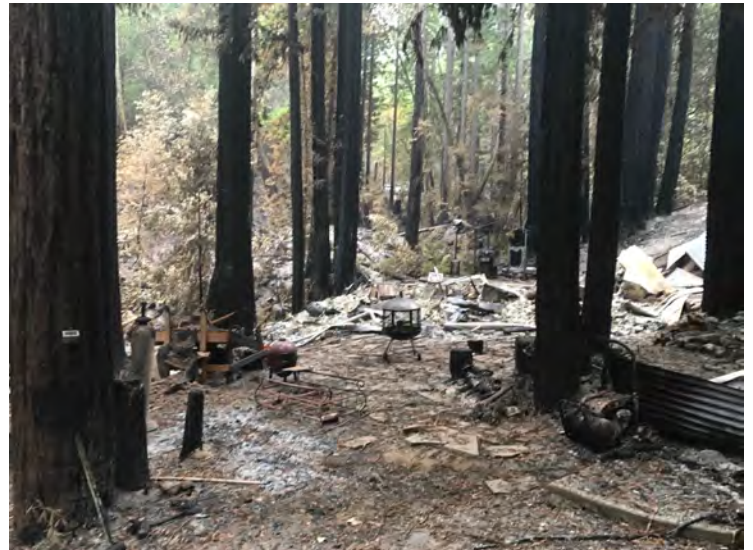
Field Observation Multiple residential properties along Jamison Creek. High potential for debris or *Potential Hazard:* flow. About 4 sq km drainage above, addition determinations and observations should be made by a PG or PE.

Potential Hazard to Life: **high**

Potential Hazard to Property: **high**

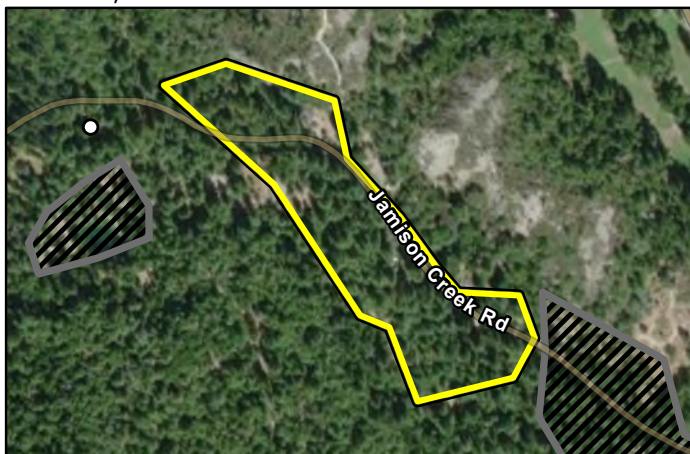
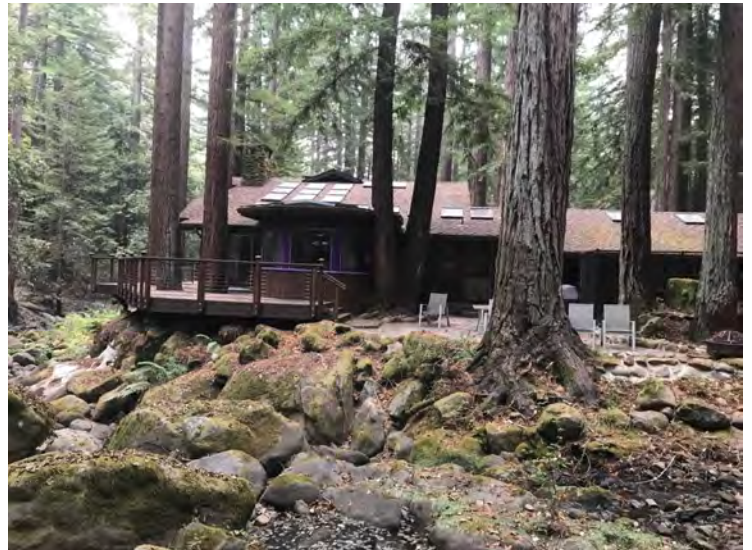
Field Observation Multiple residential properties alluvial fan at bottom Jamison Creek. About 4 sq
or Potential Hazard: km drainage above, addition determinations and observations should be made
by a PG or PE.

Potential Hazard to Life: **moderate**

Potential Hazard to Property: **moderate**

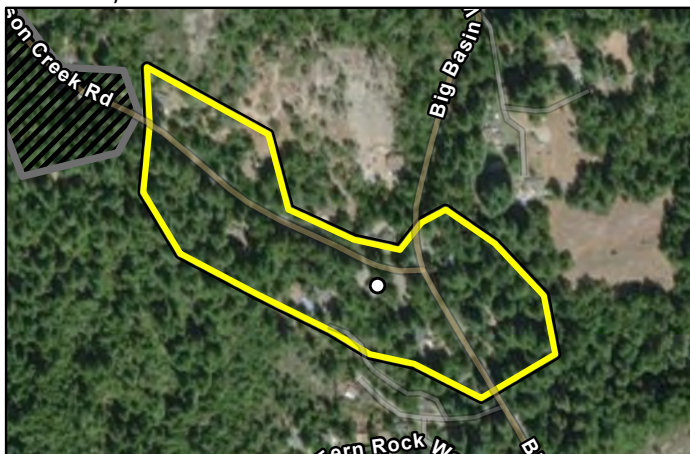
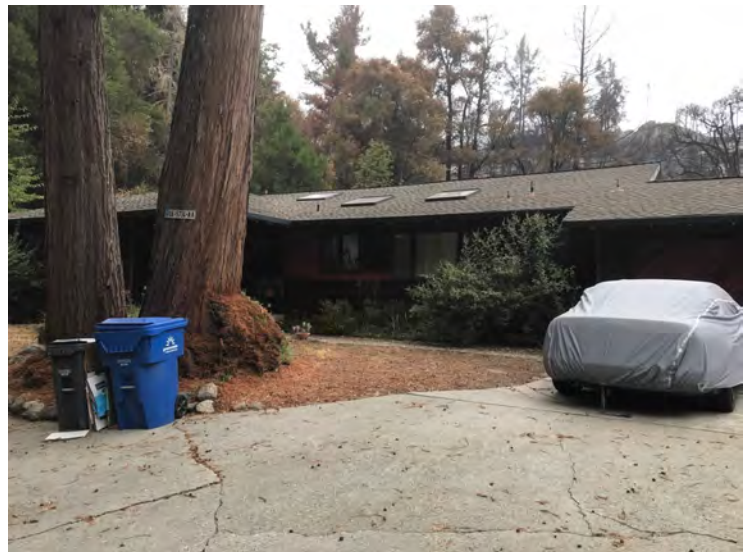
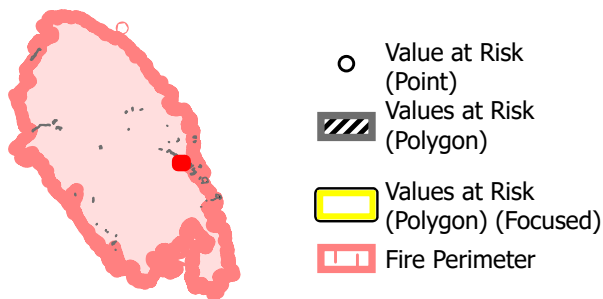
Field Observation Neighborhood constructed on alluvial fan. Avulsion point observed at top of
or Potential Hazard: development. Several foundations constructed over and/or immediately adjacent to watercourse channel. Also impacts to State Highway 236. Evidence of historic debris flow activity

Potential Hazard to Life: **high**

Potential Hazard to Property: **high**

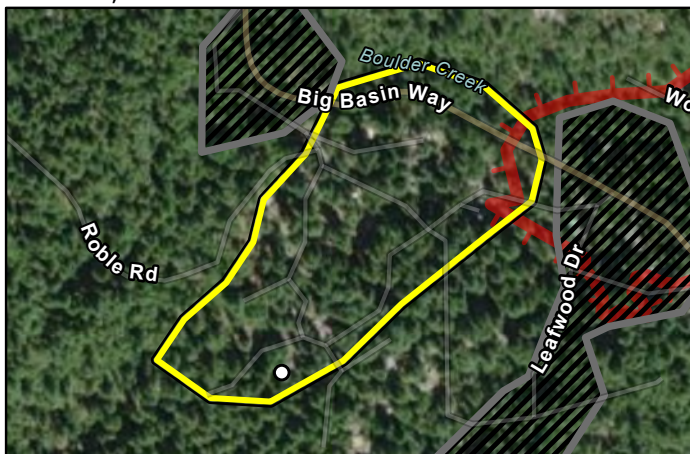
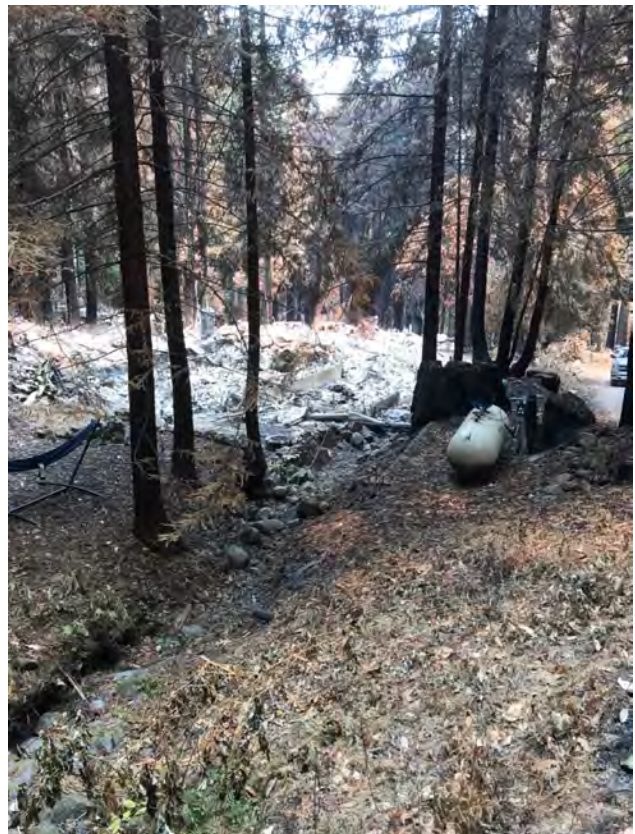
Field Observation Three houses east of SR236 located at mouth of fan deposit. Undersized or *Potential Hazard*: culvert crosses highway and proceeds under house.

Potential Hazard to Life: **low**

Potential Hazard to Property: **moderate**

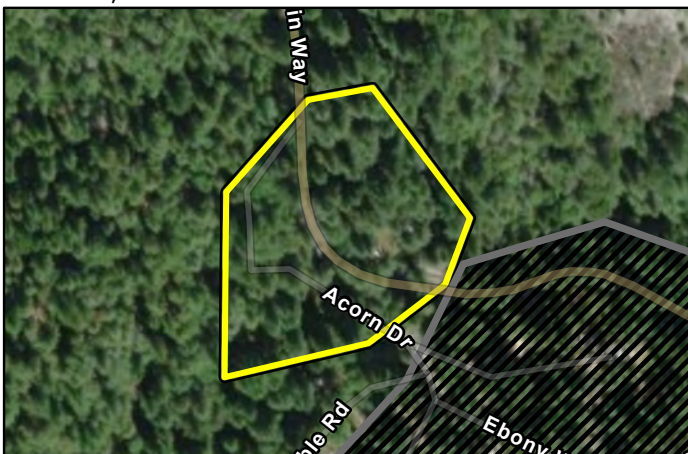
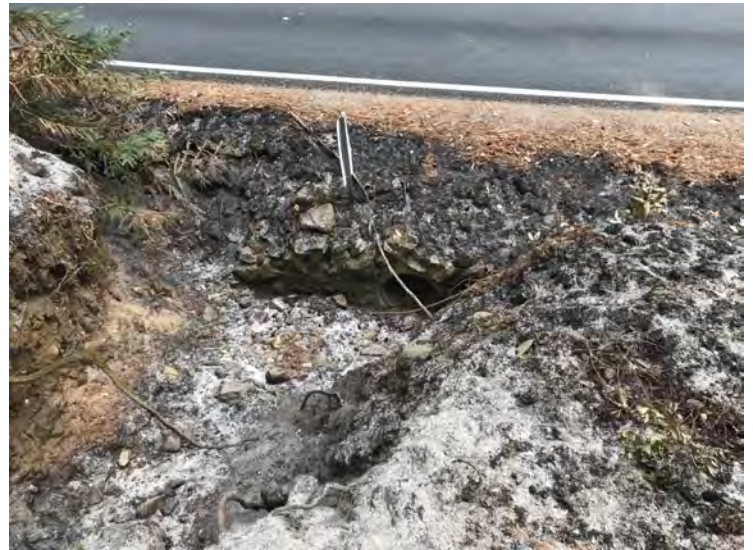
Field Observation Neighborhood constructed on alluvial fan. Several foundations constructed or *Potential Hazard:* over and/or immediately adjacent to watercourse channel. No obvious channel observed within the deposit fan. Also impacts to State Highway 236.

Potential Hazard to Life: **moderate**

Potential Hazard to Property: **high**
