Watershed Emergency Response Team Evaluation

CZU LIGHTNING COMPLEX

CA-CZU-005205

October 1, 2020

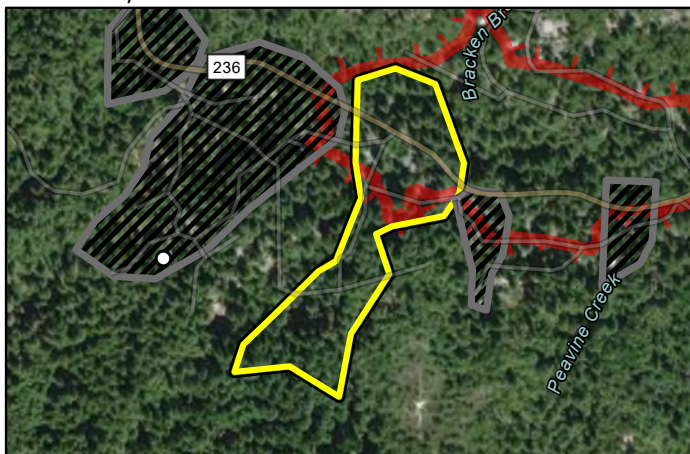
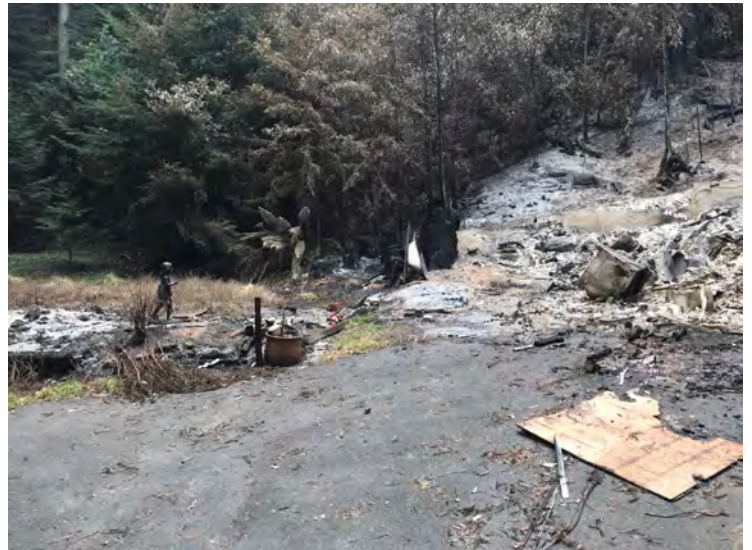
Field Observation Houses located along Boulder Creek in flood plain. Also immediately or Potential Hazard: downslope of debris slide slopes.

Potential Hazard to Life: **low**

Potential Hazard to Property: **moderate**

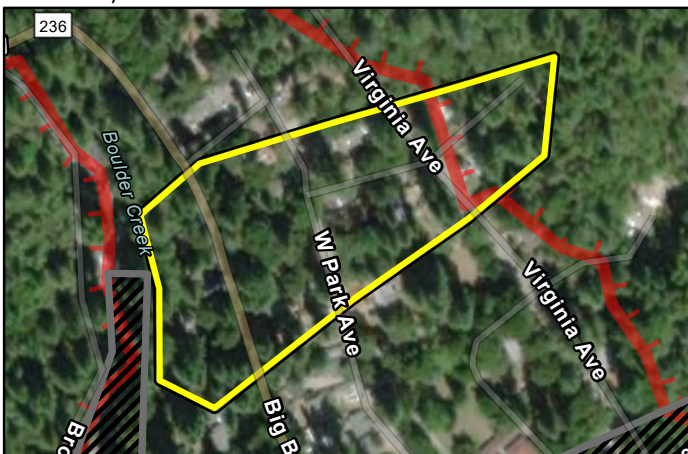
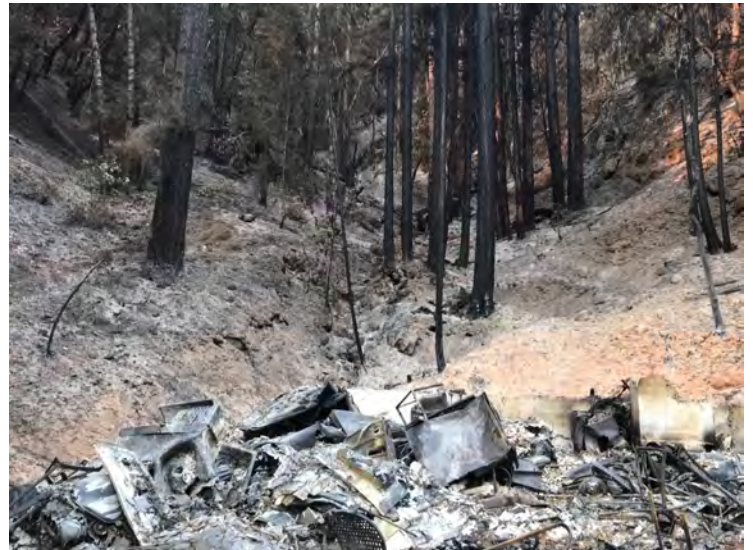
Field Observation Houses adjacent to and downstream of channel. Additional houses downstream
or Potential Hazard: of apparent fan deposit. One storm drainage inlet located in swale above Ridge Road. Storm drain on Ridge Road. Upstream drainage area below model threshold.

Potential Hazard to Life: moderate

Potential Hazard to Property: moderate

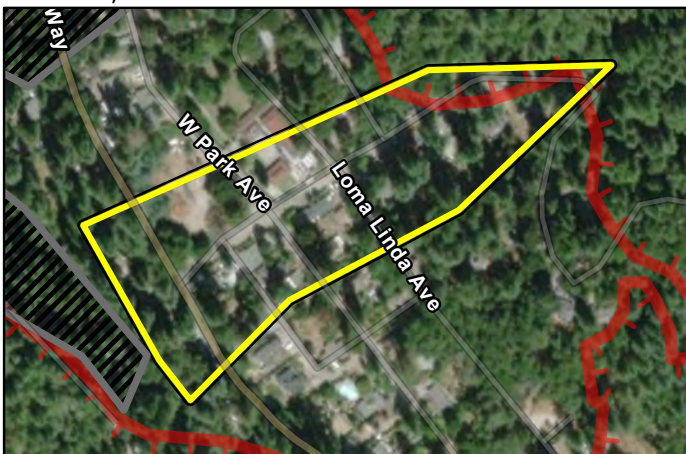
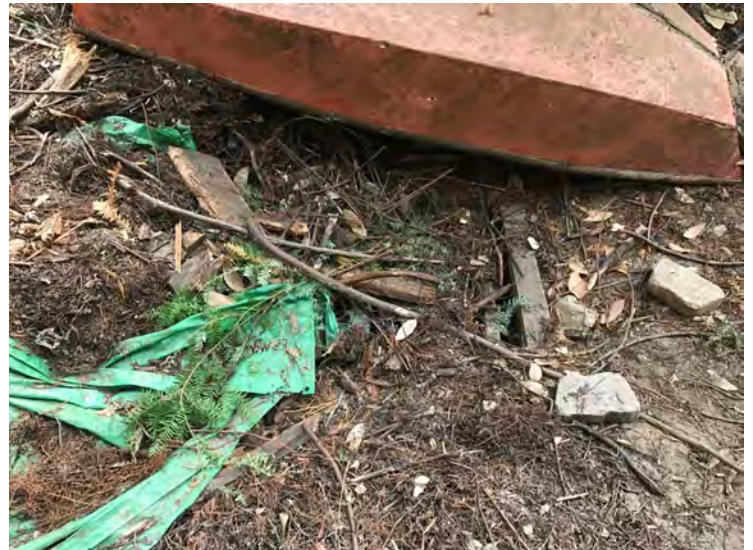
Field Observation One house adjacent debris flow channel. About 18 houses further downslope
or Potential Hazard: on apparent fan deposit. Park Road appears to be preferential pathway.
 Upstream drainage area below debris model threshold.

Potential Hazard to Life: **moderate**

Potential Hazard to Property: **moderate**

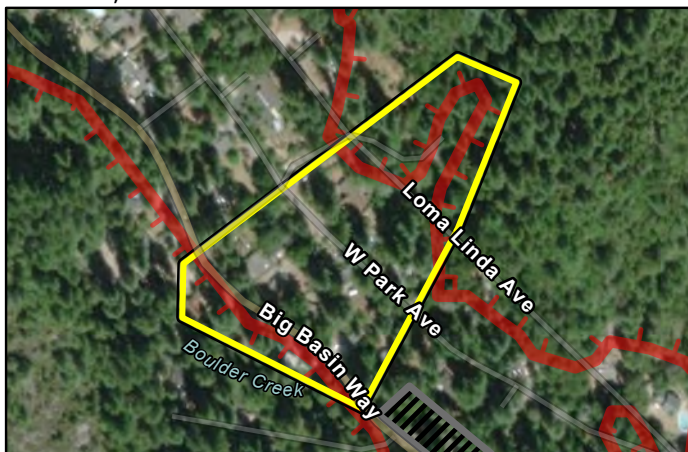
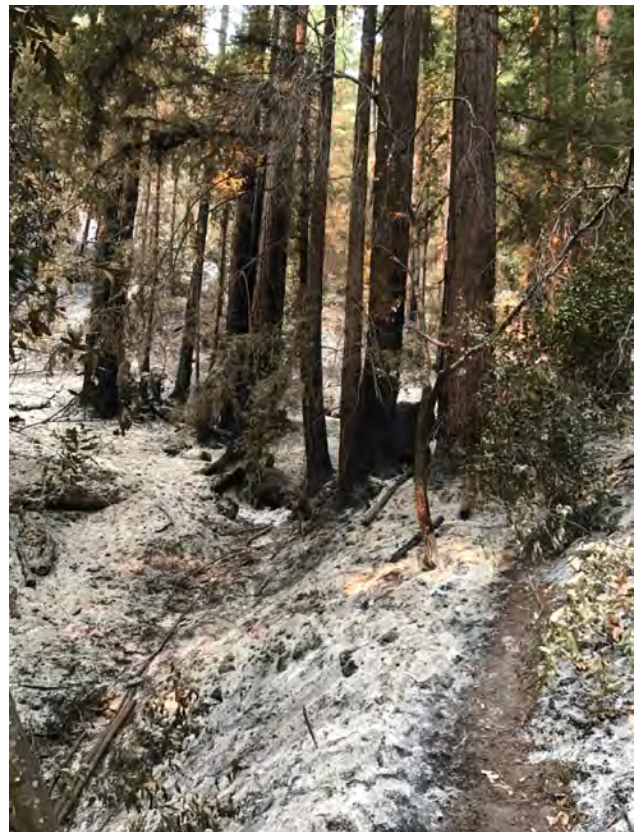
Field Observation Residential homes adjacent and in Foreman Creek. High potential for debris or *Potential Hazard:* flow. Debris flow deposits and boulders in channel. Debris flow levee observed within channel. About 2 sq km drainage above, addition determinations should be made by PG or PE

Potential Hazard to Life: **high**

Potential Hazard to Property: **high**

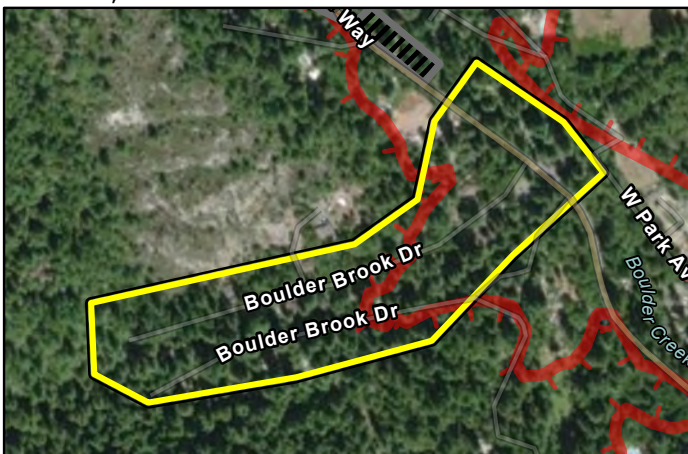
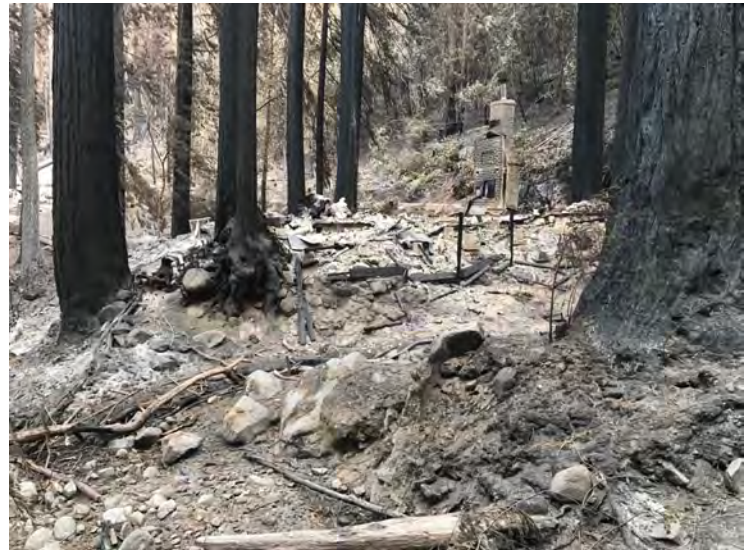
Field Observation Two Houses located along watch stream/ debris flow segment. Existing
or Potential Hazard: concrete retaining walls at base of house along creek to protect house foundations.

Potential Hazard to Life: **low**

Potential Hazard to Property: **moderate**

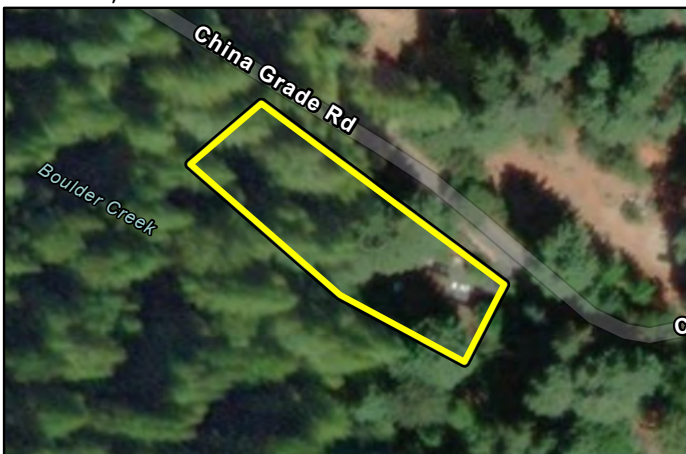
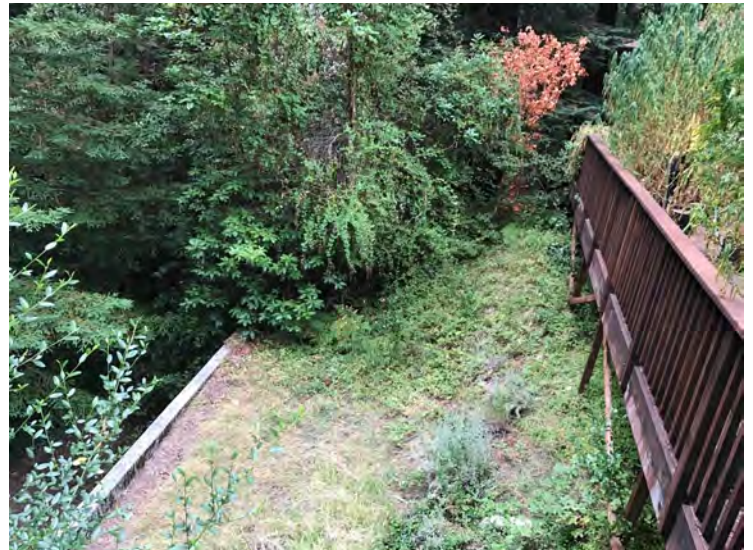
Field Observation Several houses located on fan deposits
or Potential Hazard:

Potential Hazard to Life: **moderate**

Potential Hazard to Property: **moderate**

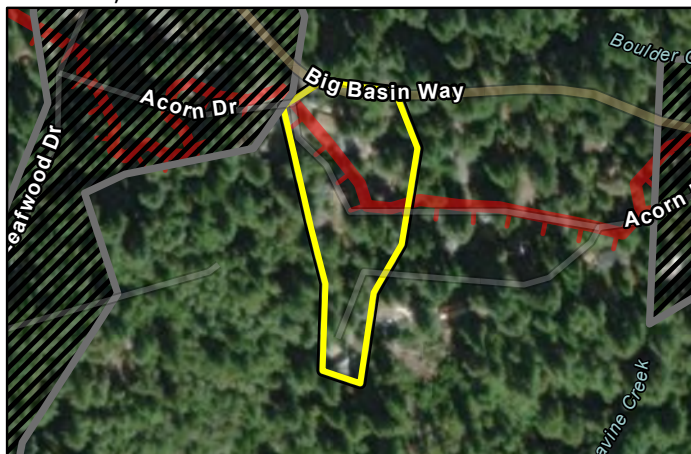
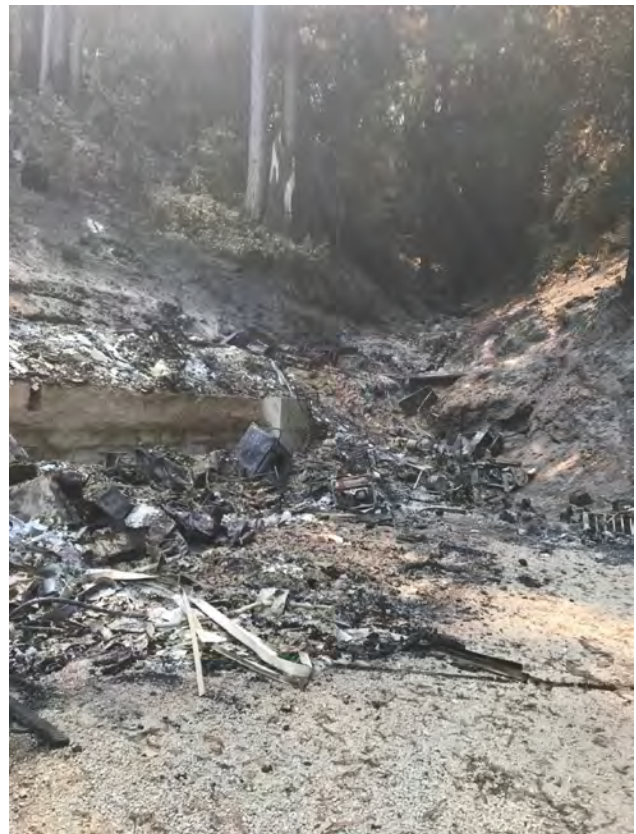
Field Observation At bend in Peavine Creek. Model indicates moderate to high potential or *Potential Hazard*: upstream. Watershed extends to top of Ben Lomand Mountain.

Potential Hazard to Life: **low**

Potential Hazard to Property: **moderate**

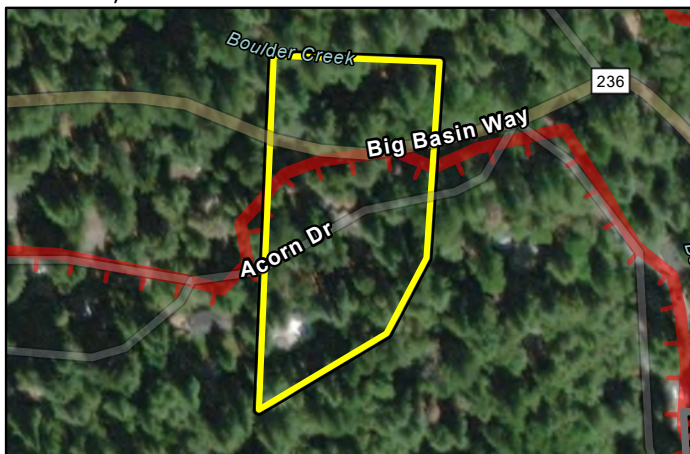
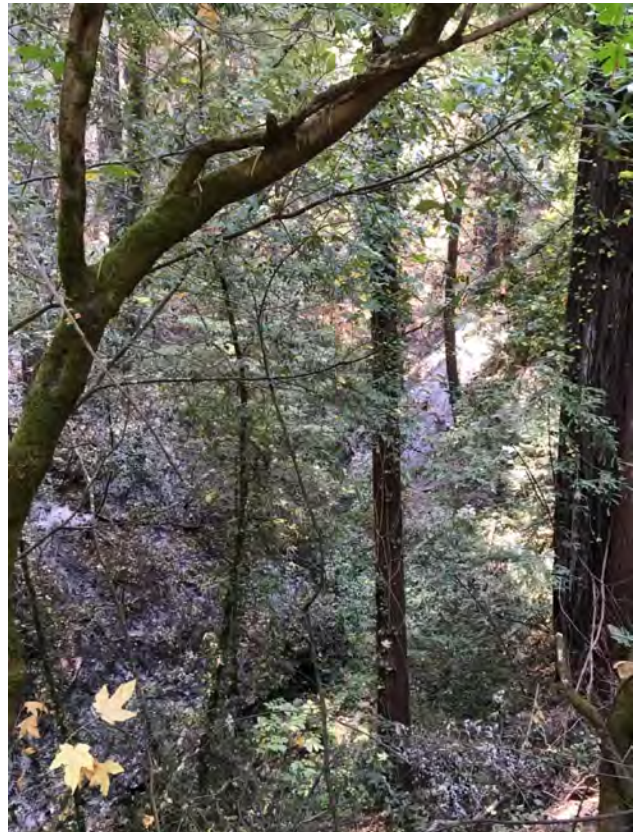
Field Observation Three Houses located along Boulder Creek. Foundation supports within the 1-
or Potential Hazard: year flood plain. Some foundation elements are rotated. Evidence of ongoing
scour and foundation problems.

Potential Hazard to Life: **moderate**

Potential Hazard to Property: **high**

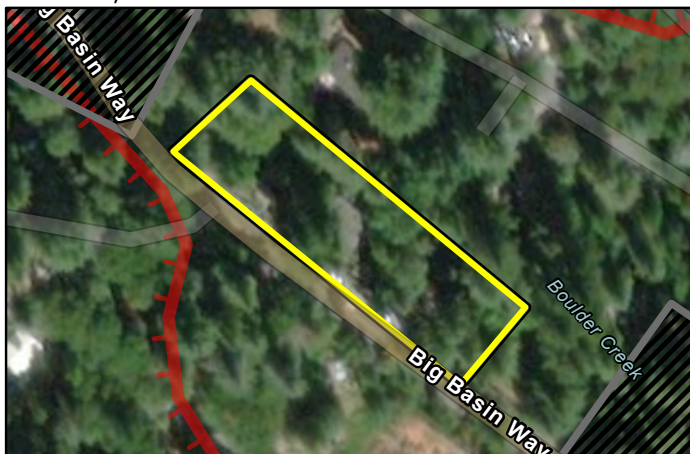
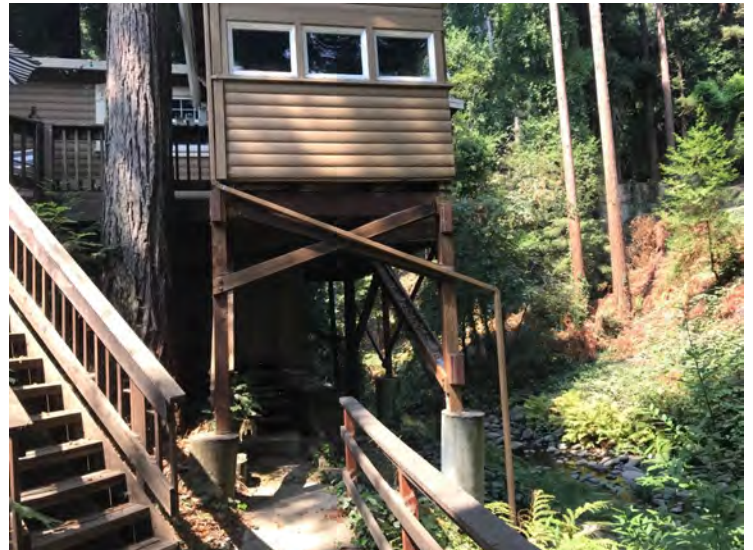
Field Observation Three houses built on watercourse channel. Evidence of creep and foundation or *Potential Hazard*: issues. Existing structural weakness could be exacerbated with increased post-fire sediment and runoff.

Potential Hazard to Life: **low**

Potential Hazard to Property: **moderate**

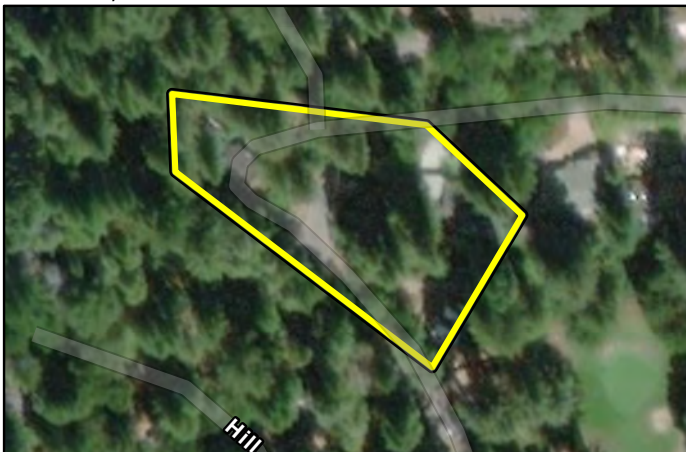
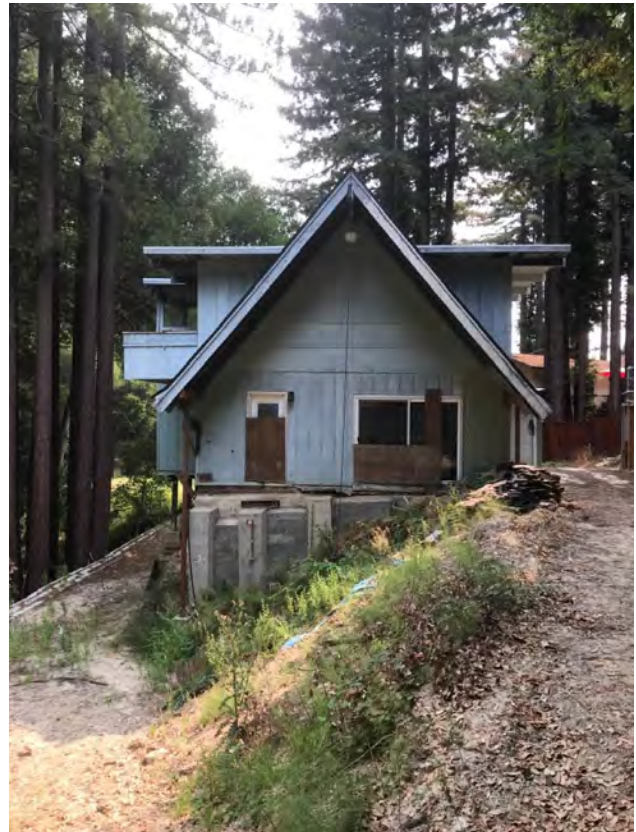
Field Observation About a dozen houses located immediately adjacent to watch stream. Pool or *Potential Hazard*: located within channel. Gabion walls and retaining structures observed along channel adjacent houses.

Potential Hazard to Life: **moderate**

Potential Hazard to Property: **moderate**

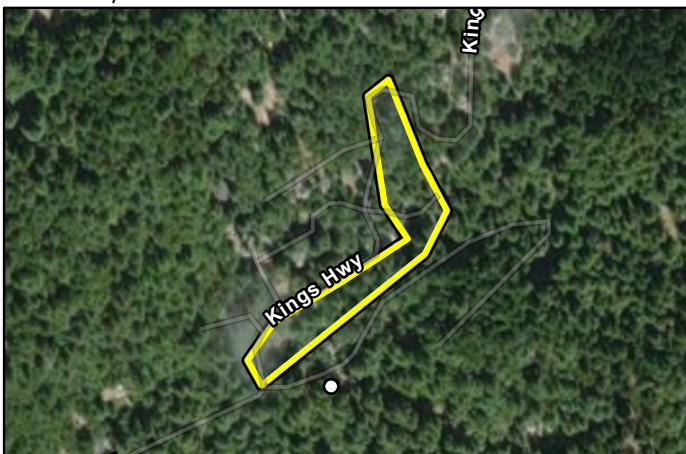
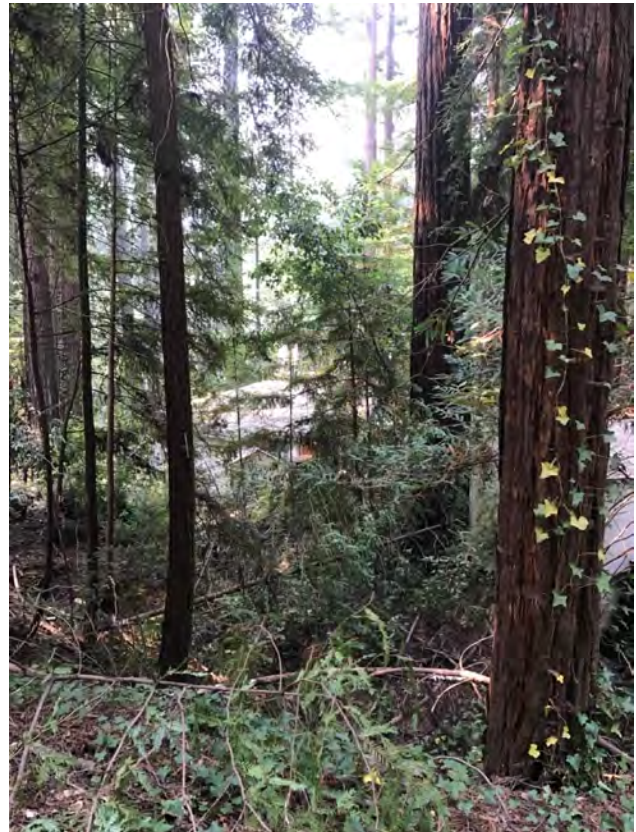
Field Observation Houses on apparent old alluvial fan. Channel mapped as low probability.
or Potential Hazard: Channel is minor about 2 feet wide by 18" depth. Potential for minor avulsion. And flood debris impacts.

Potential Hazard to Life: **low**

Potential Hazard to Property: **moderate**

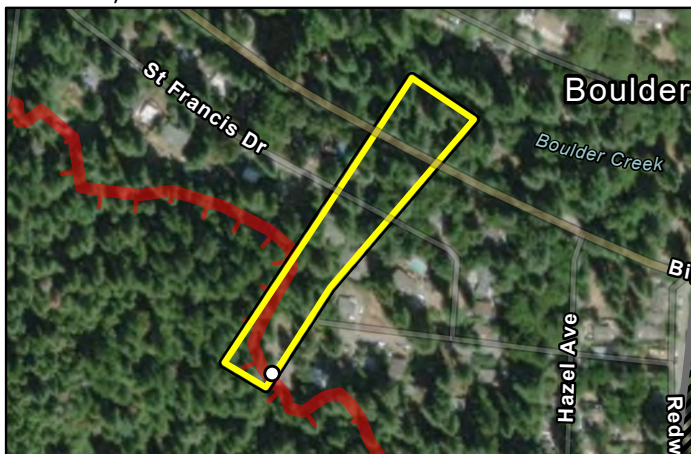
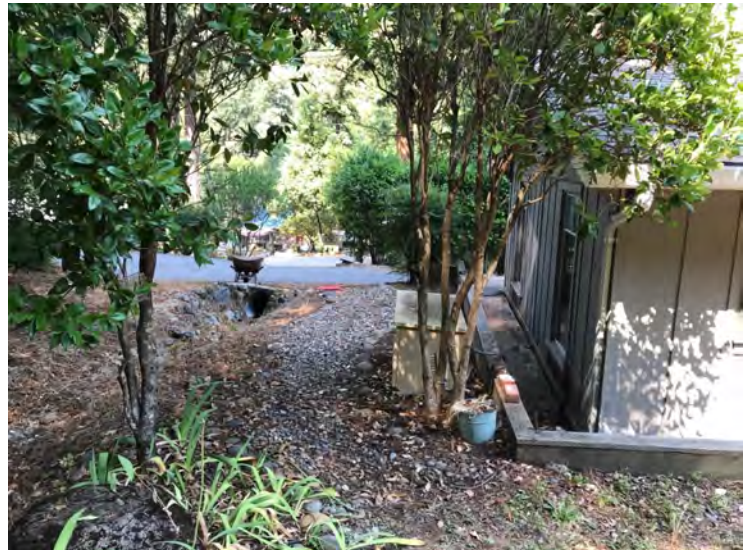
Field Observation or Potential Hazard: Large alluvial fan observed town of Boulder Creek. Elementary school and cemetery at fan apex. Avulsion pathway highly uncertain. Potential avulsion point observed ~500ft SW of cemetery. Addition determinations and observations should be made by a PG/PE

Potential Hazard to Life: **moderate**

Potential Hazard to Property: **moderate**

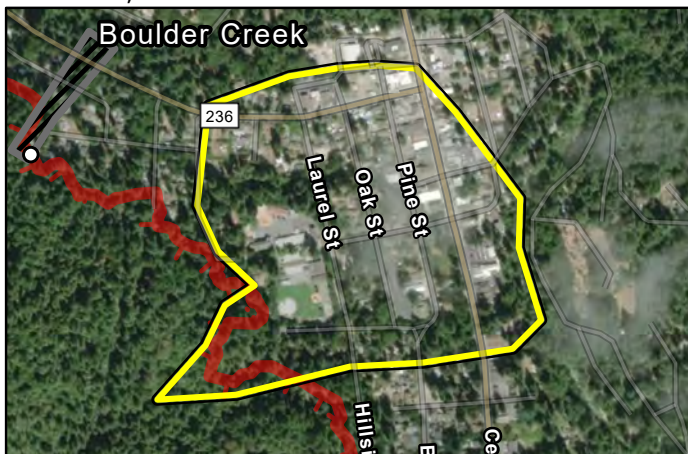
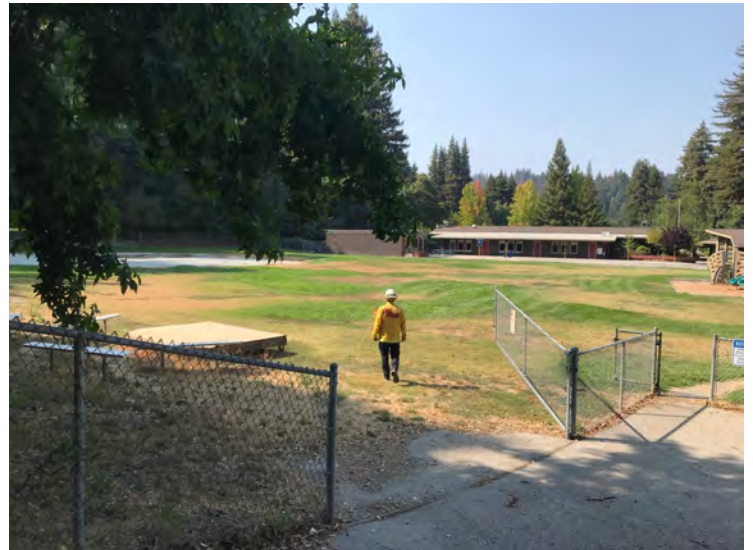
Field Observation Neighborhood built on fan deposit. Resident at top of street reports existing or *Potential Hazard*: drainage has handled surface drainage within the past 9 years. Additional determinations and observations should be made by a PG or PE

Potential Hazard to Life: **low**

Potential Hazard to Property: **moderate**

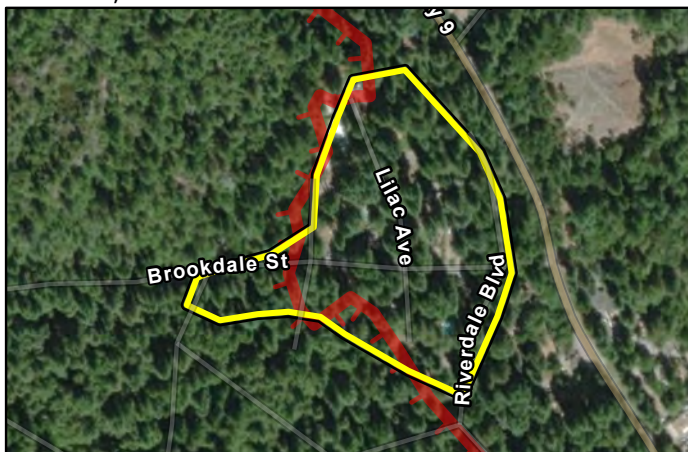
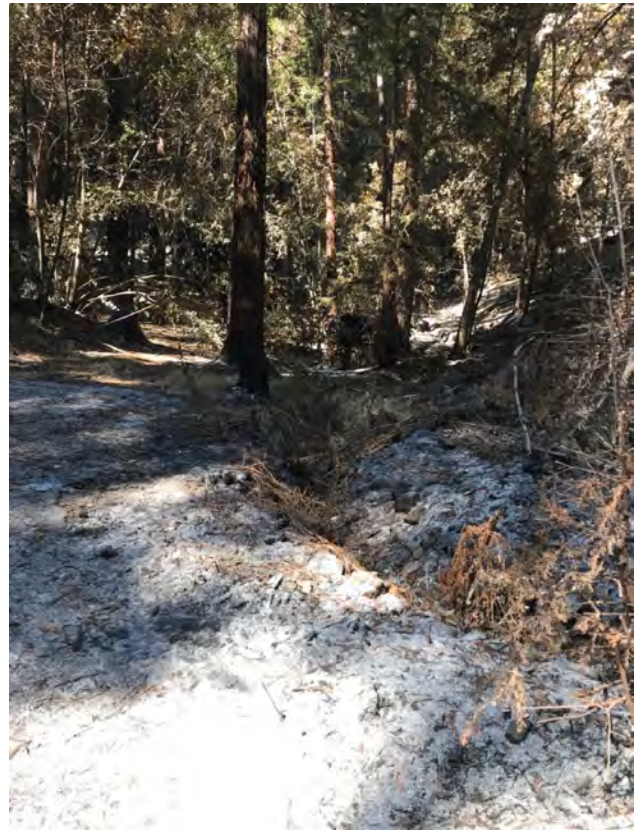
Field Observation Potential for debris flow to impact temporary housing site. Existing structures or Potential Hazard: destroyed.

Potential Hazard to Life: **high**

Potential Hazard to Property: **moderate**

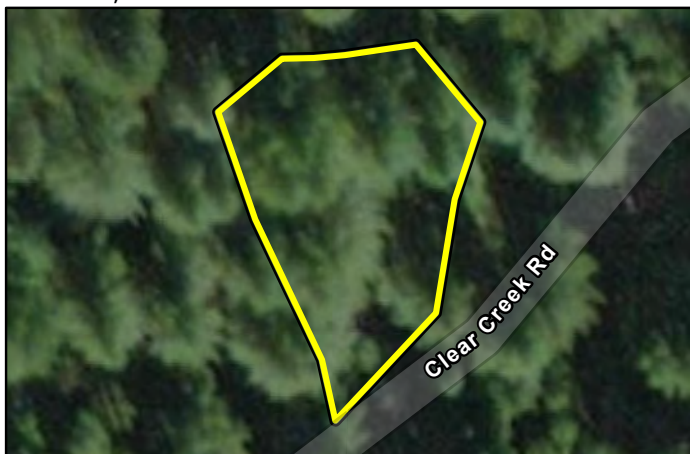
Field Observation Burned homes pads that can be used as temp housing. Additional or Potential Hazard: determination and observations should be made by a PG or PE.

Potential Hazard to Life: **high**

Potential Hazard to Property: **moderate**

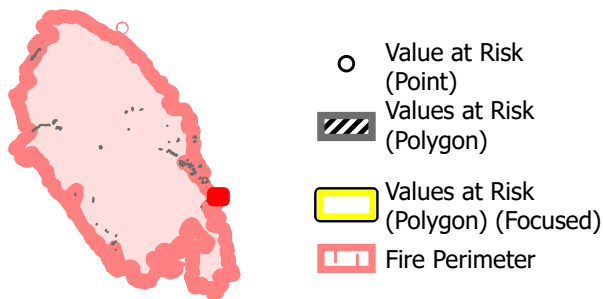
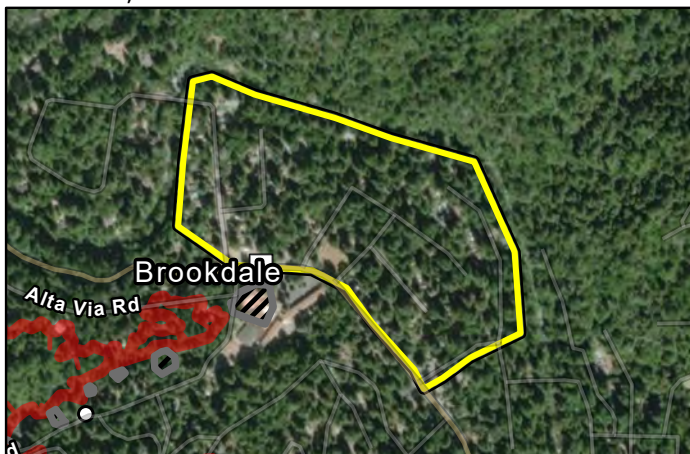
Field Observation Residential community on alluvial fan. Additional determination should be made or Potential Hazard: by a PG or PE

Potential Hazard to Life: **high**

Potential Hazard to Property: **high**

Description: 3.8 sq km drainage area above, uncertain where avulsion would flow, additional determinations and observations should be made by Professional Geologist/Engineer.

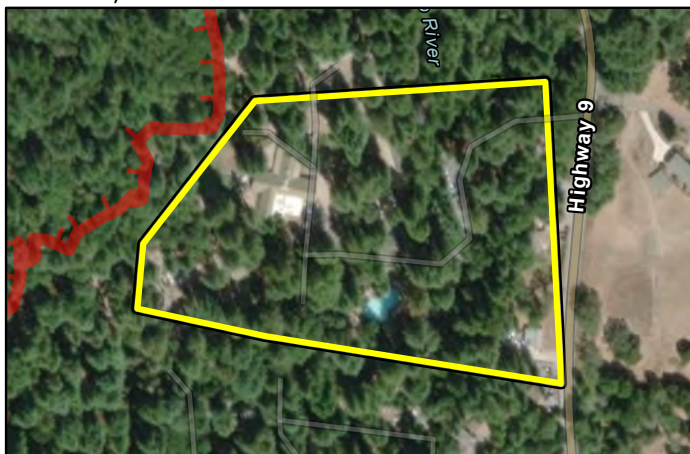
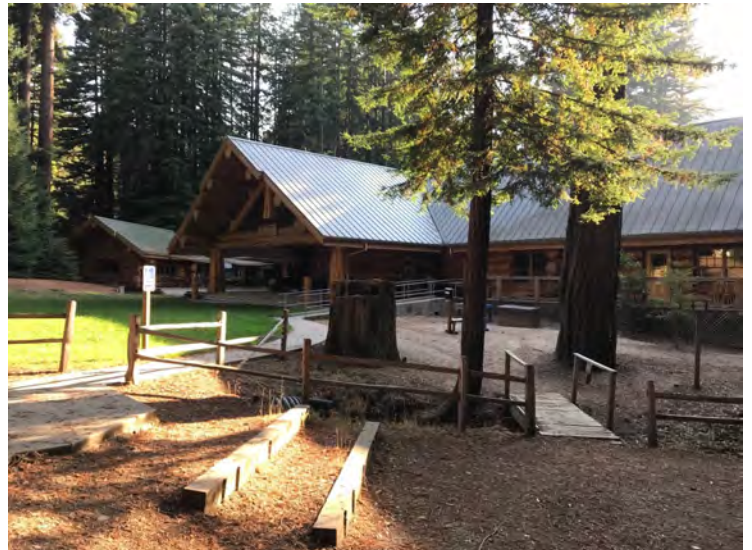
Field Observation or Potential Hazard: YMCA camp located along San Lorenzo River. Low debris flow potential on tributaries to San Lorenzo. Possible flooding on structures adjacent to San Lorenzo.

Potential Hazard to Life: **low**

Potential Hazard to Property: **moderate**

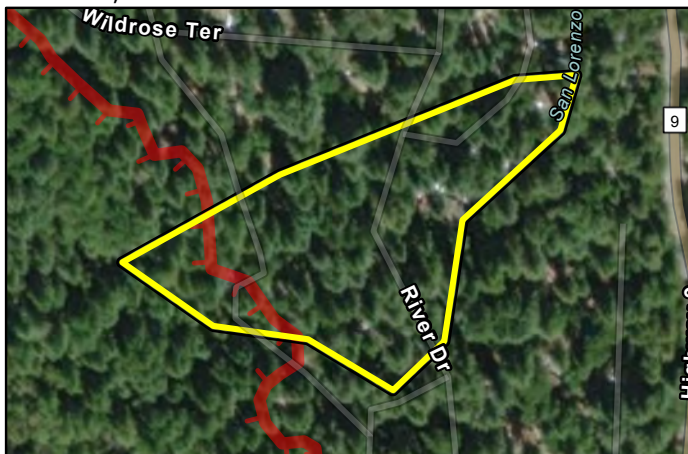
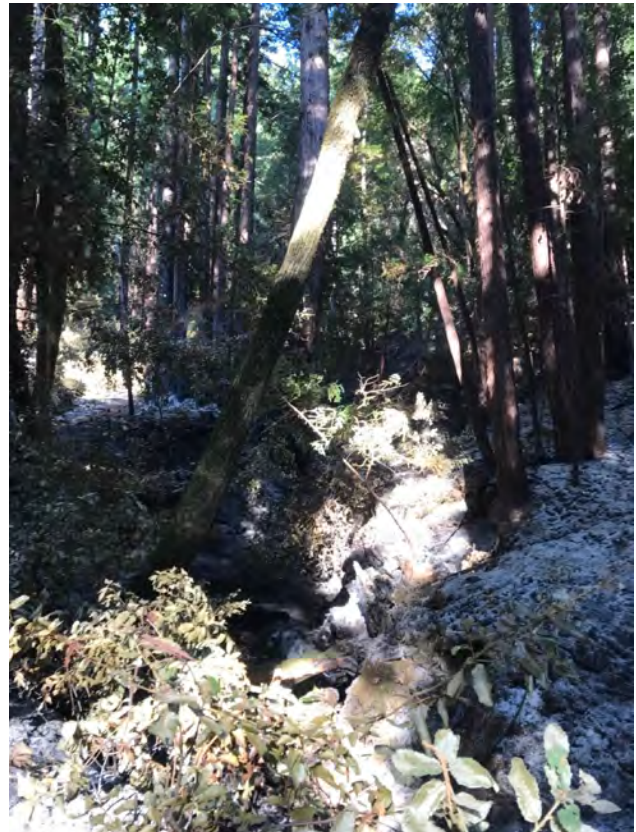
Field Observation or Potential Hazard: Low debris flow potential on tributary to San Lorenzo. Possible debris flow impacts to residential structures adjacent to San Lorenzo. Channel is deeply incised, near vertical side channels. Potential choke point at culvert crossing on Wildwood Road

Potential Hazard to Life: **moderate**

Potential Hazard to Property: **moderate**

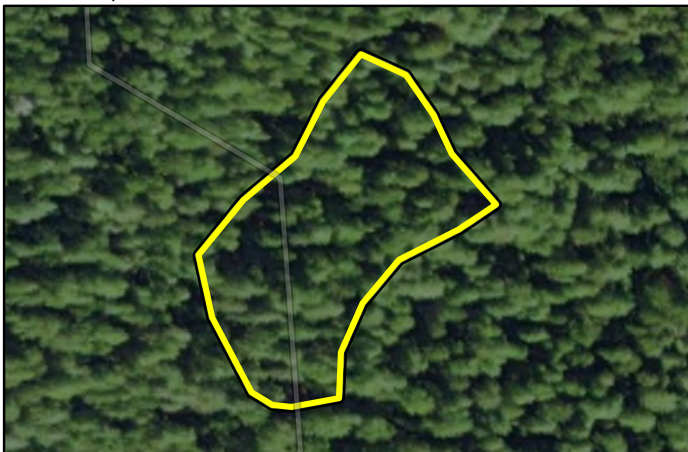
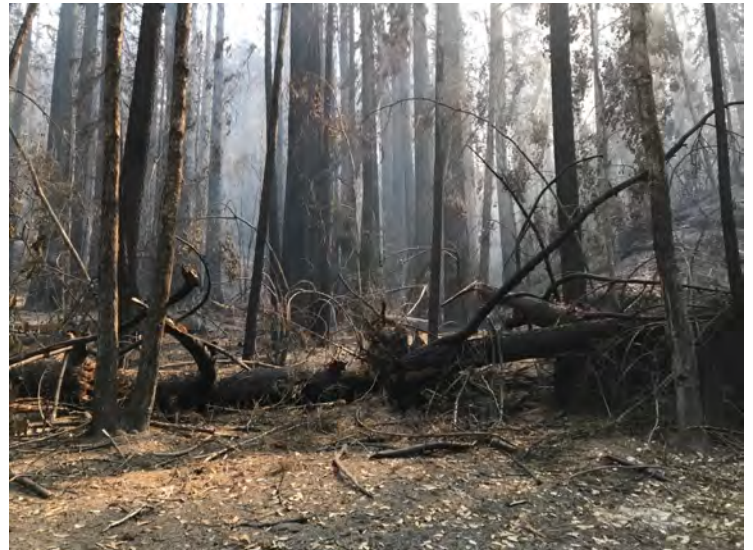
Field Observation Debris flow/slide. Campgrounds located on alluvial fan deposits visible of or Potential Hazard: hillshade imagery. Moderate to steep slopes above.

Potential Hazard to Life: **moderate**

Potential Hazard to Property: **low**

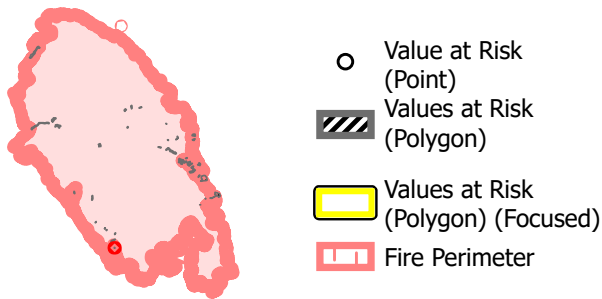
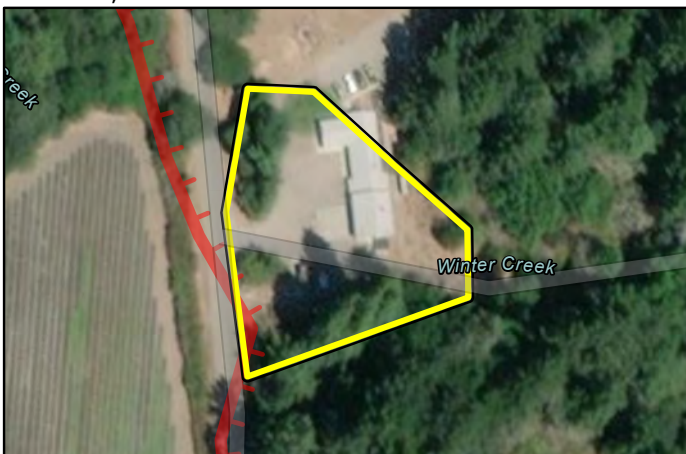
Field Observation Impact to CAL FIRE station including fuel tank. Plugging at culvert just
or Potential Hazard: upstream (east) of station, may direct flows towards structure and/gas vault.

Potential Hazard to Life: **moderate**

Potential Hazard to Property: **moderate**

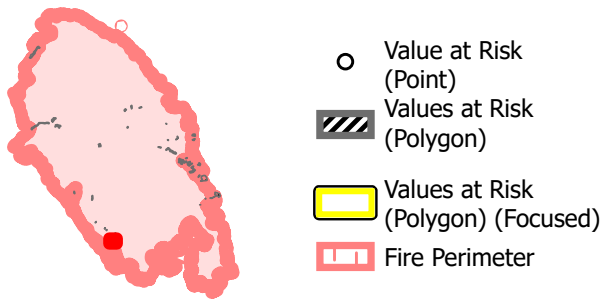
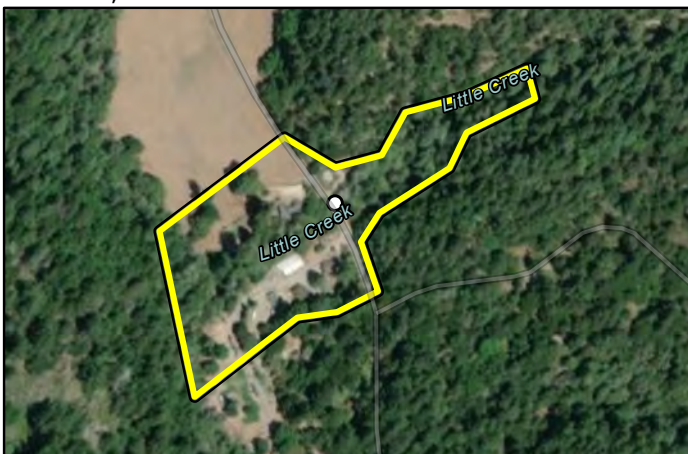
Field Observation Potential for flooding to impact temporary housing site. Existing structures or Potential Hazard: destroyed.

Potential Hazard to Life: **moderate**

Potential Hazard to Property: **moderate**

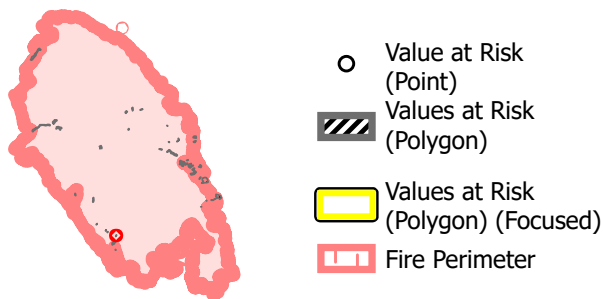
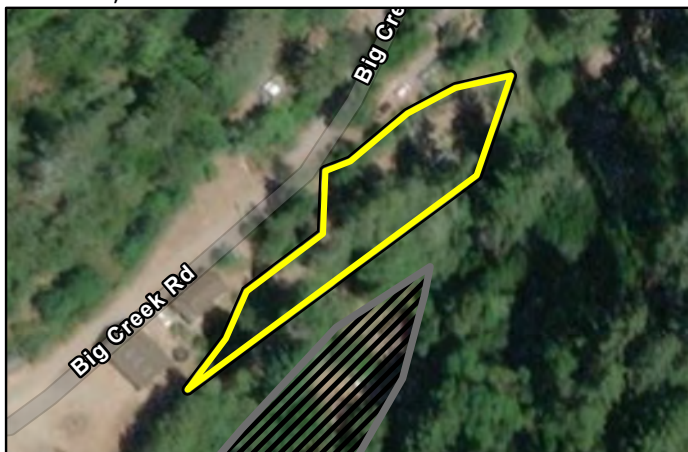
Field Observation Potential for flooding to impact temporary housing site. Existing structures or Potential Hazard: destroyed.

Potential Hazard to Life: **moderate**

Potential Hazard to Property: **moderate**

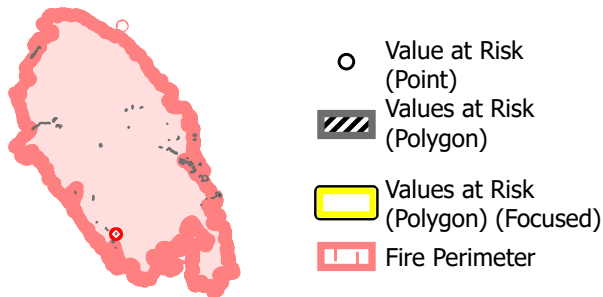
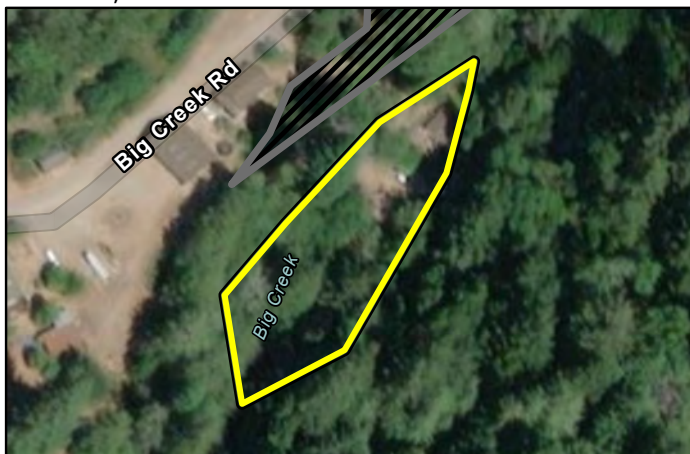
Field Observation Potential for flooding to impact temporary housing site. Existing structures or Potential Hazard: destroyed.

Potential Hazard to Life: **moderate**

Potential Hazard to Property: **moderate**

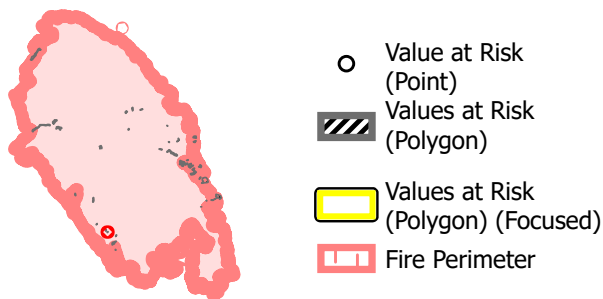
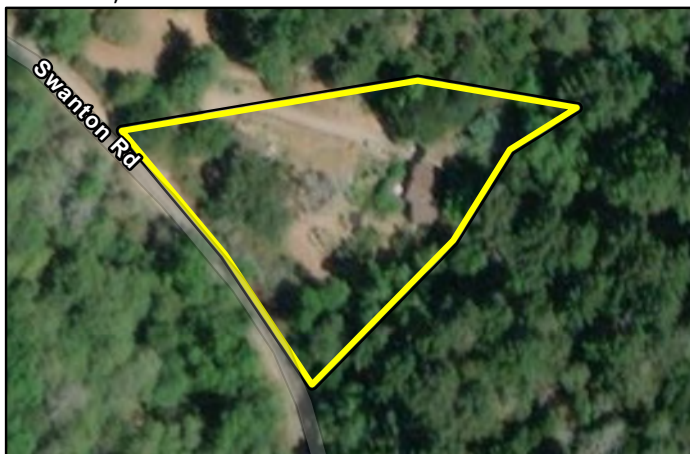
Field Observation Potential for flooding to impact temporary housing site. Existing structures or Potential Hazard: destroyed.

Potential Hazard to Life: **low**

Potential Hazard to Property: **low**

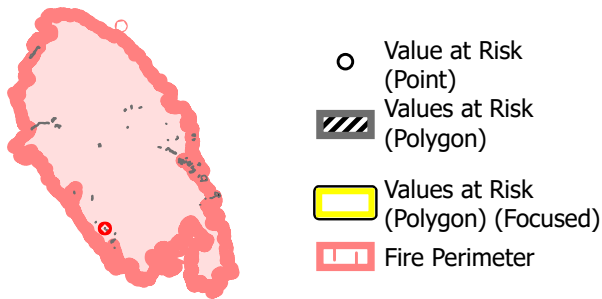
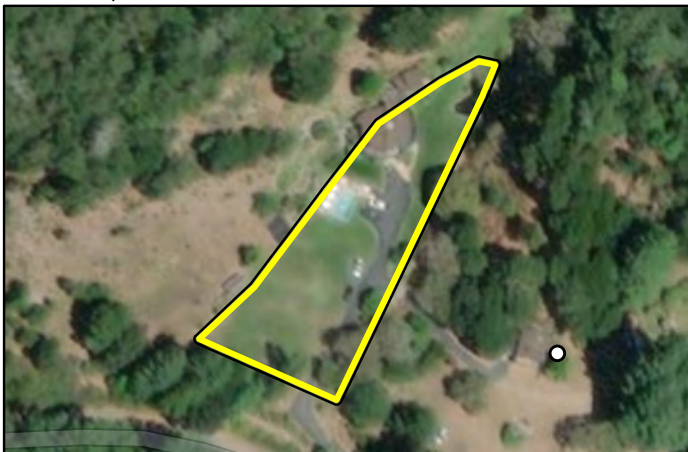
Field Observation Potential for flooding to impact temporary housing site. Existing structures or Potential Hazard: destroyed.

Potential Hazard to Life: **moderate**

Potential Hazard to Property: **moderate**

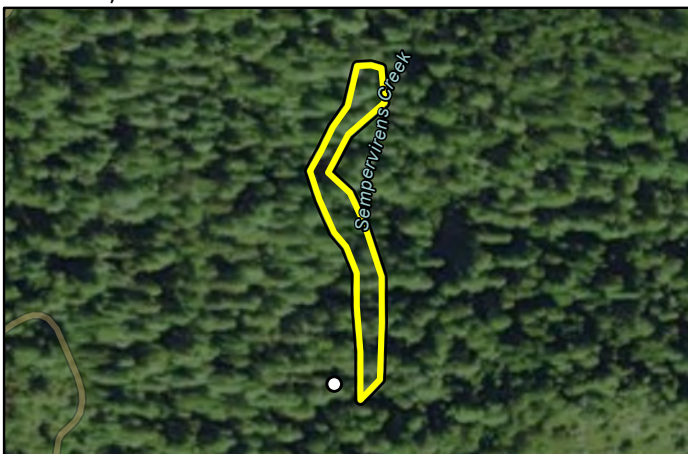
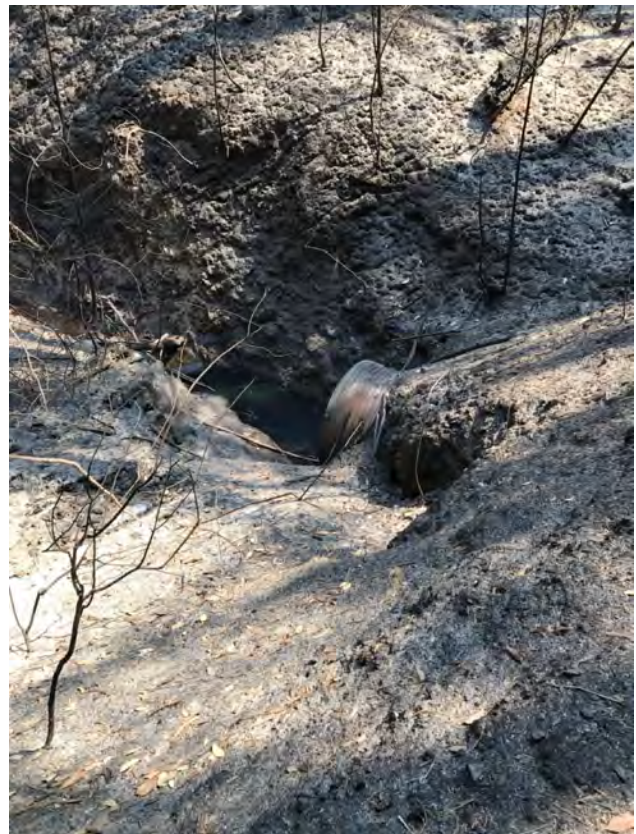
Field Observation Loss of access, numerous culverts along road prone to plugging and blowing
or Potential Hazard: out. Waterline from dam runs within road prism. Watercourse contains significant amount of woody debris

Potential Hazard to Life: **low**

Potential Hazard to Property: **moderate**

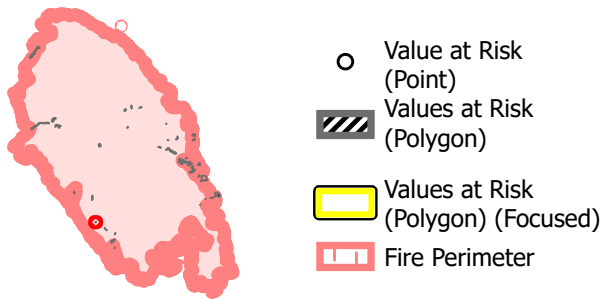
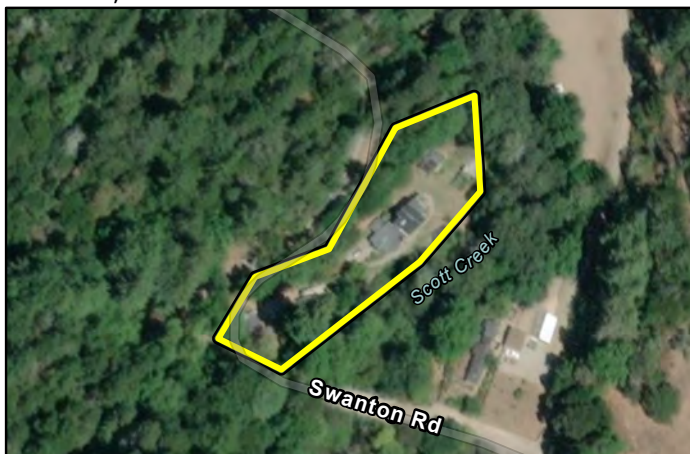
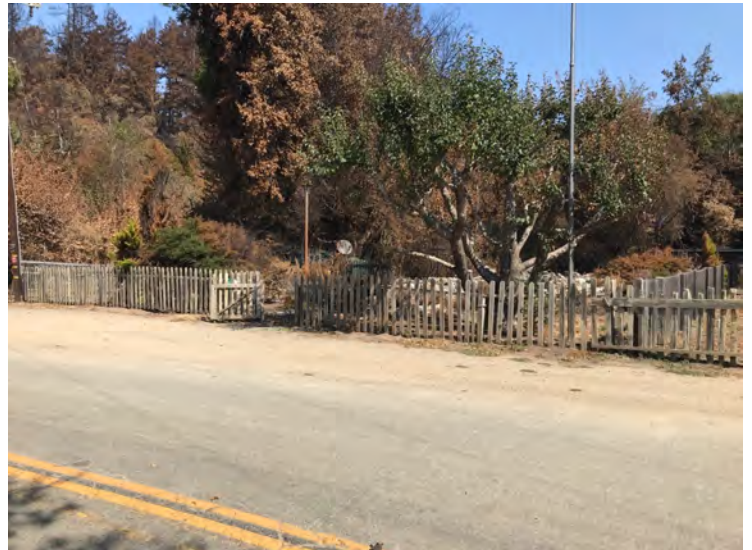
Field Observation Homes within floodplain
or Potential Hazard:

Potential Hazard to Life: **low**

Potential Hazard to Property: **moderate**

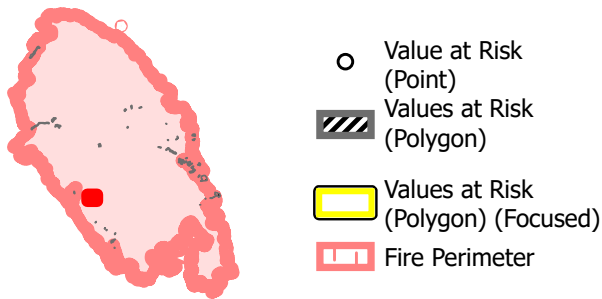
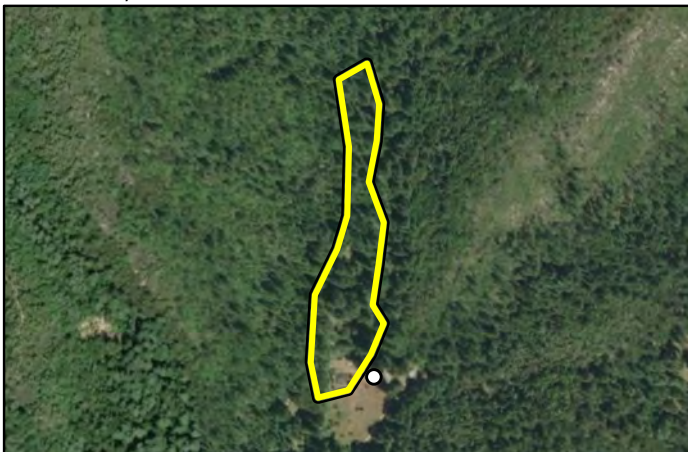
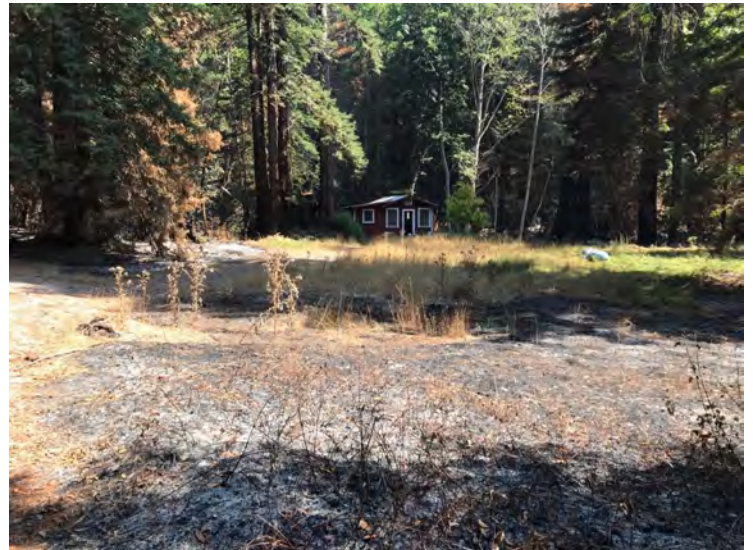
Field Observation Homes within floodplain
or Potential Hazard:

Potential Hazard to Life: **low**

Potential Hazard to Property: **moderate**

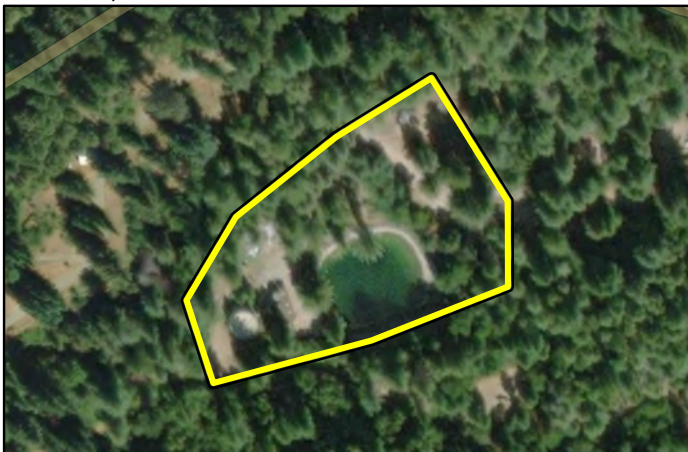
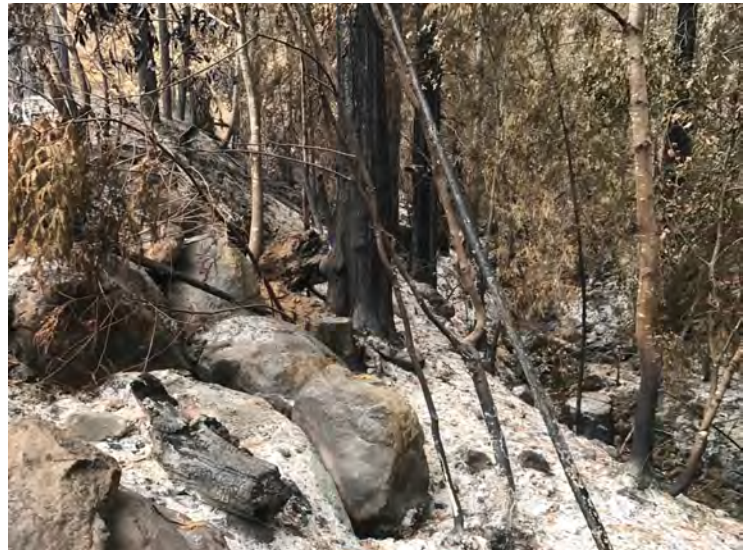
Field Observation or Potential Hazard: Domestic water company located on a tributary to Jamison Creek. Large boulders observed in channel indicate past debris flow activity and potential for avulsion.

Potential Hazard to Life: low

Potential Hazard to Property: moderate
